NAFLIC

TECHNICAL BULLETIN - FEBRUARY 1993

046. Zamperla Galleon Seating Arrangements 1

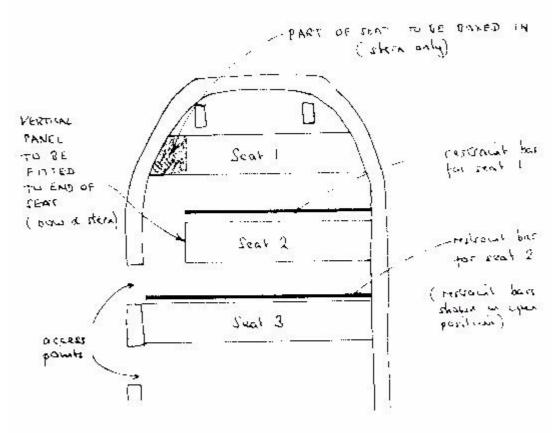
We have been informed by the Health & Safety Executive that they have noted, on one of these devices, that it is possible for passengers sitting at the extreme ends of the device to slip off the ends of the seats. The attached diagram helps to clarify the two problems.

The first problem is caused by the necessity for a walkway past the last but one seat and it was noted that there was no arrangement to stop a person sliding off this seat into the gangway. One remedy is obvious and entails fitting a raised timber shoulder or vertical panel to the end of the seat, thus providing a side stop.

Another problem has been noted on the rearmost seat, where the restraint does not extend the full length. Again, a passenger could slide along the seat to a position where they were not held securely. The reason for the shorter restraint is because, on most of these devices, there is a box fitted to the seat which physically forms a stop to prevent a passenger from sliding too far. In this instance the box had been removed.

Zamperla Pirate ship : Recommended informaments

Appointed Persons should check that either this box has not been removed or that a suitable alternative blocking device has been put in its place.
