TECHNICAL BULLETIN — JUNE 2008

## 339. Over the shoulder passenger restraint Safety Alert

## SAFETYALERT

**Drawing No:** SC-033-101  
**Item No:**

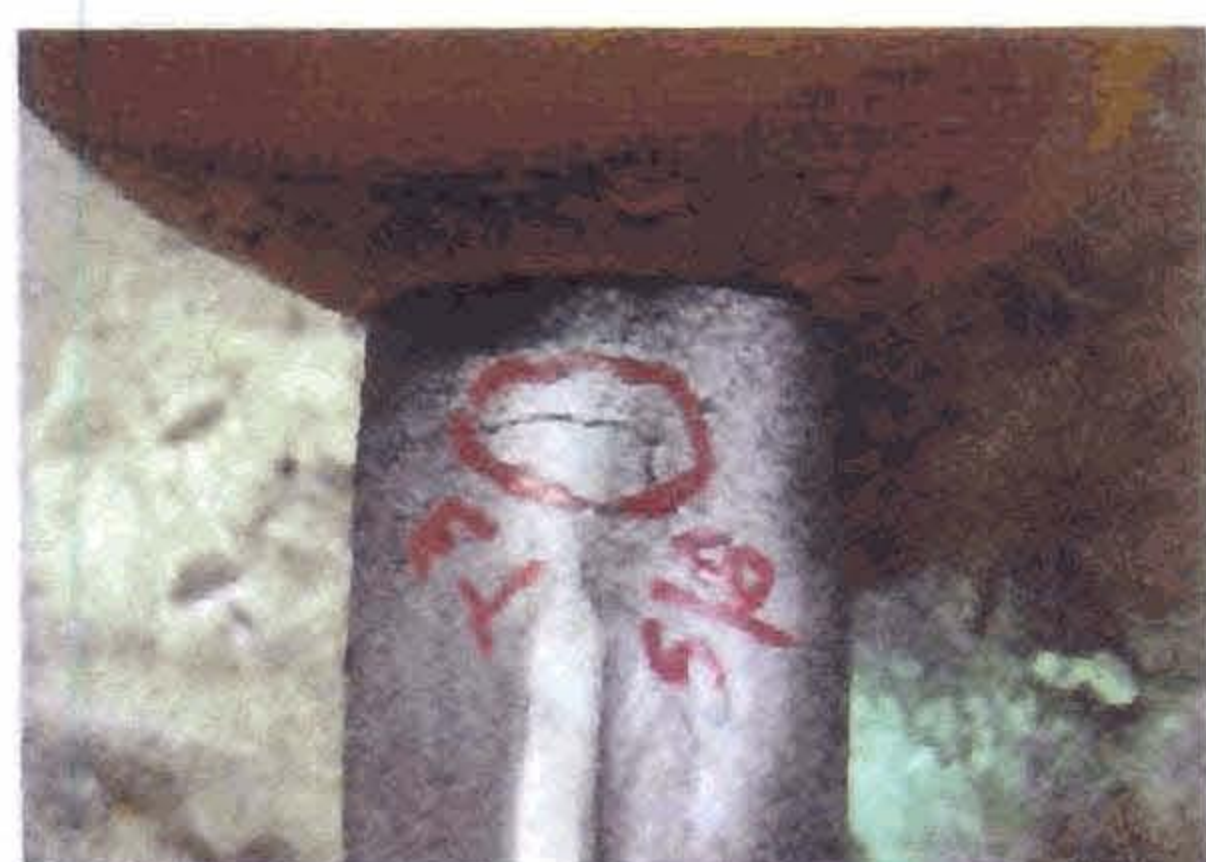
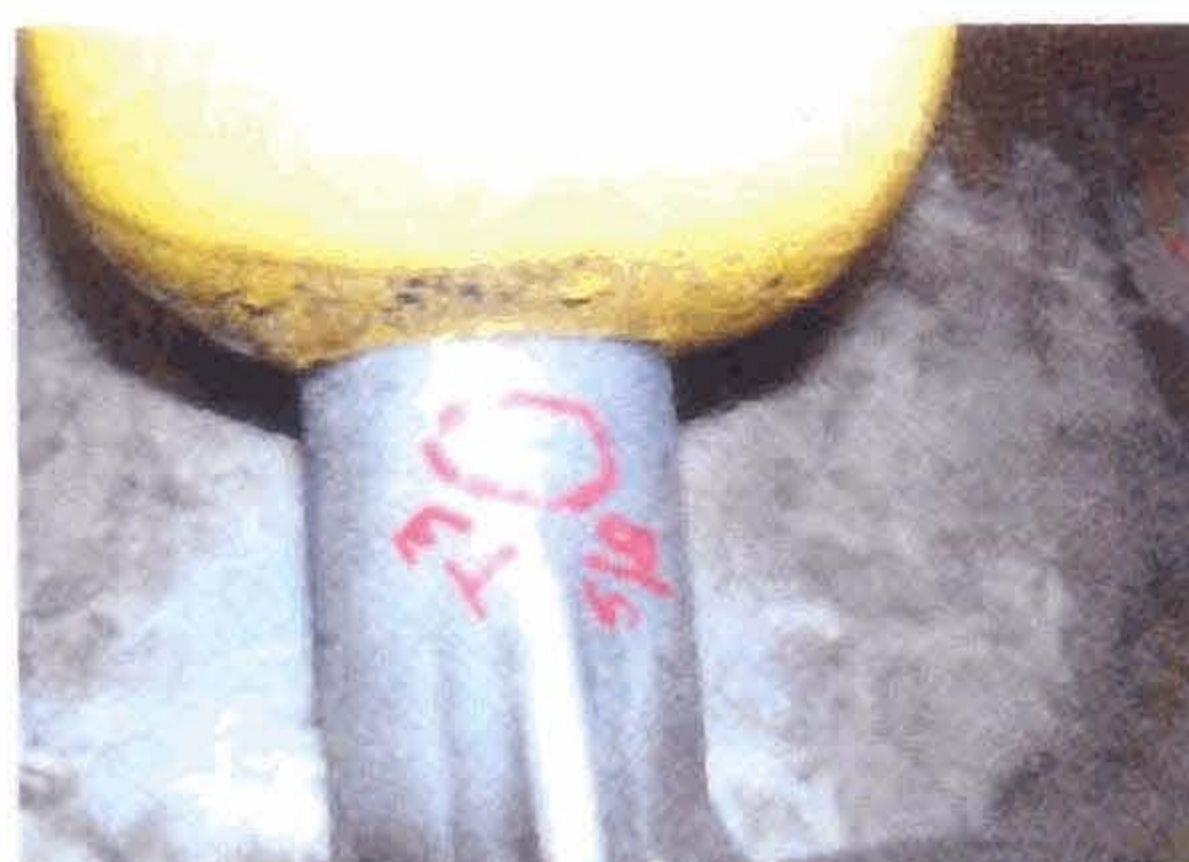
**Detail of Issue:**

Cracks were discovered on several harnesses.

**Indication found**

⇒ harness can be repaired if the indication is smaller than 25 mm (1 inch) in length. Harness presenting larger indication must be rejected and replaced.
