NAFLIC

TECHNICAL BULLETIN — JUNE 2008

341. Satori Techno Jump

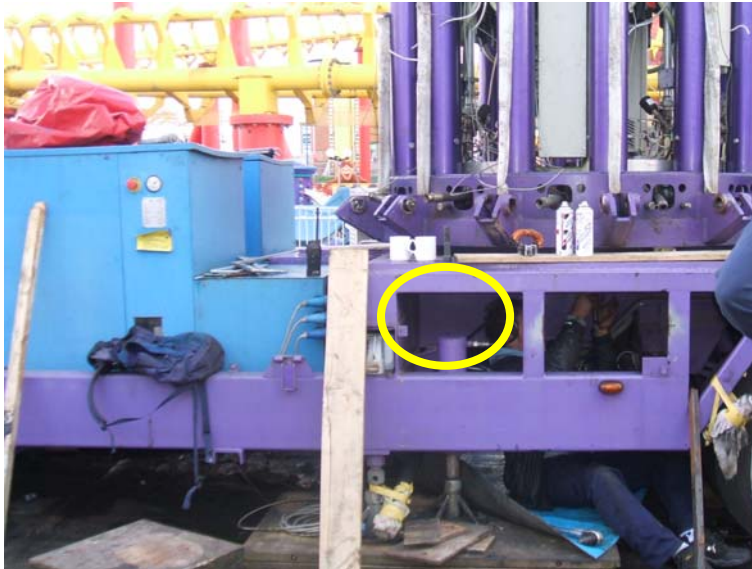
The cracking has occurred underneath the slewing ring bearing as shown below. Sartori have been informed about the defect for which they provided a repair scheme. However, the cracking re-appeared within one season. It is considered necessary that an inspection of this area is included in the annual in-service inspection and the controller should also ensure that the trailer structure is included in the documented periodic checks.

2. 1Location of cracking under the slewing ring.
