TECHNICAL BULLETIN — July 2014

374. Pinfari Z40 Anti Roll Back (ARB)

HEALTH AND SAFETY EXECUTIVE - SAFETY ALERT/SAFETY NOTICE/GENERAL SAFETY NOTICE

Pinfari Z40 Roller Coaster Car Runaway 2012

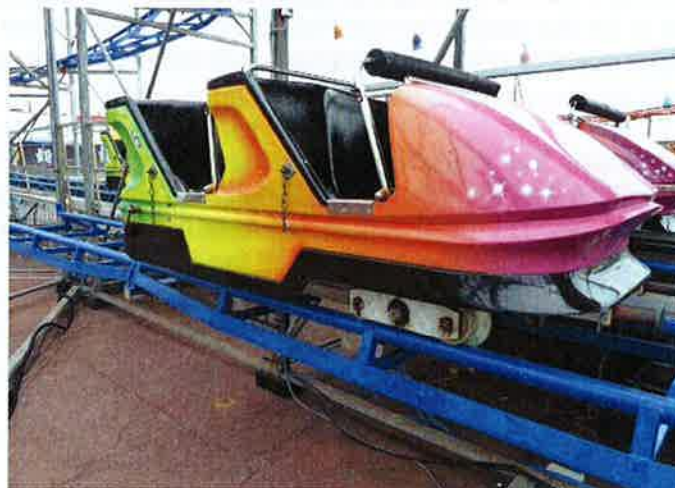
Fig 1

The HSE is issuing this notice to those who own, operate, maintain and inspect Pinfari Zyclone Z40 roller coasters. In 2012, a car carrying 3 people (one in front and two in the rear) was travelling up the lift hill of the coaster. As it reached the top, the car detached from the lift chain and rolled backwards down the hill. The anti fall back system failed and the car accelerated down the hill before re-entering the station and hitting the two waiting cars loaded with people.

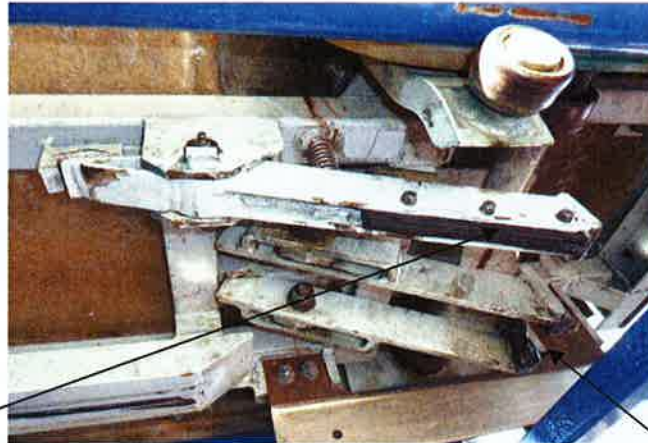
Fig 2

Anti fall back device

Chain Pawl

- Chain pawl - this is mounted on a pivot so that it can move up and down and is designed to locate onto the lift chain to pull the car up the lifts
- An anti-fall back device –this is mounted on a pivot. As the car is pulled up the hill the anti-fallback pawl is dragged over the stop blocks on the rack. The pawl should drop into each gap between the stop blocks as the cars moves up the hill. Therefore, in the event of the pick-up pawl becoming disengaged from the chain, the car should move no more than the pitch of the stop blocks/teeth (approximately 205 mm) before being brought to rest as the anti-fallback pawl engages on a stop block.

In this case, as the car reached the crest of the climb hill where the car starts to level out, the pawl disengaged and the car was not arrested as it descended the hill backwards.

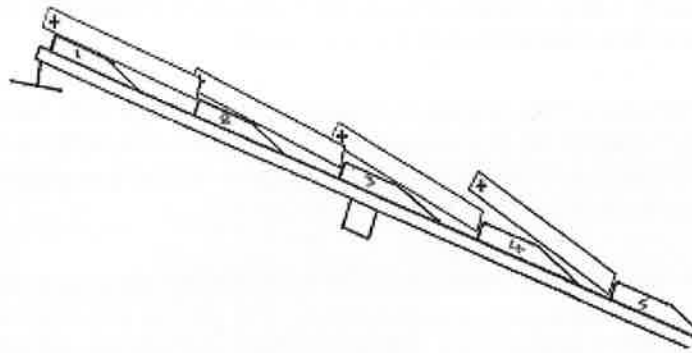
Fig 3

Further investigation found that there was only partial engagement of the anti-fallback pawl into stop blocks 2, 3 and 4 on the anti-fallback rack as the car was levelling out towards the brow of the hill. The pawl was sitting over the back of the preceding stop block and was only partially engaging at the top of the block. (see Fig 3)

ANTI ROLL BACK PAWL & RACK

Therefore the anti-rollback pawl was not able to fully engage when the chain disengaged and the car began to roll back.

- Each operator/owner should undertake a functional test, stop by stop, to ensure the full engagement of the anti fall back pawl into each of the rack stops blocks particularly in the top section.

If the anti fall back pawl does not engage properly at the bottom of each stop then the profile of the stops should be adjusted to ensure correct engagement at each one.
