NAFLIC

TECHNICAL BULLETIN — July 2014

380. Safeco Crazy Frog Arms

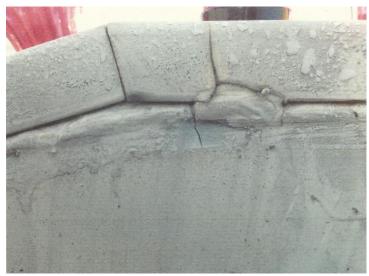
Defects have been reported by Capital Inspection Services whilst undertaking NDT on a Safeco Crazy Frog. Defects were found in three radial arms and the information from Capital is that the cracking was located 30mm from the change in section, partway along the radial arm. This particular device was manufactured in 2006.

Sketch showing location of cracking on the 2006 device

IBs and controllers are reminded that any attachment added after the initial fabrication of the device, such as drilling a hole to fix a conduit or tack welding on a short attachment, will have the affect of causing a stress concentration. This concentration will not have been accounted for in the original design assumptions and will likely reduce the expected (design) life of the device. Any safety critical modification to the device, such as the attachments described above, requires a Design Review by a registered IB.

This type of tack welding can initiate defects at or near the toe of the weld. All welds on Crazy Frog devices, including tack welds that attach lighting strips and other nonstructural items, should be visually inspected by the controller on a daily basis.
