## Bolliger and Mabillard Flying Coaster

### SERVICE BULLETIN

FLYING COASTER

Driving wheels gearbox shafts

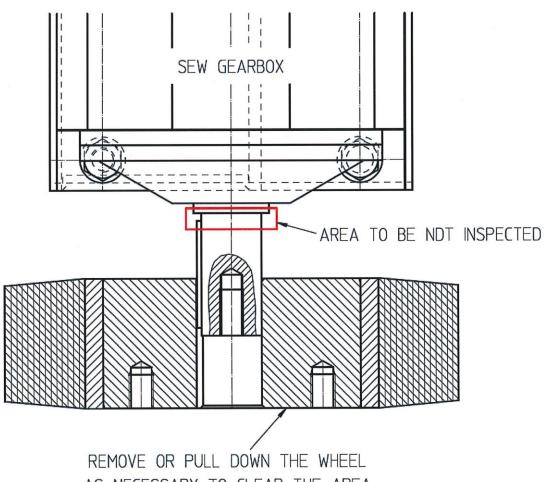
#### Detail of issue:

AS NECESSARY TO CLEAR THE AREA TO BE NDT INSPECTED

- NDT inspection (MT or PT) of all driving wheels gearbox shafts of the station, transfer, lift base, brake and waiting areas within 30 days as per Detail of issue. (Maintenance area excepted)
  Replace the gearbox immediately if indication is found.
- Annual NDT inspection (MT or PT) of all driving wheels gearbox shafts of the station, transfer, lift base, brake and waiting areas as per Detail of issue. (Maintenance area excepted)
- At every wheel replacement, carefully clean the area and carry out a close visual inspection as per Detail of issue. In case of any doubt, proceed with a MT or PT inspection.
