440.

Simuline Mini Rider 2 cracking

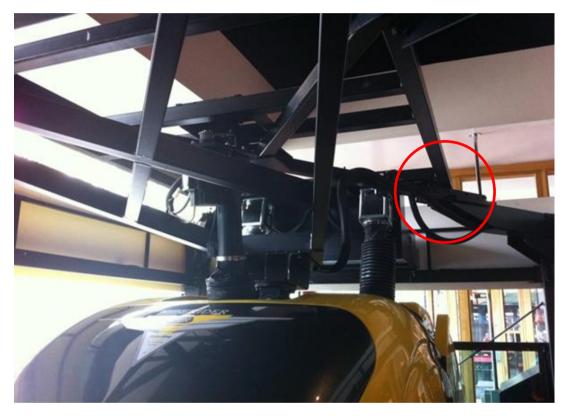
Photo shows the general location of the cracking on the main support frame.

Controllers and inspection bodies should pay particularly close attention to these areas when carrying out maintenance checks and inspections.

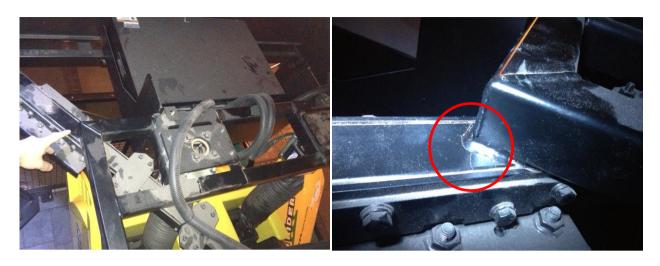
Main area of cracking, looking from the top of the frame. Cracks extend across the top of the $50 \times 50 \text{ mm}$ box section and down either side (possibly also underneath).

The adjacent bracket is also cracked in some instances, as shown in the photographs below.
