NAFLIC - Standards & Related Documents Committee | TECHNICAL BULLETIN

## **476.** Zamperla Samba Balloons pinion failure

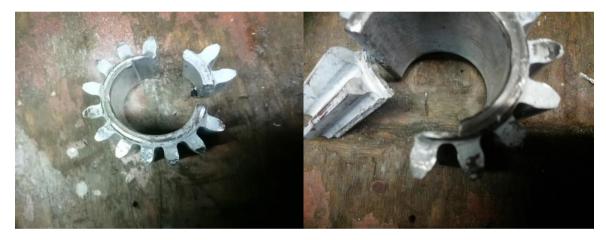
Figure 1

NAFLIC has been informed by a UK inspection body of the failure of a drive pinion during service on a Zamperla Samba Balloons. On further investigation, it was determined that the failure had originated from the keyway.

The manufacturer has been contacted and it is understood that the keyway on the pinion had been manufactured in the incorrect position.
