Dartron

Bulletin # SB-5K-091208

SERVICE BULLETIN

Ride Name: Cliff Hanger

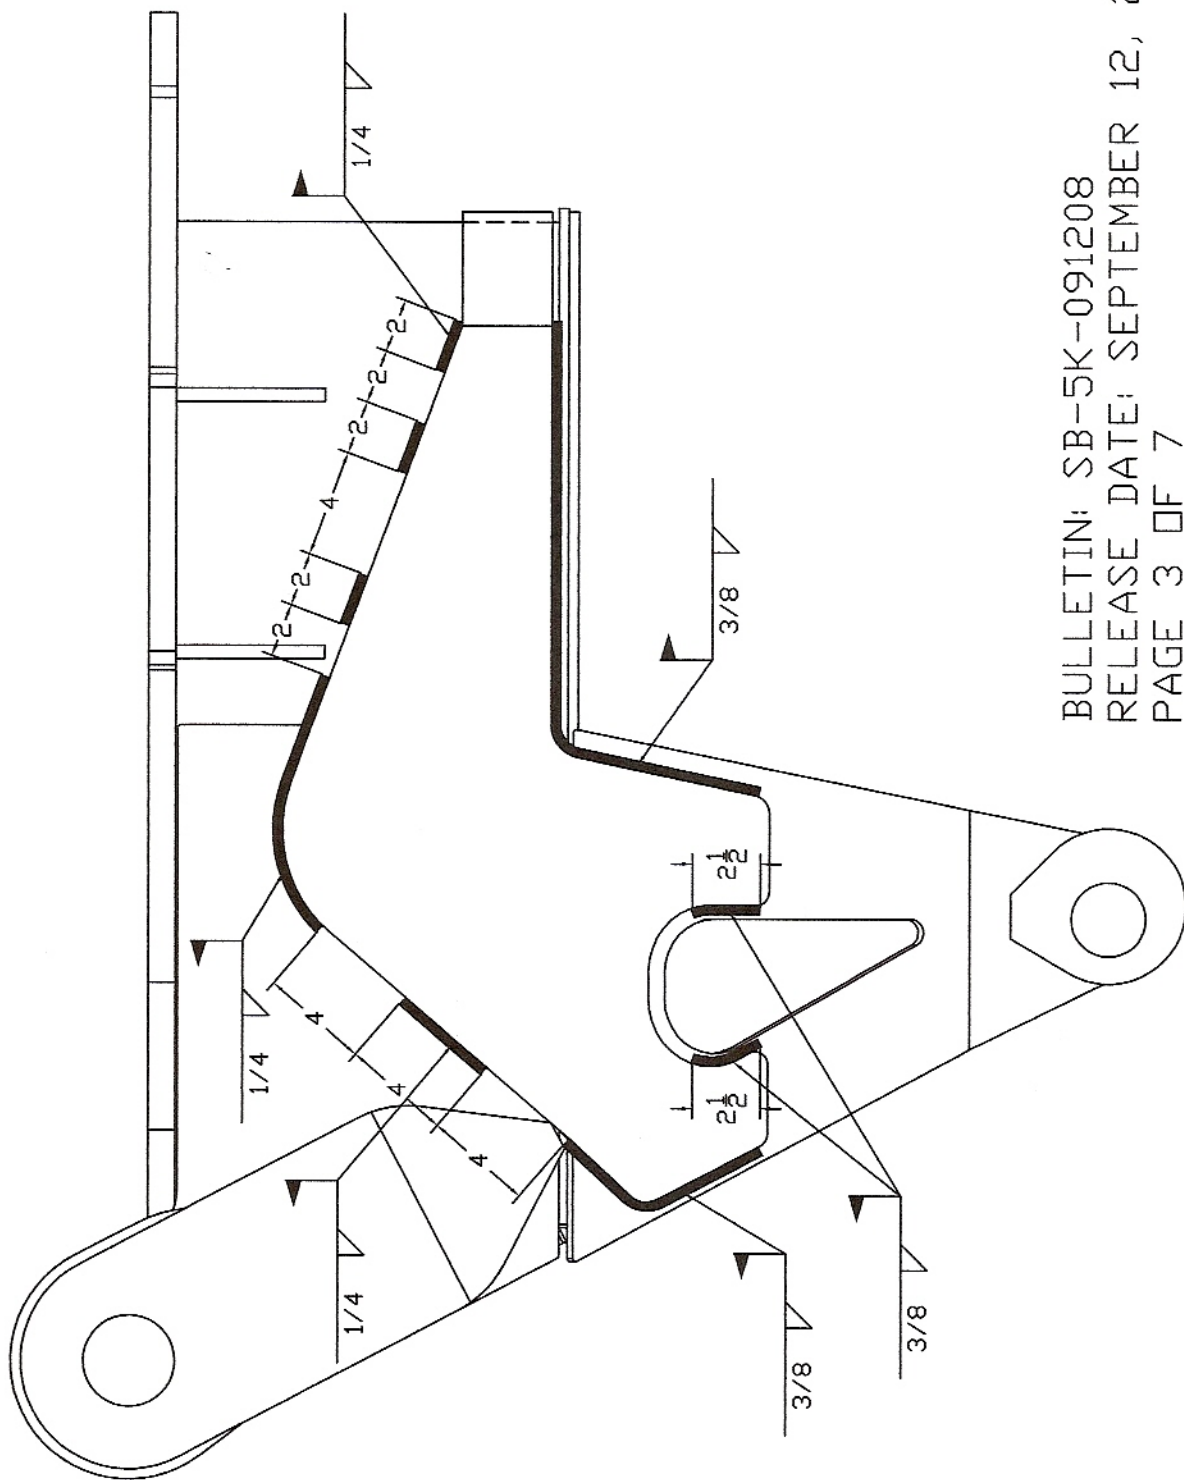
BULLETIN: SB-5K-091208
 RELEASE DATE: SEPTEMBER 12, 2008
 PAGE 3 OF 7

1. The ride must be set-up to perform this inspection.
2. The boom must be raised off of the boom rest pad and the Commutator Cover Plate must be removed to inspect some of these areas.
3. Five areas must be visually inspected for cracks. Those areas are shown on the drawings on pages 3 - 6 as detail areas A, B, C, D and E.
4. The areas to be inspected must be cleaned so that they are free of dirt and grease.
5. Visually inspect the location of the reinforcing plates and the associated welds as shown on pages 3 and 4.
6. Visually inspect the five areas for cracks or broken paint.
7. If broken paint is found, the paint must be removed to allow a more thorough visual crack inspection.
8. Verify the modifications to the sweep support jack assembly are per the drawing on page 7 of this bulletin.
9. If a crack is discovered please contact Dartron at 503-362-2536 to coordinate repairs.

1. A one time visual inspection must be conducted to inspect for cracks in the upper and lower bearing base as detailed below.
2. Inspect the reinforcing plates to confirm that they are installed as required by Bulletin PI-5K-003.
3. Inspect the sweep support jack to confirm that the modifications are correctly implemented as required in Bulletin SB-5K-001.
4. If cracks are found, repairs need to be completed per Dartron Specified procedures and Dartron must be notified.

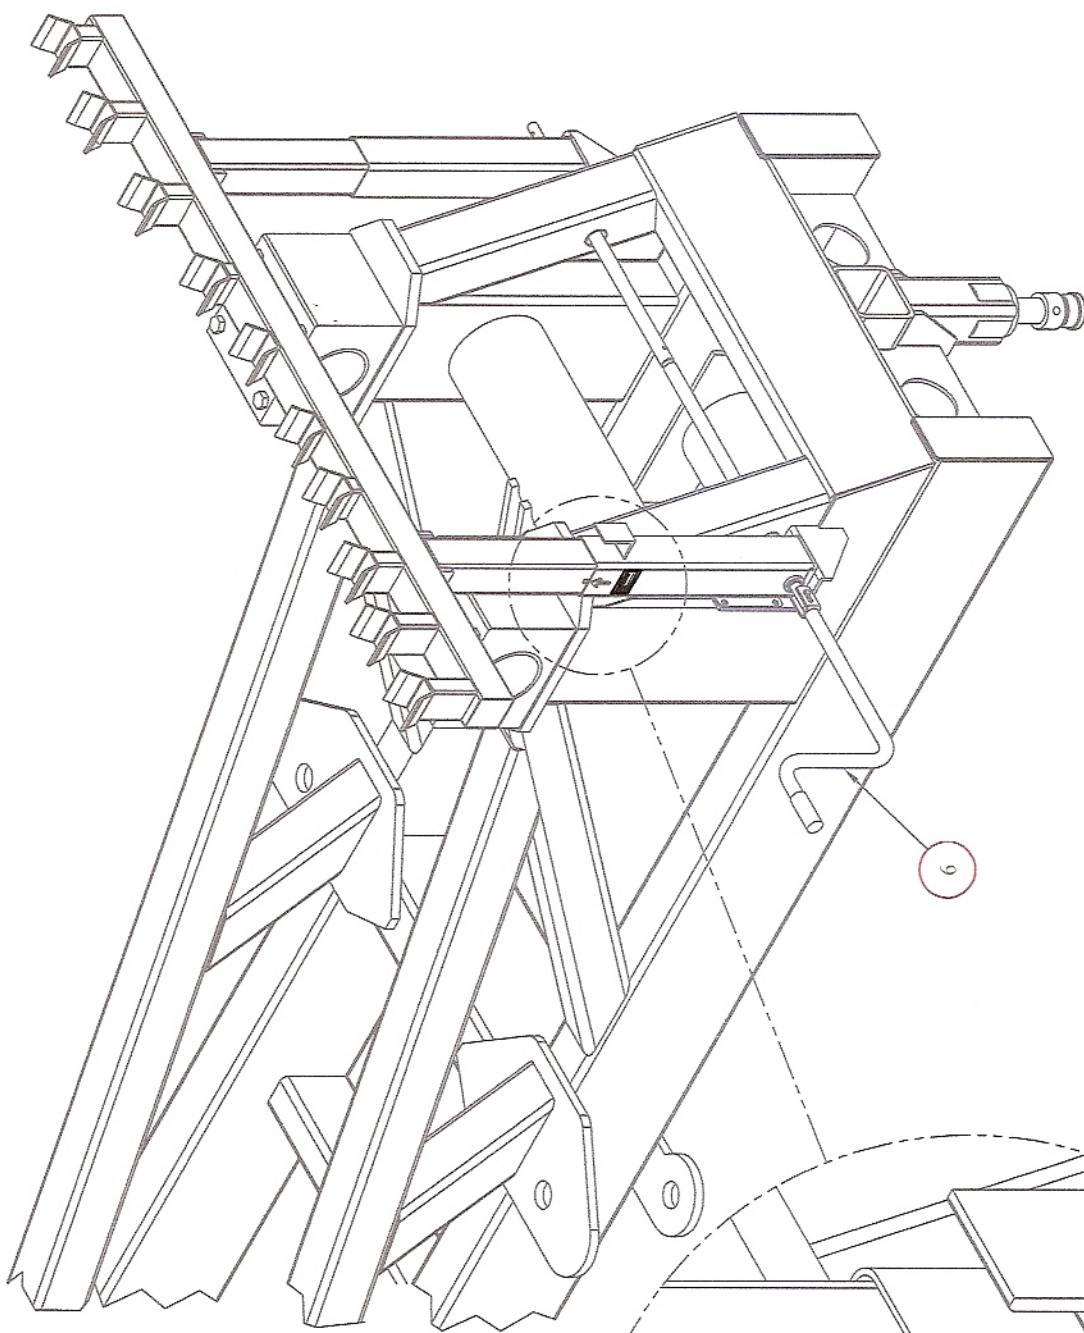
- 1. INNER TUBE
- 2. OUTER TUBE
- 3. ARROW
- 4. REFERENCE HOLE
- 5. WARNING PLACARD
- 6. CRANK HANDLE
