SORIANI srl

Bulletin No: 2005 TF03

SERVICE BULLETIN

Affected Production Dates: All manufactured before date of
issueRide Name: Turbo Force and
StratosphereAffected Serial Nos.: GTF08R001US99 GTF08R00141US
GTF08R00317US GTF08R00444US GTF08R00445US
GTF08R01158US

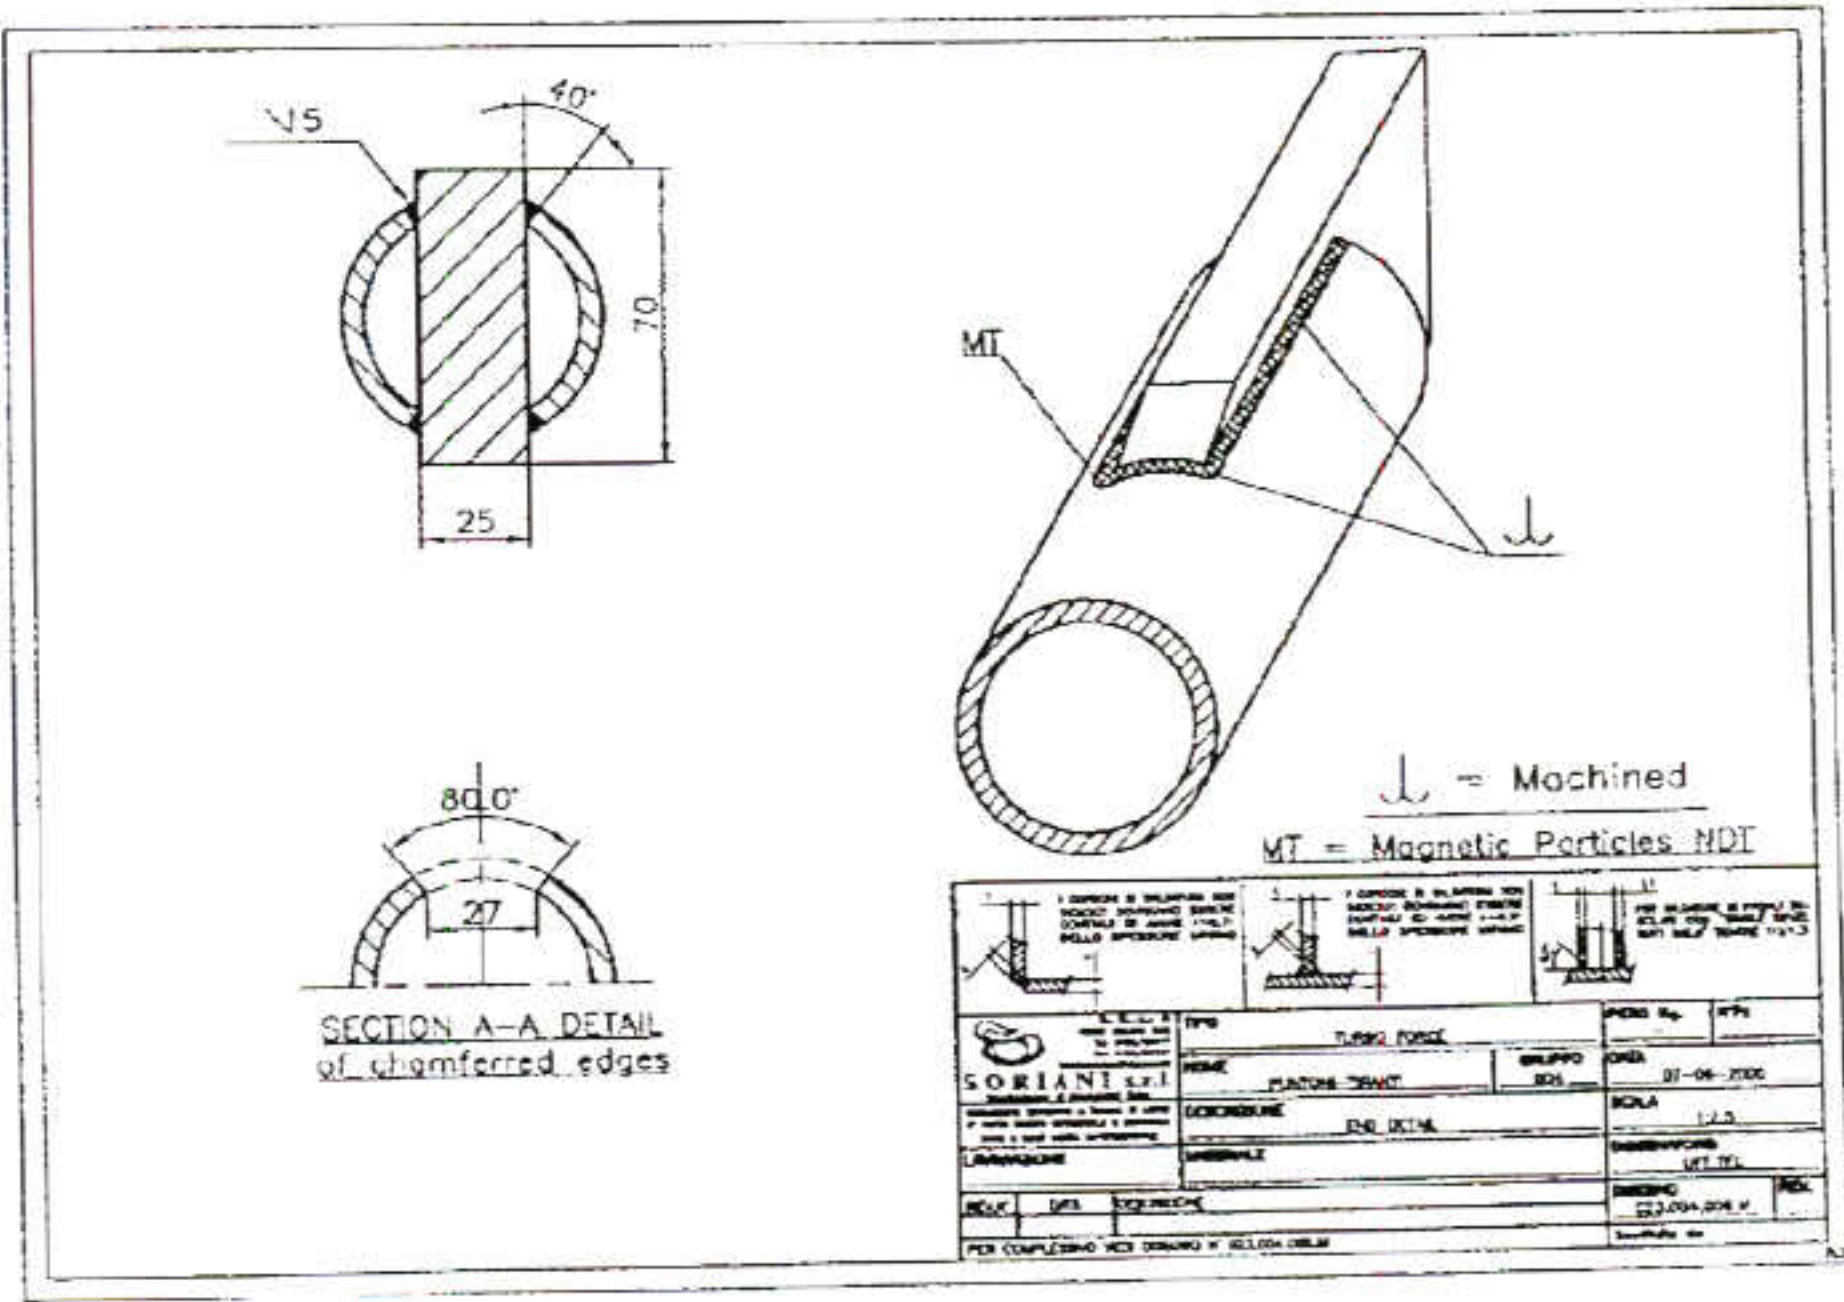
The notch in the pipe to for the 25 mm steel plates must be machined and have a chamfer along its sides and ends to accommodate the weld bead. The steel plate must be welded to the pipe all around, which is recommended by the DIN Standard 15018, on table 31, notch case K3, code 342 and code 343. The slot in the pipe will accommodate a plate with angled ends, which is welded with a single bevel butt weld with fillet weld. The weld is then machined across the end and 125mm back along each side, starting at the end to avoid notch effect. (DIN 15018 is the reference standard for the design and calculation of the Turbo Force). After welding and machining the weld is to be inspected by magnetic particle. See following diagram and drawing:

Code	Description and illustration	Symbol
343	Continuous component slotted to accommodate a plate with chamfered or radlused ends, which is welded on. The end welds in the zone not less than $5 \times t$ in width are made in the form of double bevel butt weld with double fillet welds and machined to avoid notch effect.

End weld only.

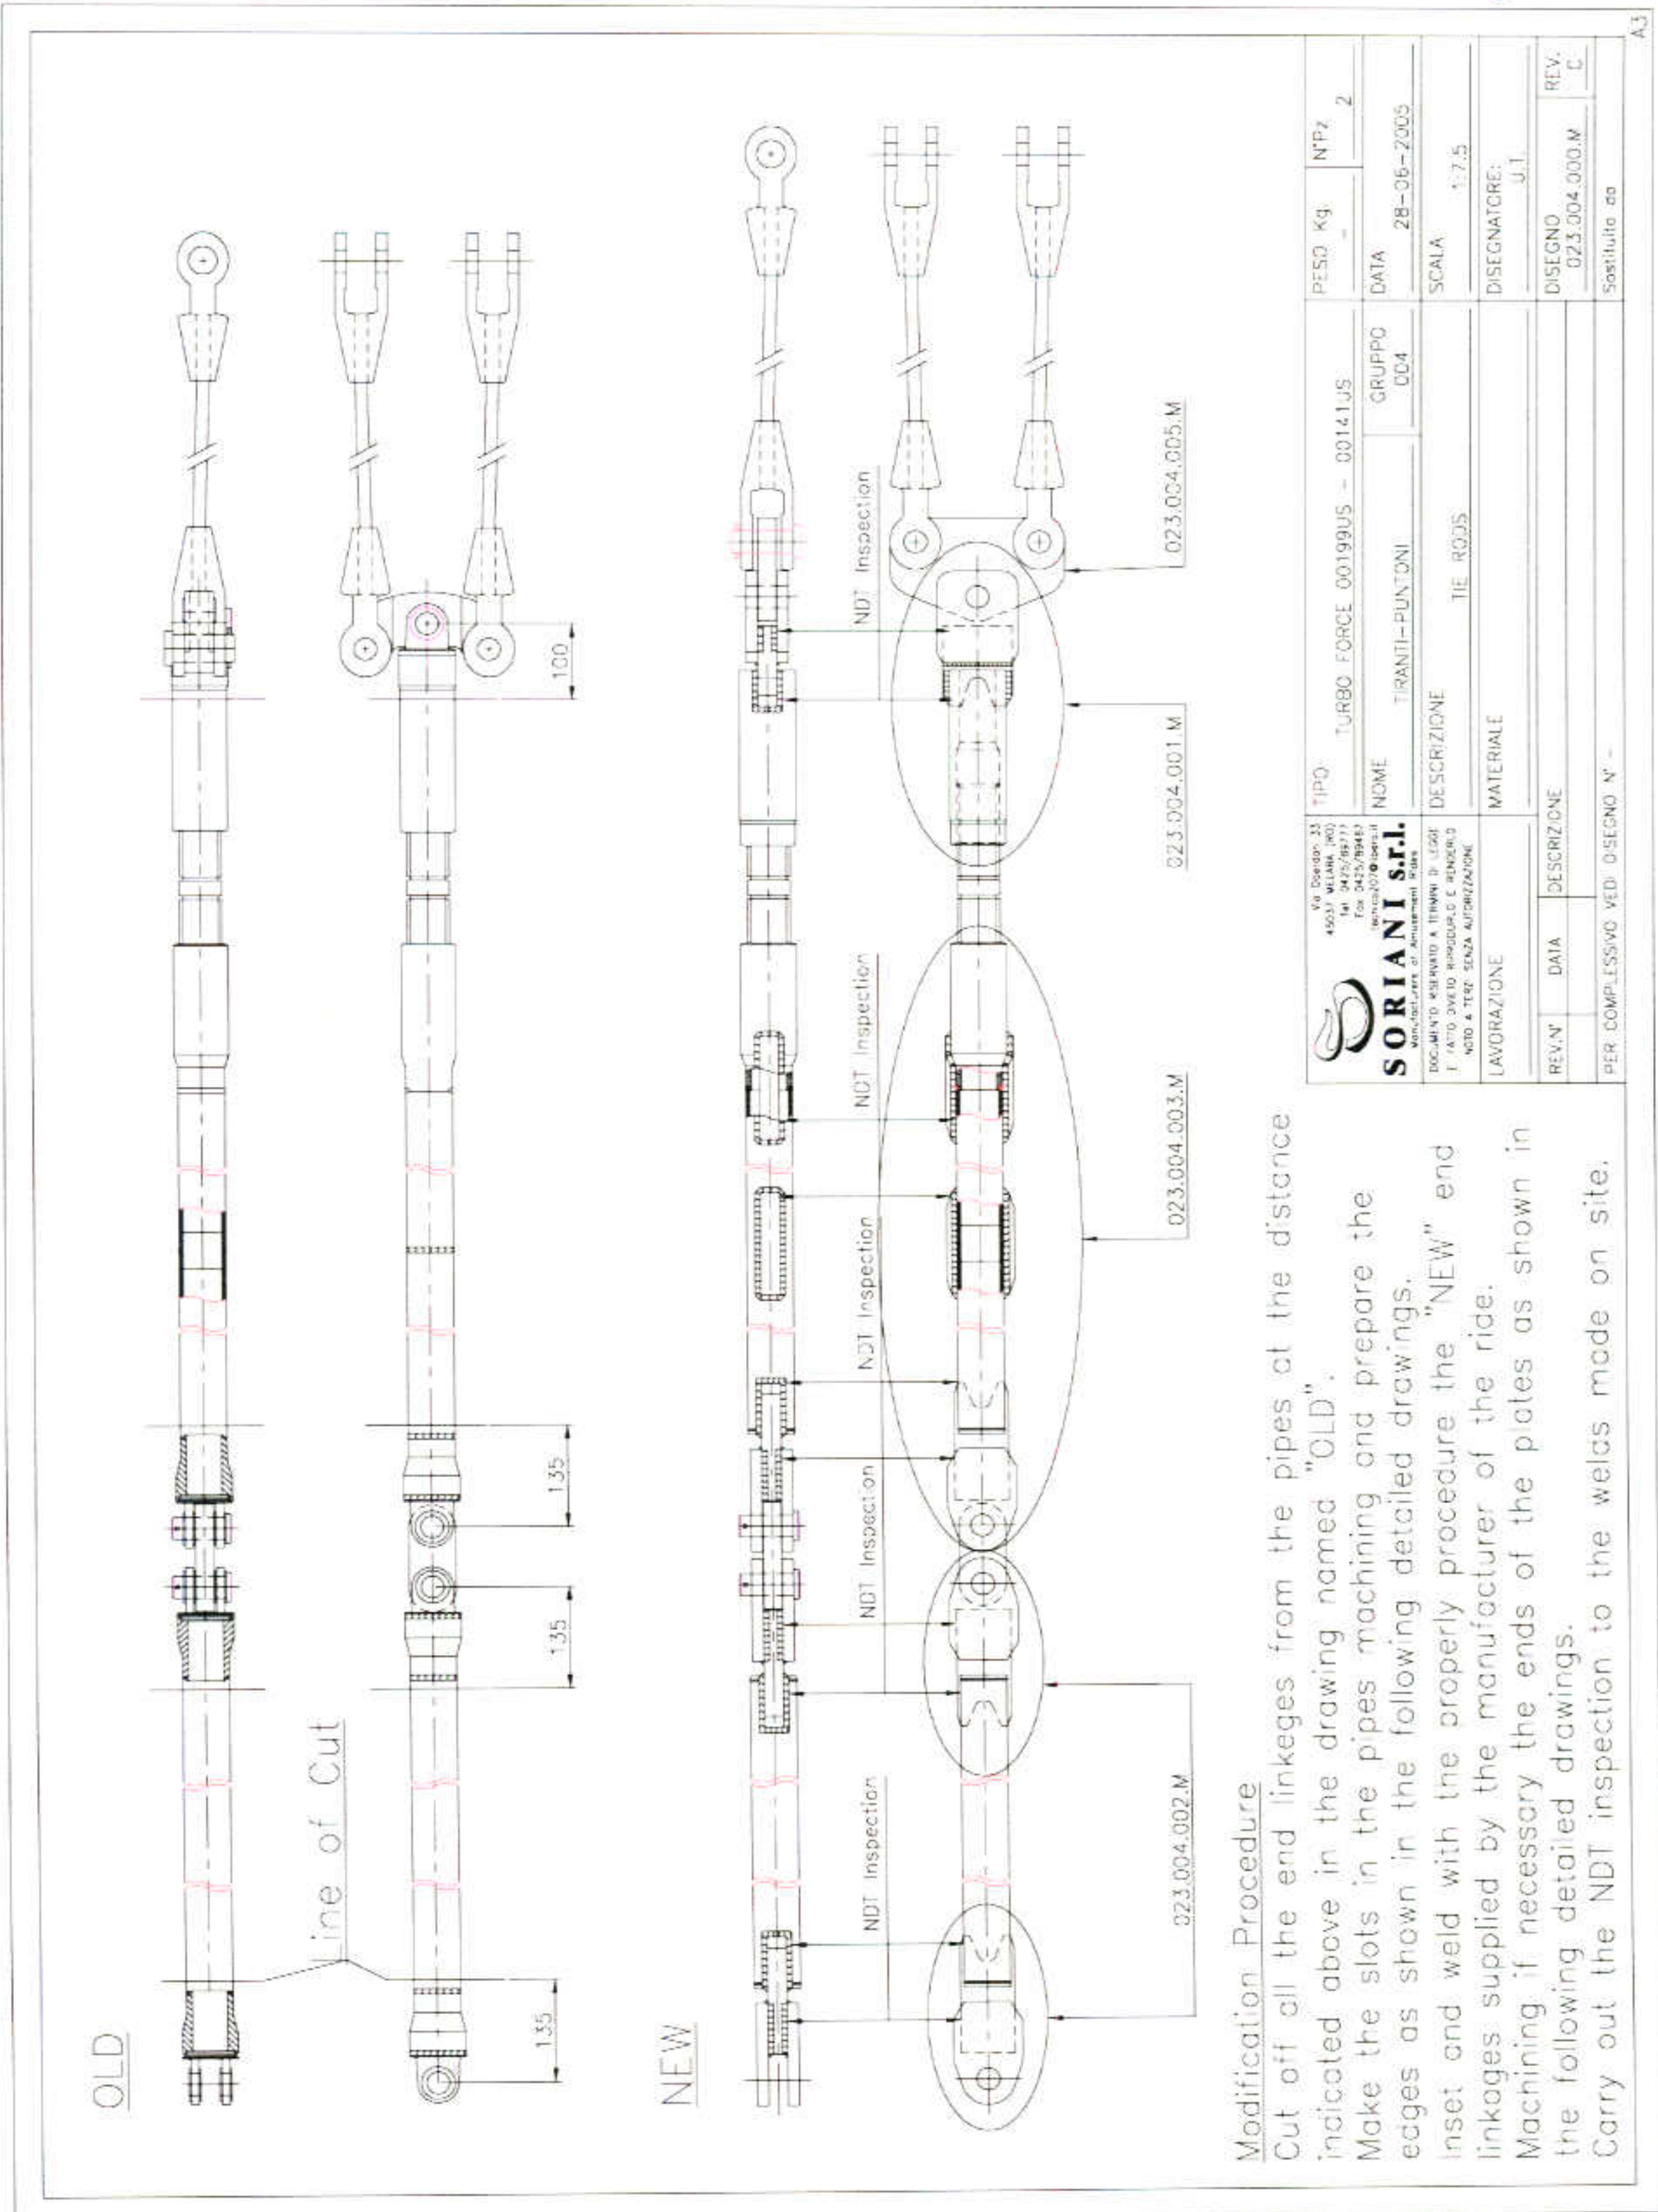
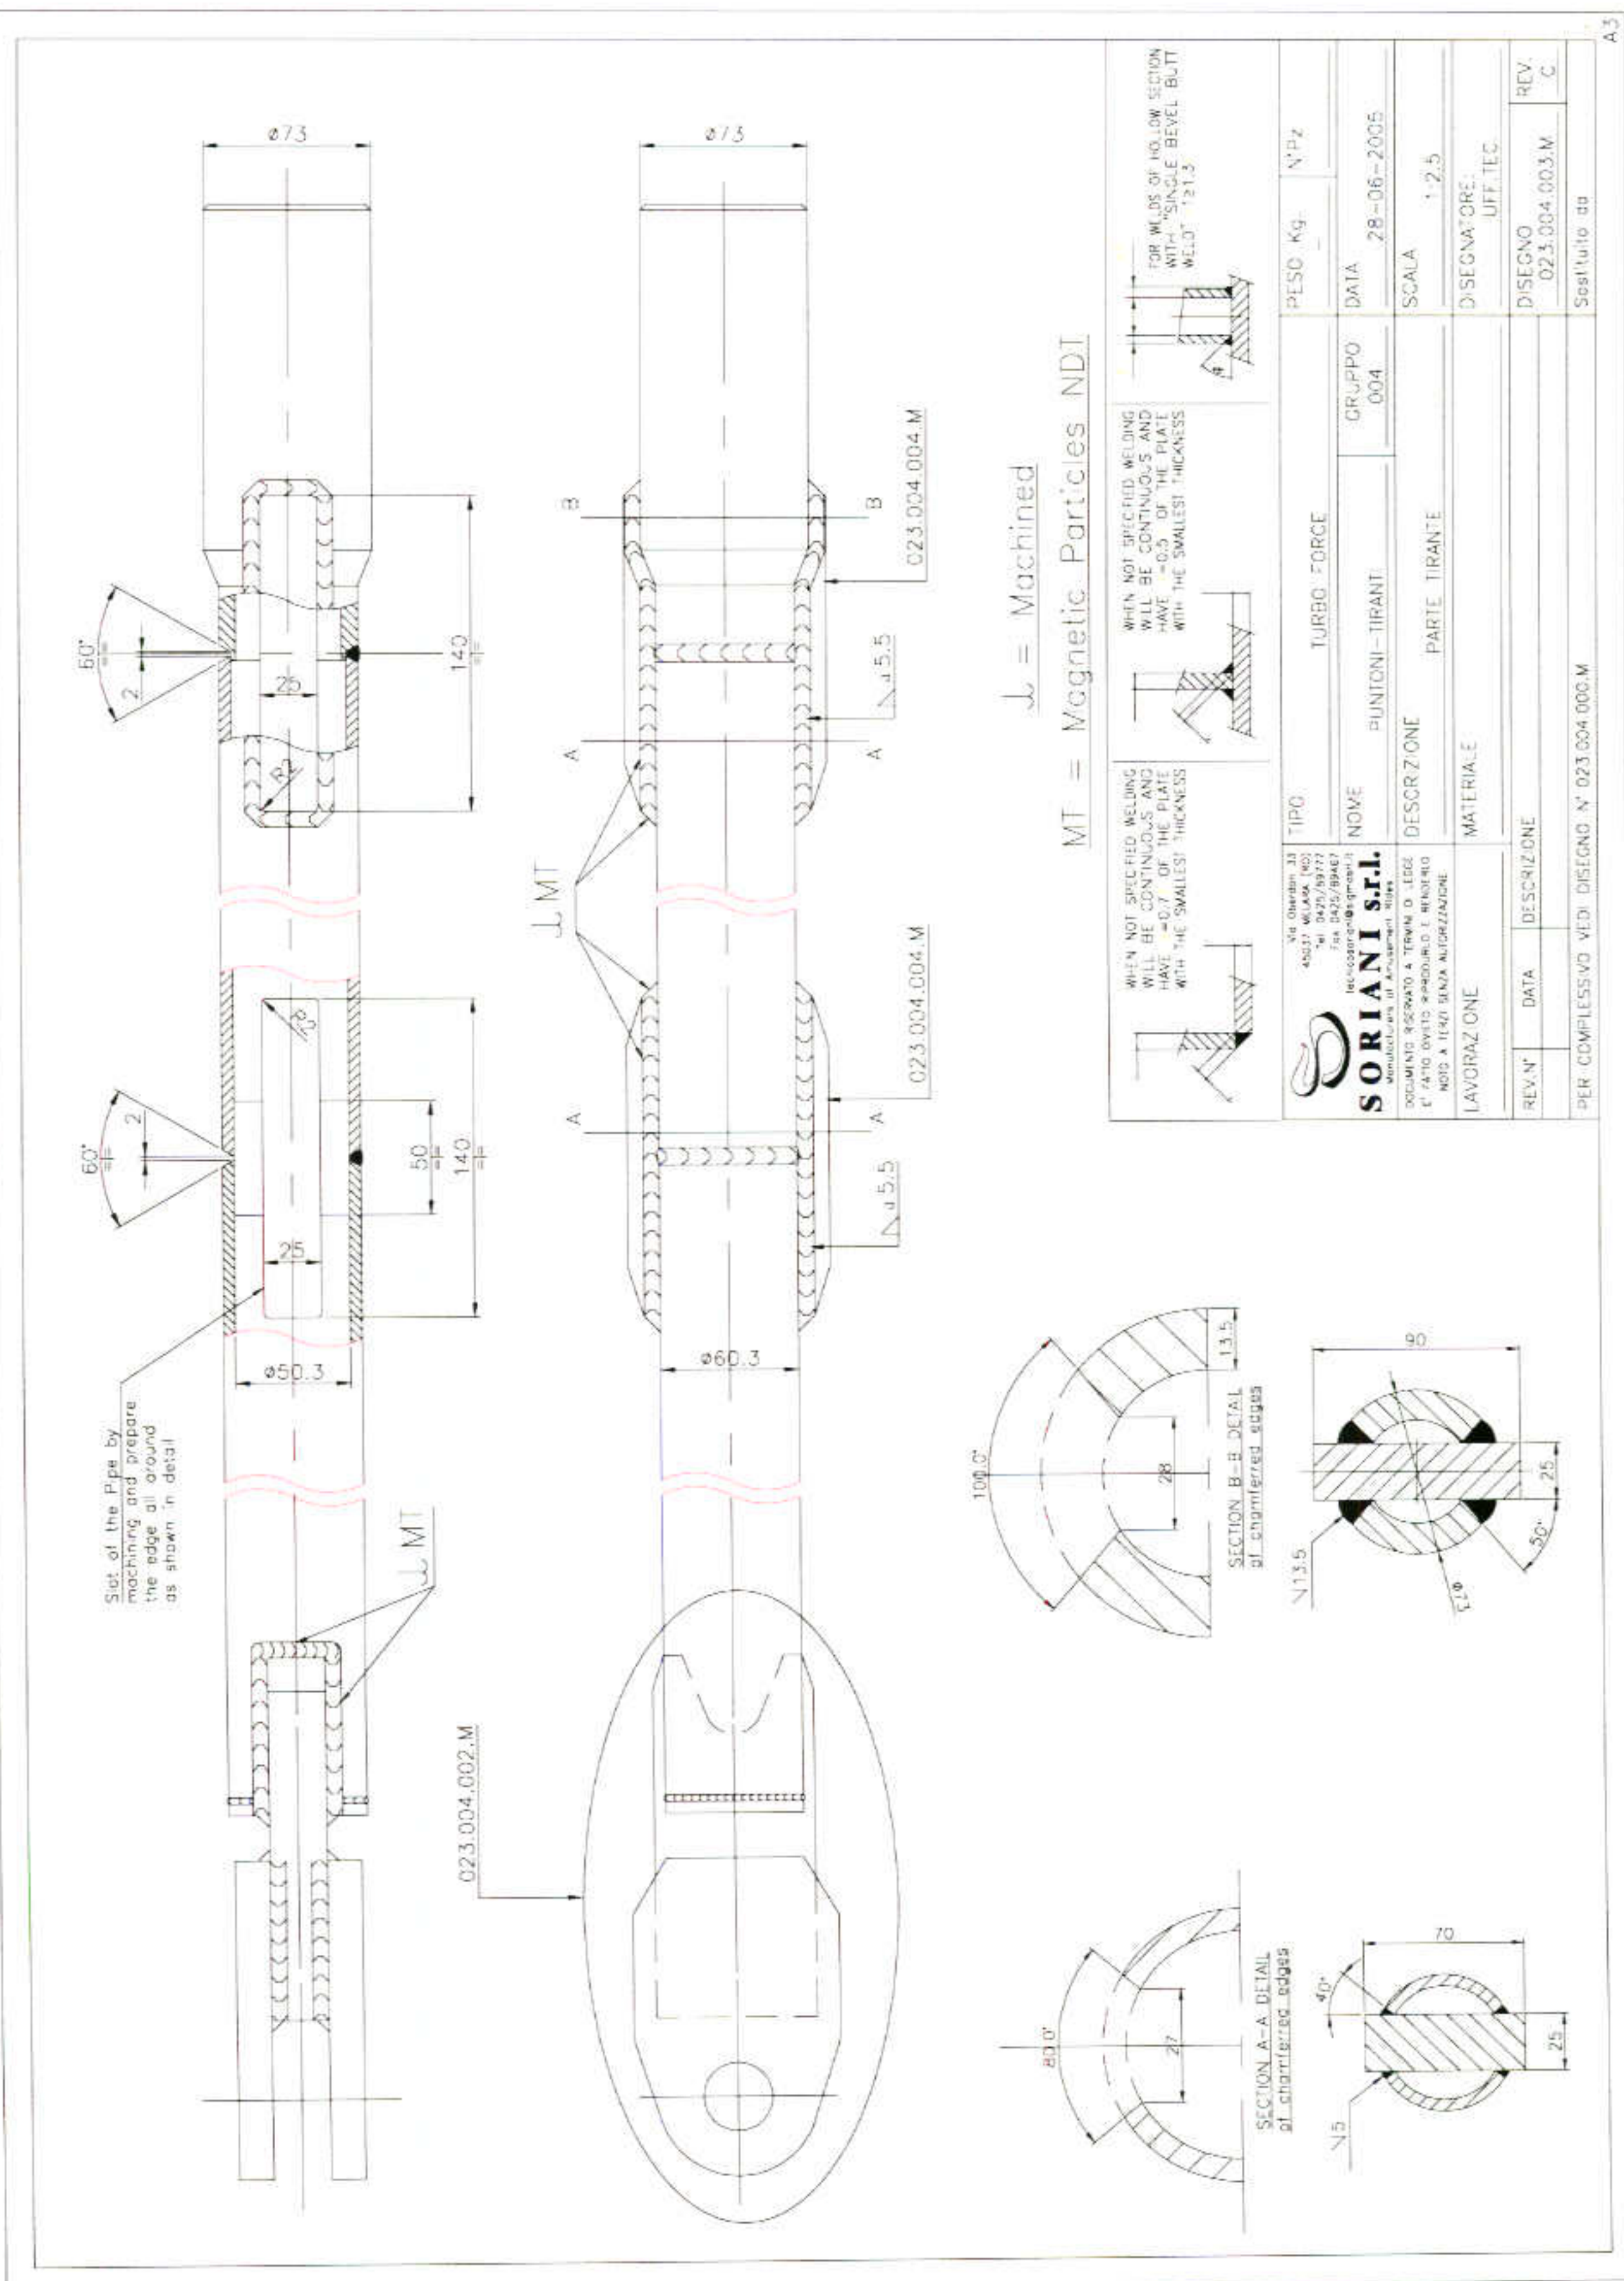
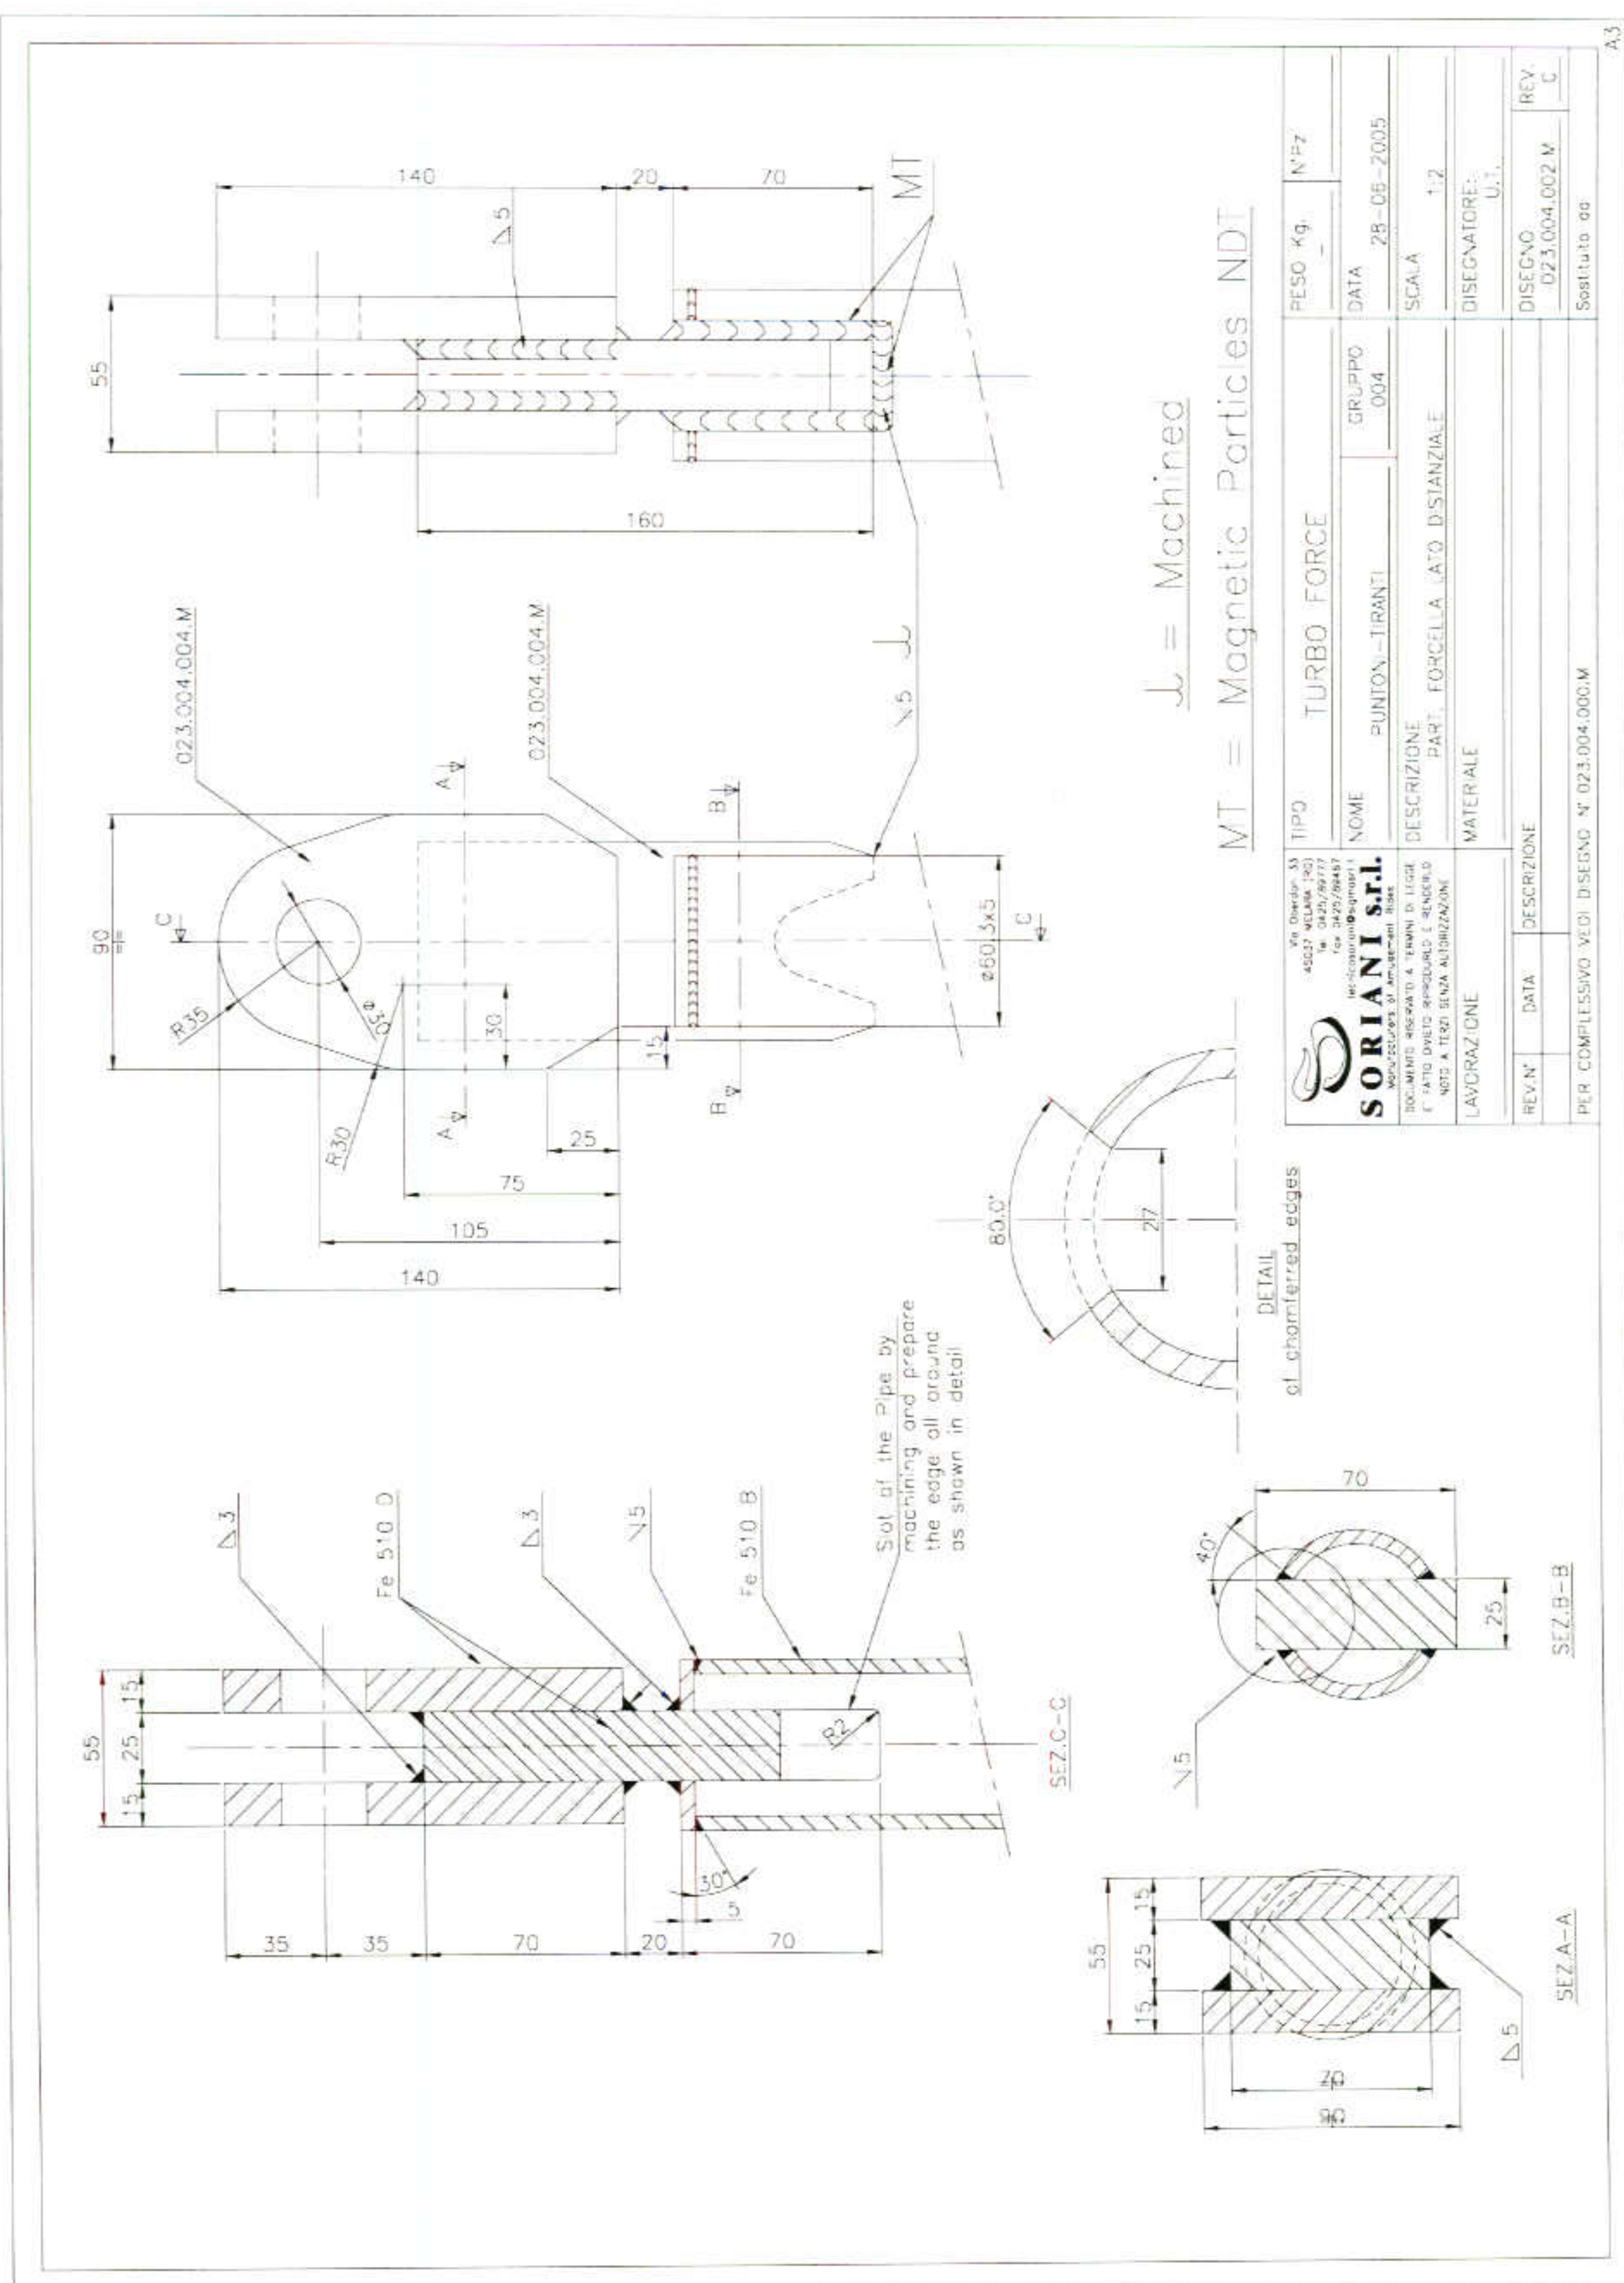
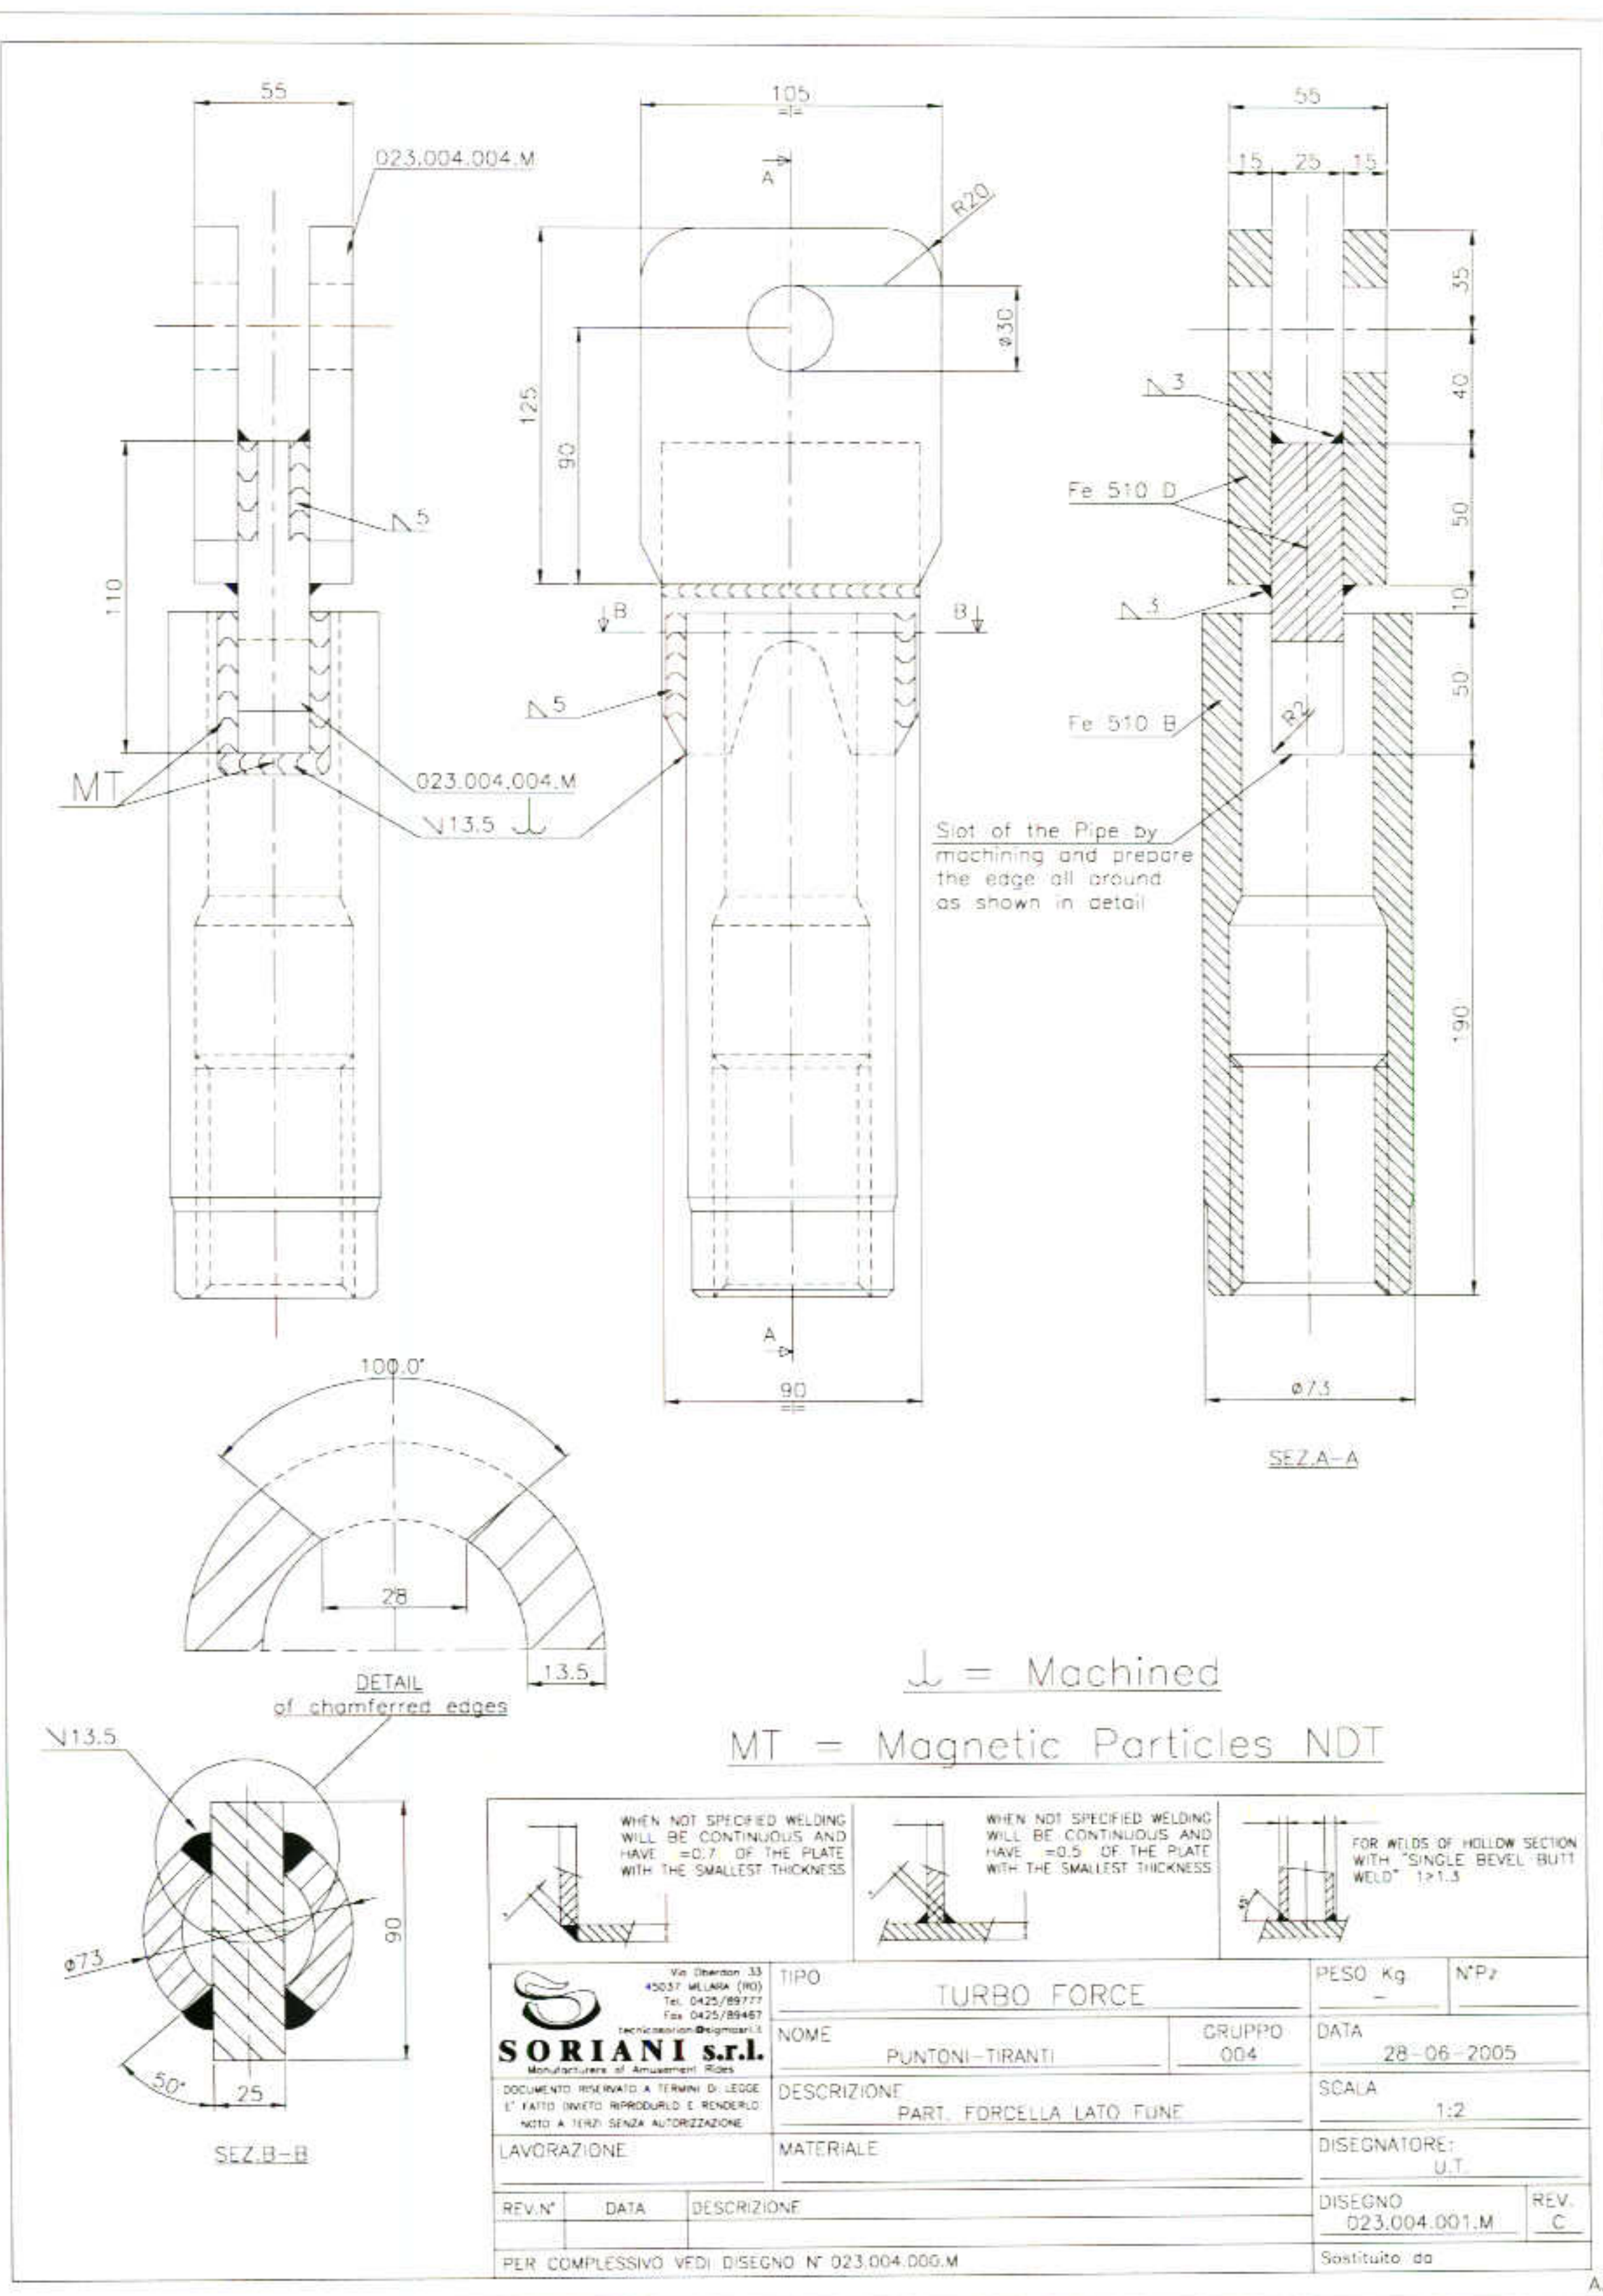
The NDT inspection should be conducted at all five positions listed in this drawing.

Ensure that the repairs have been accomplished in accordance with the approved repair procedure by a certified welder and that the safety ropes previously supplied are properly installed. Thereafter: a magnetic particle inspection is to be performed by a Level II (ASNT) licensed inspector before restarting operation of the ride to detect any welding cracks or any other welding imperfection. (See pages 3 – 6 detailing area to be inspected.)
