SORIANI srl

Bulletin No: 2005 TF03

SERVICE BULLETIN

Affected Production Dates: All manufactured before date of
issueRide Name: Turbo Force and
StratosphereAffected Serial Nos.: GTF08R001US99 GTF08R00141US
GTF08R00317US GTF08R00444US GTF08R00445US
GTF08R01158US

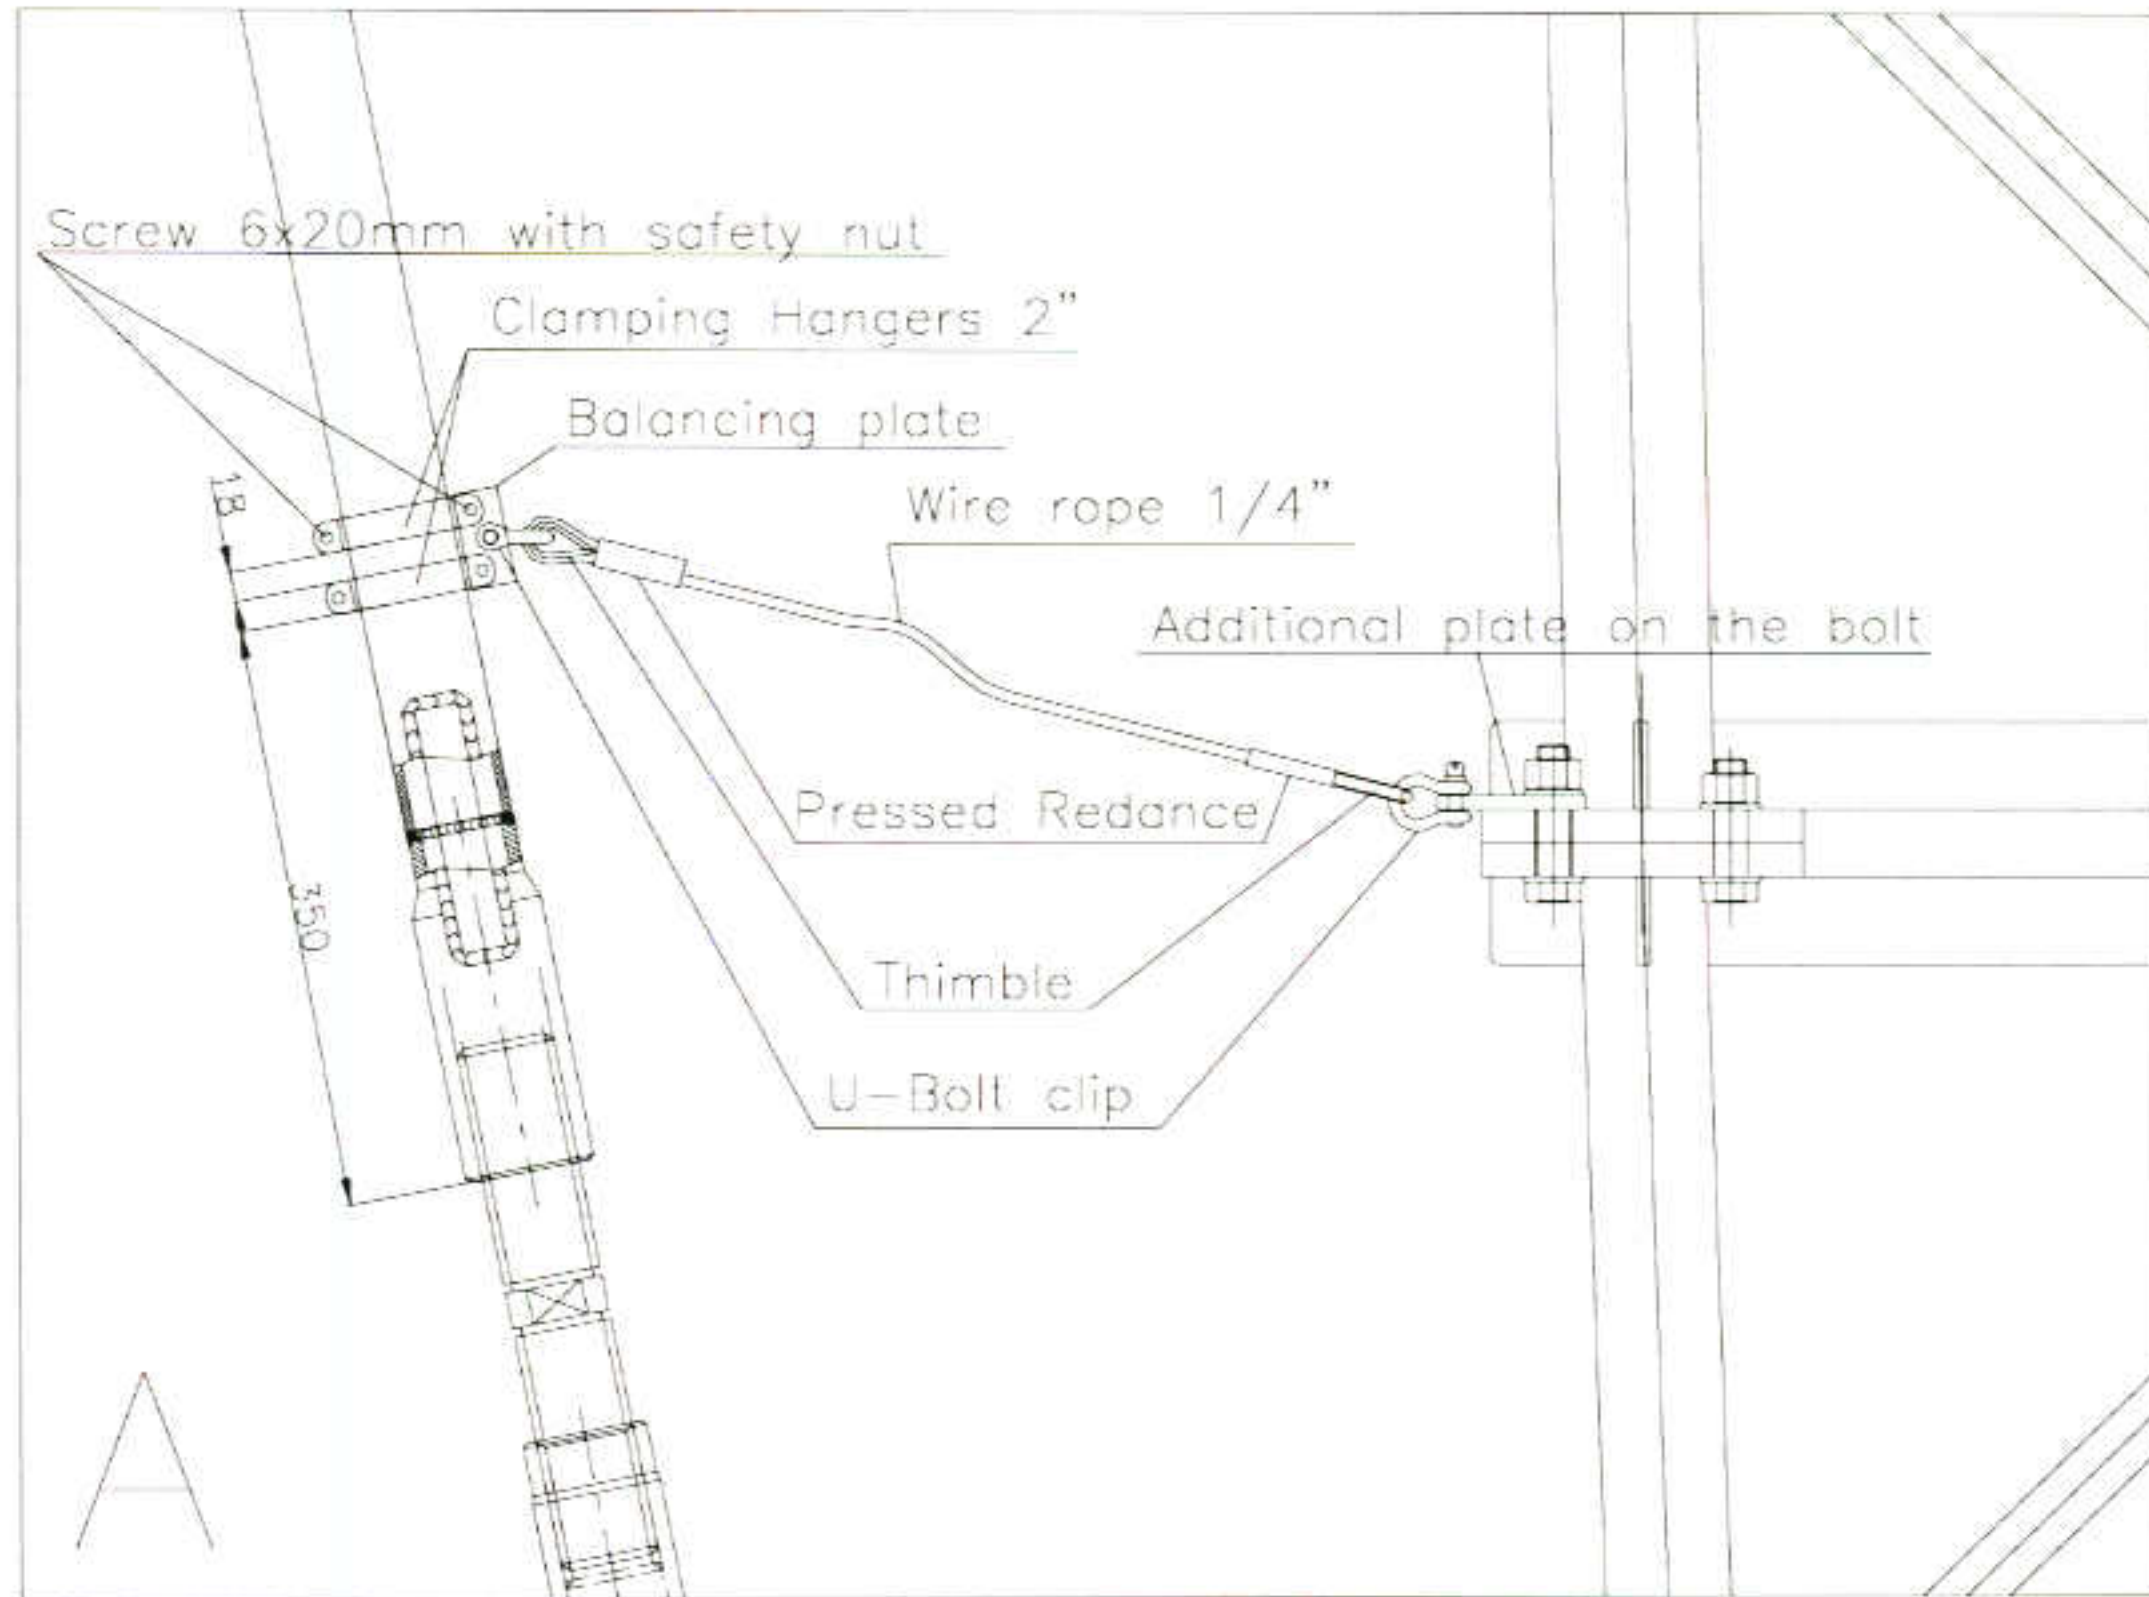
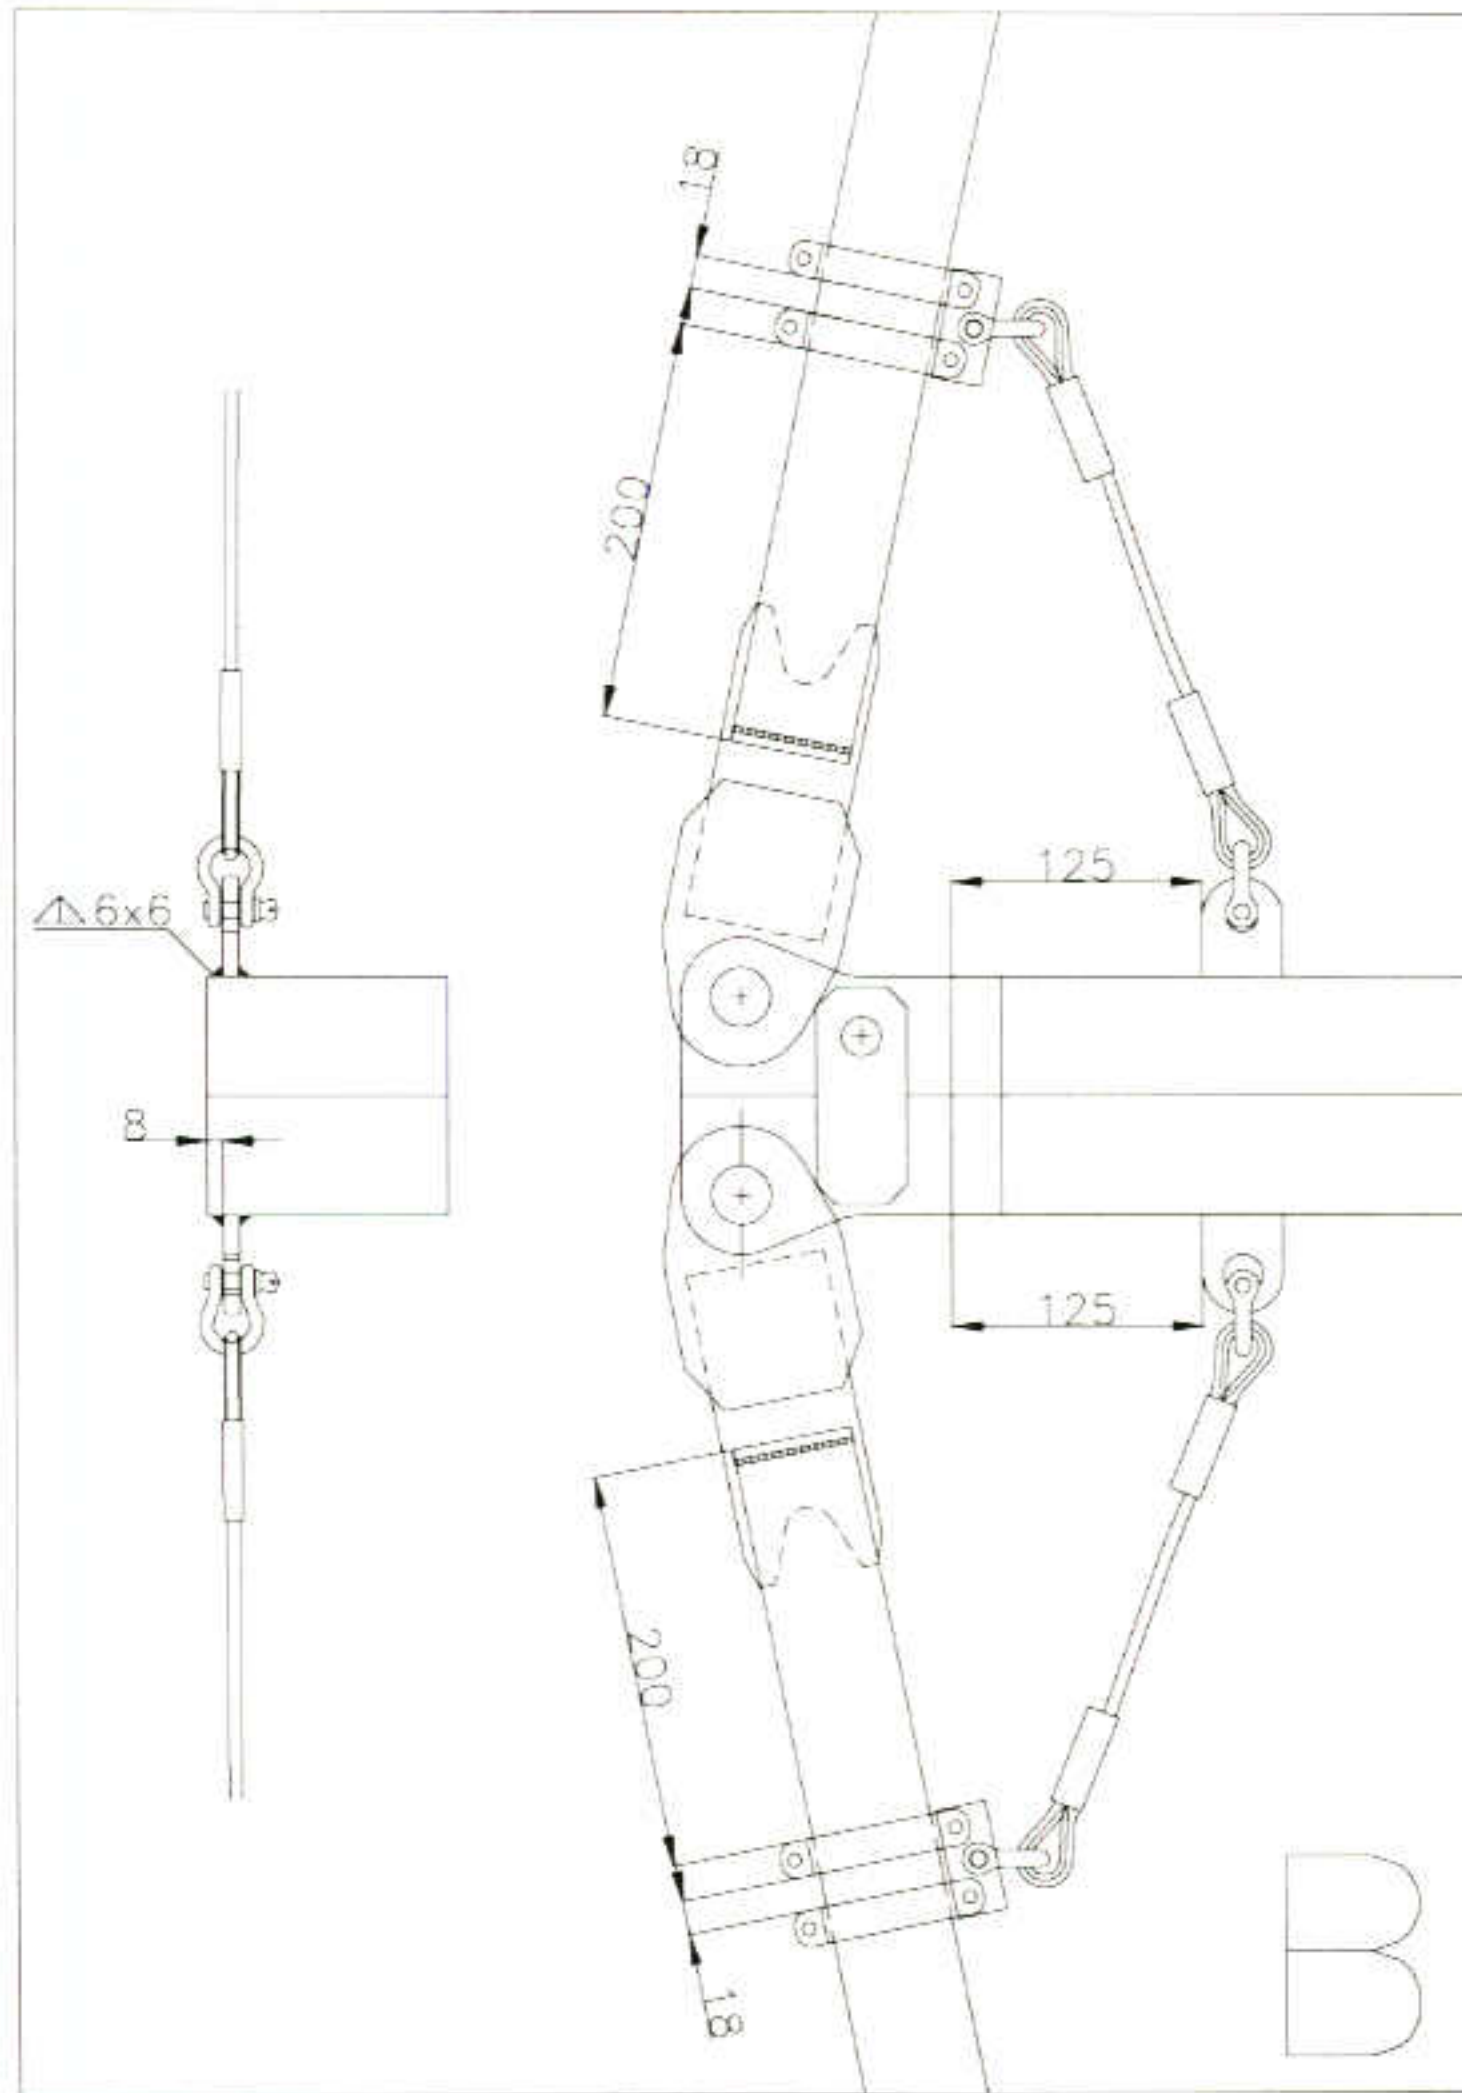
As you will note, one side of the tie rod must be tightened at the turnbuckle, to the center arm connecting flange, substituting one bolt of the flange and clamping it to the additional plate which will be supplied. On the other side, the tie rod must be tightened to the tie rod struts which connect to the center rotation, welding it to the additional lug which also has been supplied.

Please reference pages 9 and 10 of this bulletin for installation diagrams while conducting this repair.

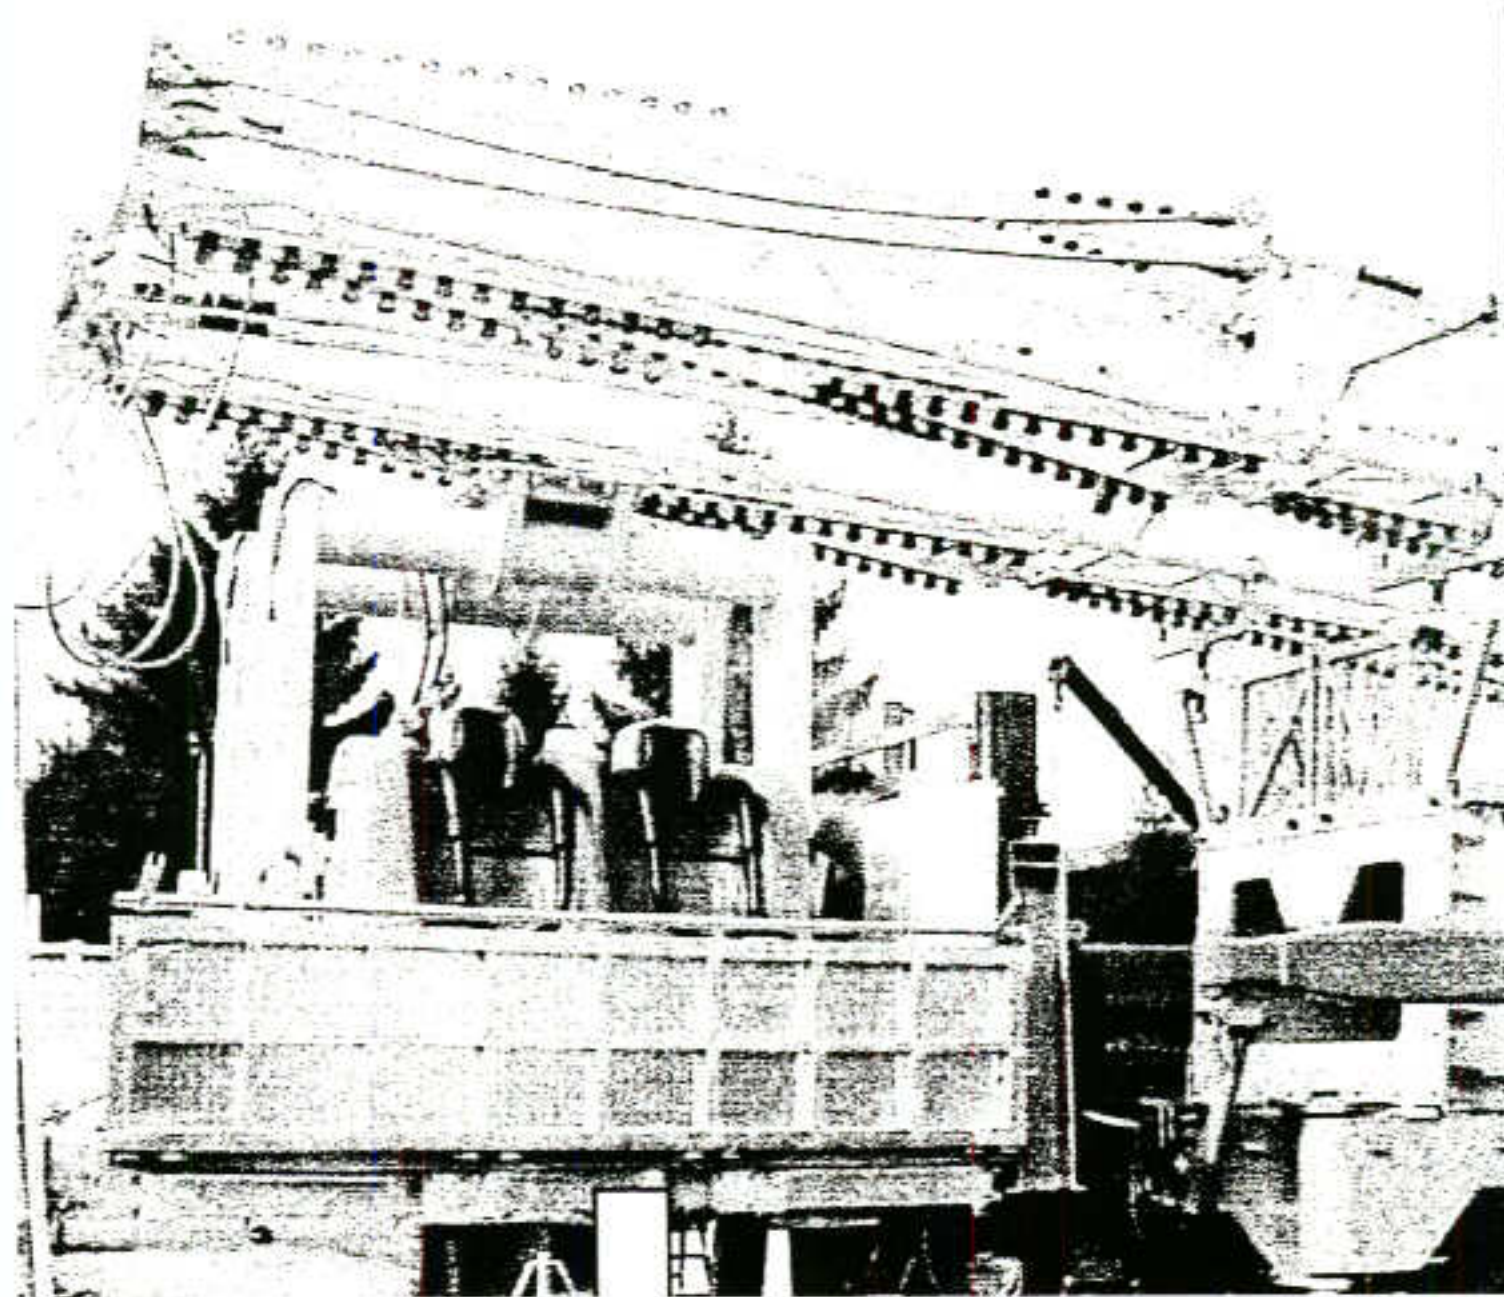
Transport Bracket

Your ride is equipped with a transport bracket which allows the tie rod to be retained on the lattice main structure during transportation. (See below photo.) Keep the transport bracket in place during operation. Should the tie rod separate on the cable end, the safety ropes will hold the tie rod end. The transport bracket will retain the cable assembly and keep it from swinging loose.
