Issuing Entity: Dartron Industries, Inc	Bulletin # SR-5K-004
Dartron	P. O. Box 13114 Salem, Oregon 97309 Phone: 503-362-2341	Release Date:January 27, 2004Effective Date:February 1, 2004Supercedes:N/A
	Fax: 503-362-2536 www.dartronrides.com	Completion Date:April 1, 2004Page 1 of 2

## **SAFETY BULLETIN**

Ride Manufacturer: Dartron Industries, Inc.	Affected Production Dates: All Cliff Hanger Rides
Ride Name: Cliff Hanger	Affected Serial #'s: All
Model #'s: All

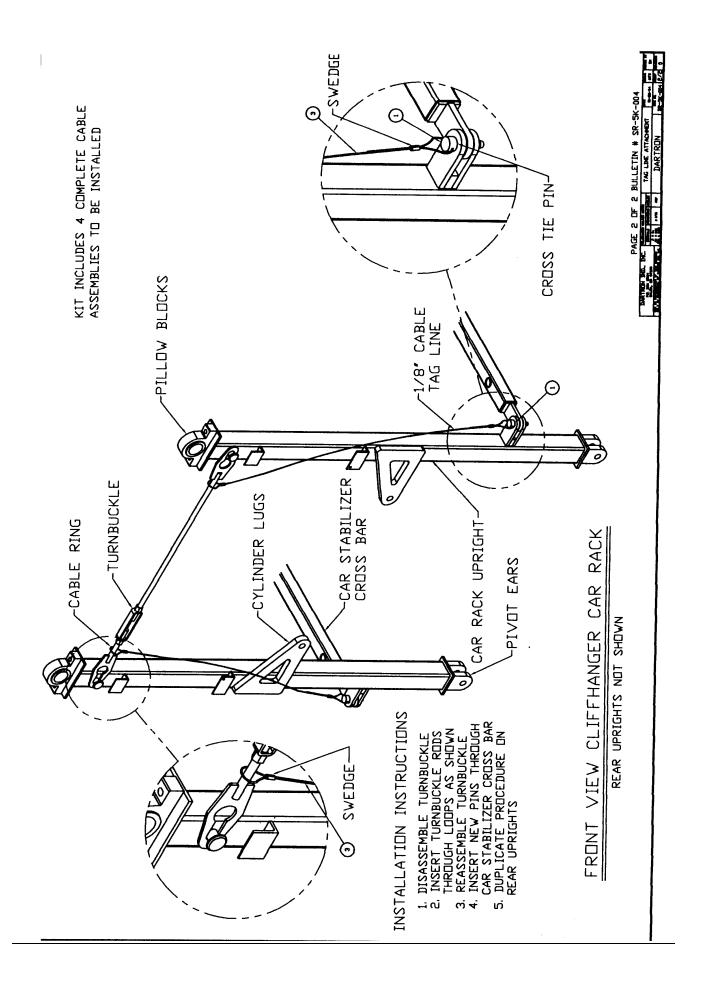
<u>Abstract of Issue</u>: Dartron is aware that some Cliff Hanger operators have experienced bent car Hanger Stems. Bent stems can result from lowering the car transport rack without removing pins that attach the Car Stabilizer Cross Tube to the car transport rack. See Page 2 of this Bulletin. Using the damaged stems can result in a failure of the stem and possibly injury to guests.

**<u>Reason for release</u>**: The chain of events that can result in a failure of the Car Hanger Stem starts with the failure to remove pins from the Car Stabilizer Cross Bar before lowering the car rack. This Bulletin requires the use of different Car Stabilizer Cross Bar pins that are difficult not to remove before lowering the Car Rack.

- 7. Four new Car Stabilizer Bar pins with cables attached must be purchased from Dartron.
- 8. The cables must be attached to the car rack turnbuckles as shown on Page 2 of this Bulletin.
- 9. After April 1, 2004 the Cliff Hanger car racks must not be operated unless the Car Stabilizer Cross Bar pins are attached to the turnbuckles as shown on Page 2.
- 10. Damaged Car Hanger Stems must not be used if two individuals manually lifting the car cannot insert them into the Lower Hanger Block.
- 11. Until the new pins/cables are installed inspection should be especially vigilant against the use of stems that do not fit correctly into the receiver tubes.
