A.R.M., (USA), INC 1506 Fernwood Rd. Wintersville, OH 43953 740.264.6599 740.266.2953 Fax Bulletin No: SA010614 Release Date: Jan 6, 2014 Effective Date: Immediate

SAFETY ALERT

Manufacturer: A.R.M. (USA), Inc. / A.R.M. (UK) LTD. Ride Name: Ali-Baba, Rainbow, 1001 Nachts

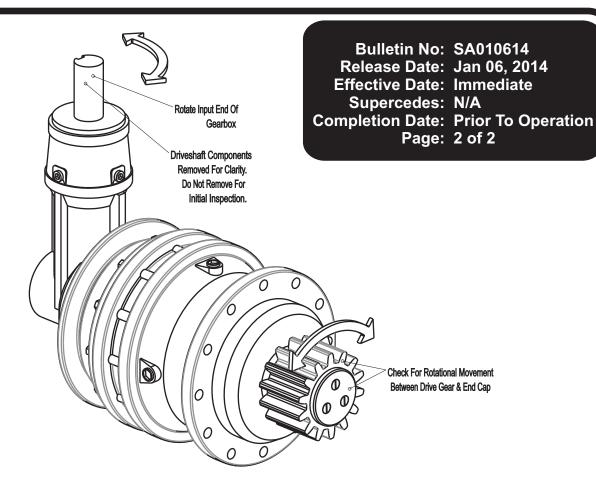
The purpose of this inspection is to detect wear or damage to the inner splines on the drive gears and/or wear of the outer splines on the output shaft of the reduction gearboxes within the carriage stabilization systems.

- 1. Remove excess lubricant from the drive gear and end cap for visual inspection.
- 2. Rotate the input shaft on the gearbox both directions until the drive gear engages the bearing teeth. Observe the end cap and note any additional rotation of the cap once the gear has stopped. Rotation of the end cap indicates the output shaft is rotating within the drive gear.
- 3. Repeat inspection of all four gearboxes and drive gears.
- 4. If movement was noted on any of the drive gears, the inspection must be expanded to include a visual inspection of the actual gear and output shaft splines (see *Spline Inspection*). If no movement was detected, the ride may be operated until the next scheduled inspection.

- 1. Prior to removing any components, it is critical that every input shaft, adaptor hub and drive shaft are marked to ensure proper timing upon reassembly. Improper timing of any component will cause uneven load distribution, accelerated component wear, and possible failure and/or personal injury.
- 2. Remove the gearbox(s) with drive gears indicating wear. Remove and thoroughly clean the drive gear.
- 3. Visually inspect the gear and output shaft splines for wear, pitting, and/or damage. Missing, cracked or damaged splines are not repairable and must be replaced prior to continued operation.
