## NOTICE OF RECOMMENDED ACTION

SKYMASTER Over the Shoulder Restraint

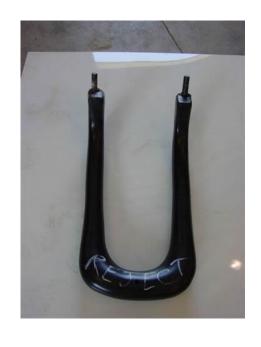
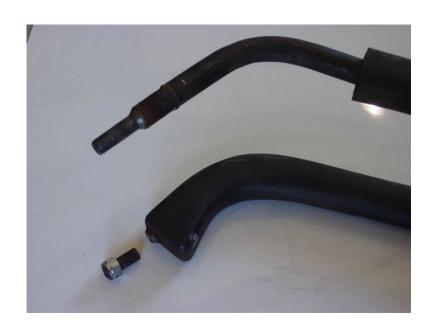
Location of cracking

Recently, an owner found hairline cracking occurring on the shoulder restraints on their Skymaster amusement device manufactured in 1994 by A.R.M. The owner performed additional magnetic particle examination on the remaining restraints and found additional restraints with similar cracking.

The cracks were found at the point where the foam padding ends. This is the area where the restraint passes through a block to secure the restraint to the device (see photos attached).

If you have this device, you are strongly urged to immediately remove all the shoulder restraints and have them non-destructively tested to ensure the integrity of the restraints.
