NUMBER: B389R1068-A

## SERVICE BULLETIN

Ride: CARROUSEL

Subject: Inspection of Horse Hanger Hooks, Bearings, Horse Pipe, Telescope Assemblies, and Crankshaft Throws

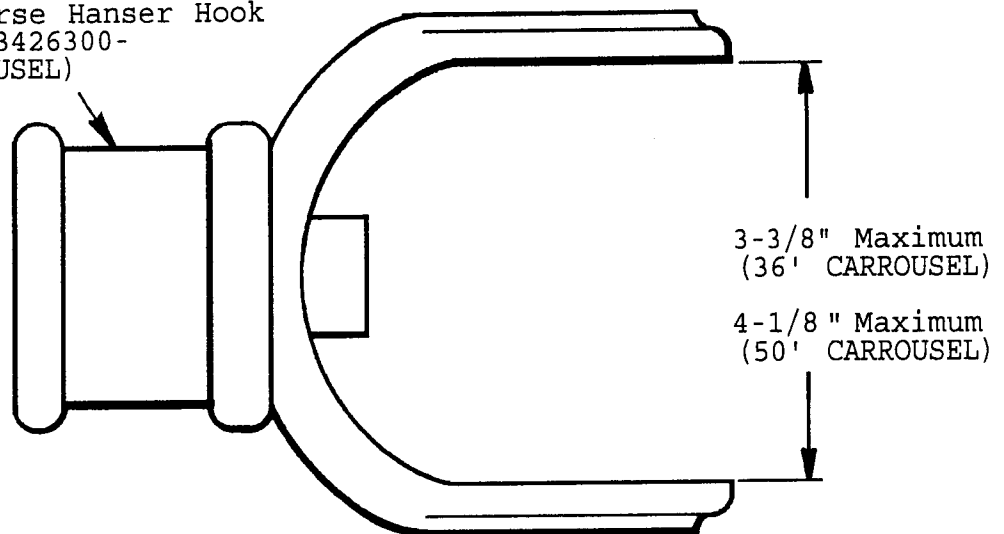
ILLUSTRATION A

MG-70 Horse Hanger Hook  
Part No. 33424000  
(36' CARROUSEL)

370-101 Horse Hanger Hook  
Part No. 33426300-  
(50' CARROUSEL)

1. Measure the distance between the hooks as shown in Illustration A. The dimension must be within the specified limits. Report any variations to the Chance Rides Customer Service Department. These hooks may face either inward or outward when attached to the crankshaft.

**WARNING: DO NOT HEAT THE HORSE HANGER HOOK TO STRAIGHTEN IT.**

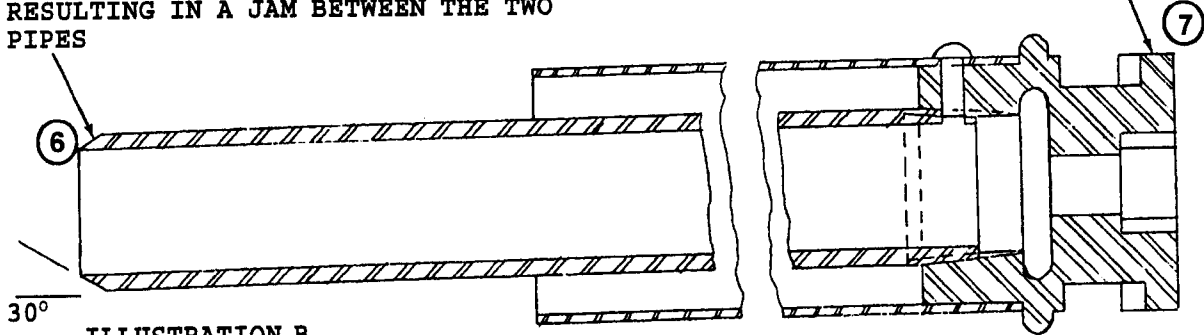
ILLUSTRATION B

NOTE: BOTTOM CASTING EARS AND MATING EARS ON TELESCOPE LOCK SHOULD BE CHECKED FOR EXCESSIVE WEAR WHICH COULD CAUSE THE TELESCOPE TO DISENGAGE FROM THE LOCK.

NOTE: TOP OF TELESCOPE PIPE MUST BE TAPERED AS SHOWN TO PREVENT A SHARP EDGE FROM CUTTING INTO HORSEPIPE RESULTING IN A JAM BETWEEN THE TWO PIPES

4. All horse pipes furnished by Chance Rides, Inc. have a 1/8 x 45 degree chamfer on the bottom (Item 5, Illustration C). The telescope pipes have a 3/16" x 30 degree chamfer on the top (Item 6, Illustration B). These are to prevent the two pipes cutting into one another and jamming. Any replacement pipes must also be chamfered.

5. The lower casting on the telescope (Item 7, Illustration B) and the upper casting on the floor lock should be inspected for wear or damage. Excessive wear could result in release of the telescope from the floor lock. Parts which allow easy locking or unlocking are worn and should be replaced.

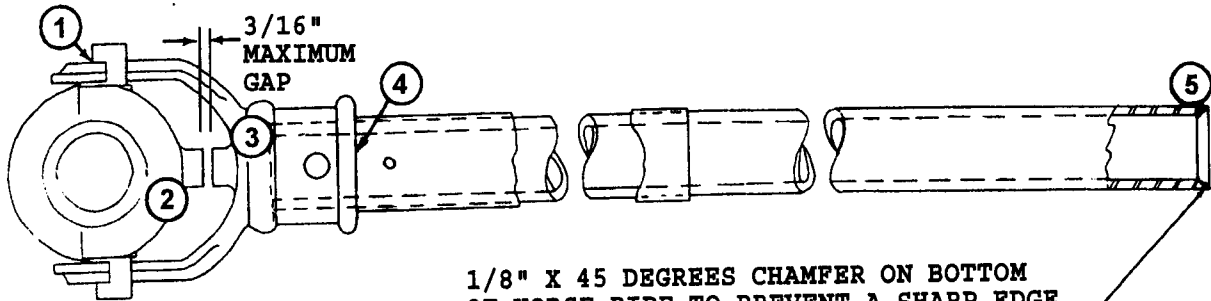
ILLUSTRATION C

NOTE: ALL HORSE HANGER HOOKS AND BEARINGS SHOULD BE INSPECTED FOR EXCESSIVE WEAR AT POINT 1. EXCESSIVE WEAR WILL RESULT IN INCREASED CLEARANCE BETWEEN STOPS 2 AND 3 WHICH SHOULD NOT EXCEED 3/16"

1/8" X 45 DEGREES CHAMFER ON BOTTOM OF HORSE PIPE TO PREVENT A SHARP EDGE FROM CUTTING INTO THE TELESCOPE RESULTING IN A JAM BETWEEN THE TWO PIPES

2. Inspect for excessive wear on top of the horse hanger bearing ears and the underside of the horse hanger hook Item 1 of Illustration C. Wear at this point increases the gap between safety stops (Item 2 and 3 of Illustration C). This gap should not exceed 3/16". Any gap larger than 3/16" will allow the hook to come off the bearing during operation.

3. Inspect for excessive wear between horse hook, horse pole, and connecting rivet (Item 4, illustration C). Maximum allowable upward and downward movement of horse hook on horse pole is 1/8 inch.

Using a piece of bar 3/16" thick, check the gap between each of the safety stops, if the bar passes easily through the gap, the hanger bearings should be replaced. Inspect horse hanger hook and replace if excessive wear is evident.

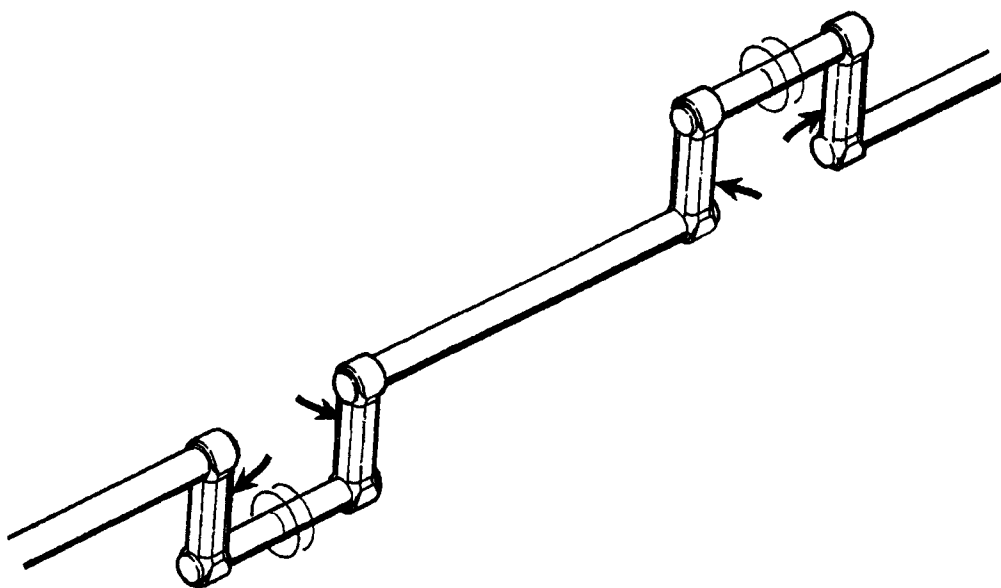
ILLUSTRATION E

6. Visually inspect crankshaft throw castings for indications of cracks (Illustration E). If indications are found, contact Chance Rides, Inc. DO NOT ATTEMPT TO WELD OR REPAIR THROWS. DO NOT OPERATE RIDE UNTIL APPROVED REPAIR IS COMPLETE.
