SERVICE BULLETIN

Ride Name: WIPEOUT Affected Serial Nos.: All Units

Model No.: 402

Hub Capscrew Torque Check

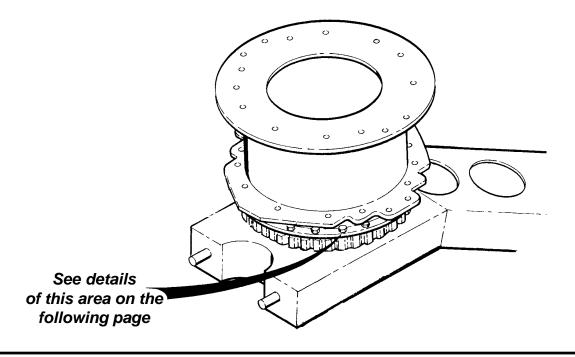
Using a torque wrench, check for proper torque of all 28 capscrews. The torque value for checking these capscrews must be 80 ft-lbs.

IMPORTANT: ALL 28 CAPSCREWS MUST BE TIGHTENED AND MAINTAINED AS DESCRIBED TO OPERATE THE RIDE. If damage in the tapped holes prevents one or more capscrews from meeting these specifications, the bearing must be replaced. Contact the Chance Customer Service Department for all necessary parts and instructions on this procedure.

If any capscrew is found to be loose, remove it and replace it with a new capscrew using the procedure described on page 4 of this bulletin. If a broken capscrew is found, contact Chance Rides, Inc. immediately for further instructions.
