Number: B106R1007-0

## SERVICE BULLETIN

Ride: ZIPPER

## SubSeat Support Axle Inspection

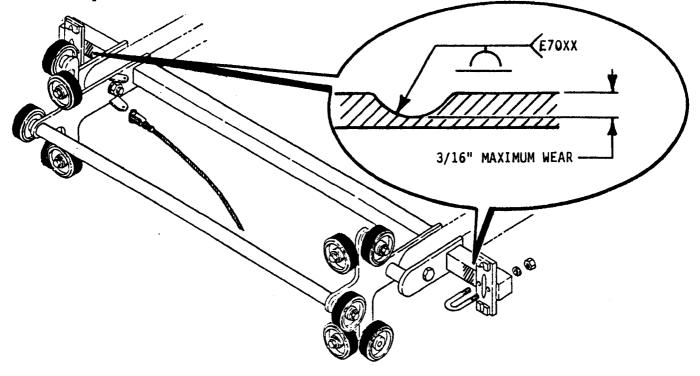
CHANCE RIDES, INC. has received reports from the field of wear on the seat support axle frame near the cable clamps on ZIPPER amusement rides. This wear is caused by occasional contact with the cable sheave during operation.

If the wear is no deeper than 3/16", it can be corrected welding the worn area and grinding the entire repaired area smooth as shown. All work must be done by competent, qualified mechanics, capable of understanding the function of the parts and their proper installation. All welding must be done by a certified welder.

If this type of wear occurs frequently, or the amount of wear is severe, contact the CHANCE CUSTOMER SERVICE DEPARTMENT for further corrective measures.
