Issuing Entity:	
	Dartron Industries, Inc	Bulletin # SR-5K-004
Dartron	P. O. Box 13114 Salem, Oregon 97309 Phone: 503-362-2341 Fax: 503-362-2536	Release Date:January 27, 2004Effective Date:February 1, 2004Supercedes:N/ACompletion Date:April 1, 2004Page 1 of 2
	www.dartronrides.com

SAFETY BULLETIN

Ride Manufacturer: Dartron Industries, Inc.	Affected Production Dates: All Cliff Hanger Rides
Ride Name: Cliff Hanger	Affected Serial #'s: All
Model #'s: All

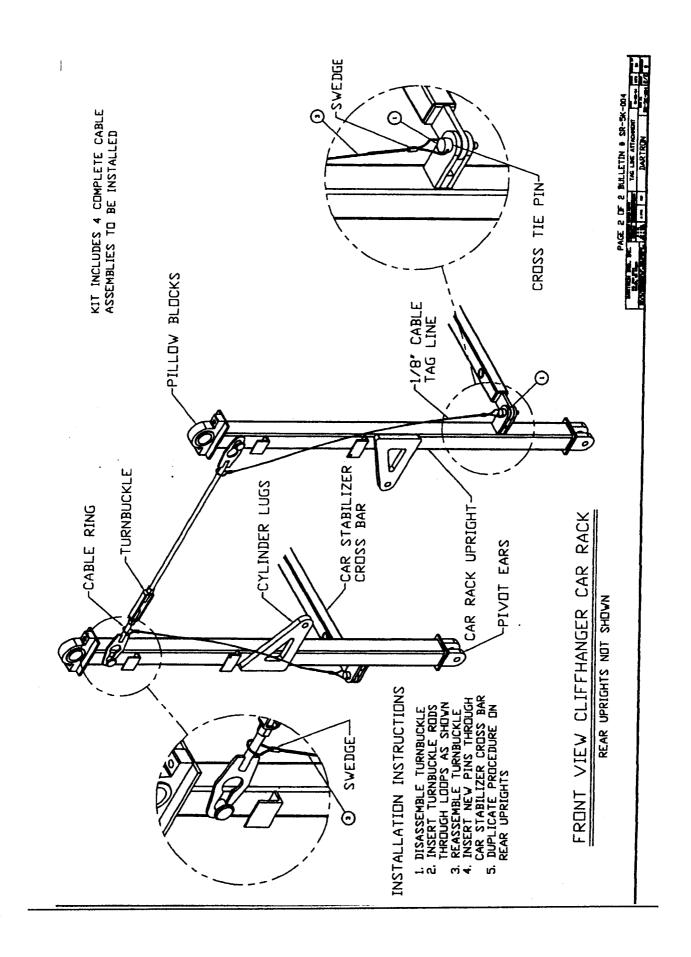
Abstract of Issue: Dartron is aware that some Cliff Hanger operators have experienced bent car Hanger Stems. Bent stems can result from lowering the car transport rack without removing pins that attach the Car Stabilizer Cross Tube to the car transport rack. See Page 2 of this Bulletin. Using the damaged stems can result in a failure of the stem and possibly injury to guests.

Reason for release: The chain of events that can result in a failure of the Car Hanger Stem starts with the failure to remove pins from the Car Stabilizer Cross Bar before lowering the car rack. This Bulletin requires the use of different Car Stabilizer Cross Bar pins that are difficult not to remove before lowering the Car Rack.

- 7. Four new Car Stabilizer Bar pins with cables attached must be purchased from Dartron.
- 8. The cables must be attached to the car rack turnbuckles as shown on Page 2 of this Bulletin.
- After April 1, 2004 the Cliff Hanger car racks must not be operated unless the Car Stabilizer Cross Bar pins are attached to the turnbuckles as shown on Page 2.
- 10. Damaged Car Hanger Stems must not be used if two individuals manually lifting the car cannot insert them into the Lower Hanger Block.
- 11. Until the new pins/cables are installed inspection should be especially vigilant against the use of stems that do not fit correctly into the receiver tubes.
