SERVICE LETTER 1 (SER-KR)

Service Bulletin

Ride Manufacturer: Huss Maschinenfabrik
Ride Name: Top Spin
Model Number: All

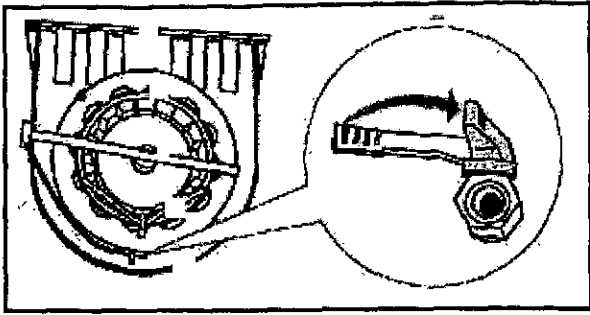
Diagram 1

Opening these valves will not normally remove all the air from the gondola's pneumatic system, however with a solenoid brake failure it is possible for the opening of these valves to exhaust all of the air from the system. If this occurs the passenger restraints cannot be opened and passengers cannot be evacuated until the air supply is recharged.

Once the gondola is level using a lift or ladder, open the brake outlet valves shown in diagram one below. If a lift or ladder is not available or if landscaping or theming of the ride makes it difficult to reach these valves, this procedure can also be accomplished in the loading position, however passengers may briefly be suspended in awkward orientations while this procedure is being completed.

Once the brakes are released and the gondola is free to rotate, return the gondola to the loading / unloading position and open the seat restraints and evacuate the ride. As stated above, if the gondola's pneumatic energy is depleted, the passenger restraint locking mechanism cannot be opened until the brake outlet valves are closed, the pneumatic compressors are reactivated and the system is recharged with compressed air. Once the system is recharged, open the passenger restraints per standard operating procedures.

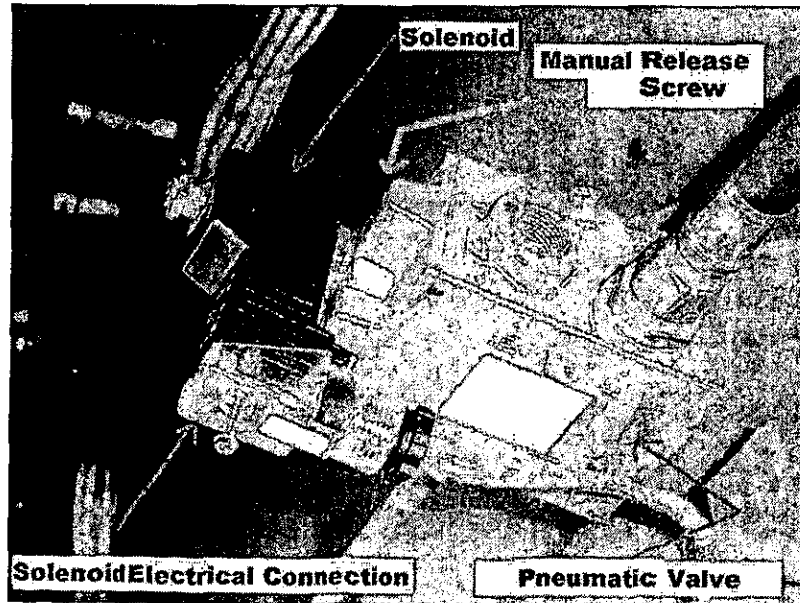
The solenoid failed because water had penetrated the device's electrical connection and short circuited the connection. As a result the valve which controls the gondola's restraint locking system did not activate and the restraints did not open at the end of the normal ride cycle.

Valve when viewed from below.

The valve and solenoid should be inspected on a regular basis. These items are located in the center of the gondola, on the bottom side of the gondola, in the middle row. See photograph below. It is important to ensure that moisture has not penetrated the solenoid's electrical connection. If any moisture is evident, the connection must be dried and sealed with silicone.

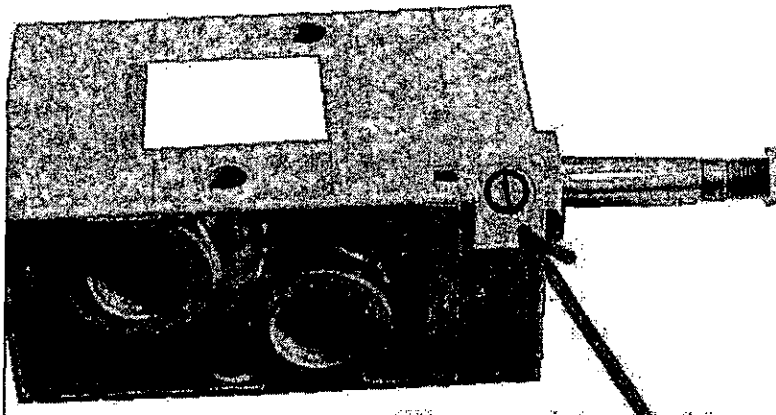
Manual Release Screw

Valve when viewed from above.

In the event that the solenoid does fail the valve can be manually opened by rotating the manual release screw located on the top of the pneumatic valve. Also see photograph below.

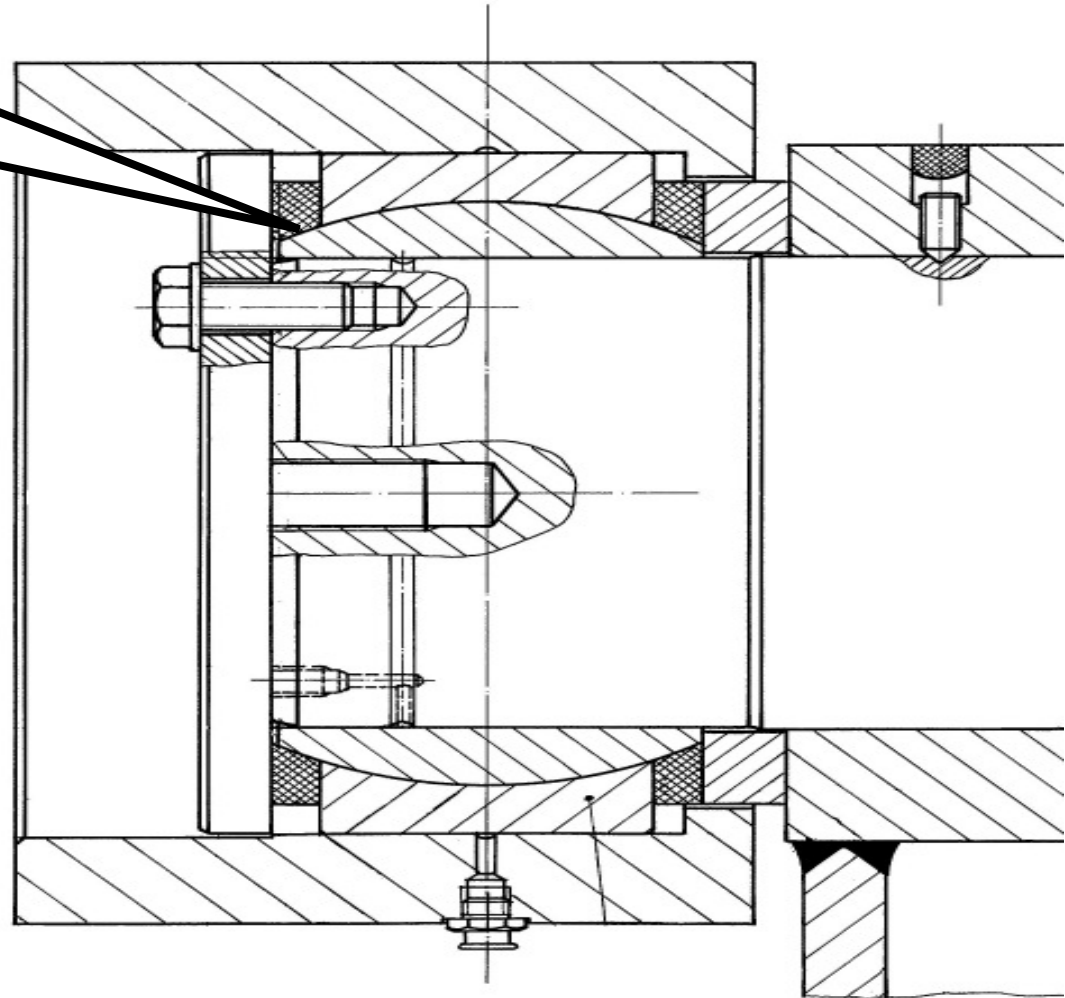
Boom arm hinge front / Drehträgergelenk vorn

Surface of the inner bearing
Ring have to be free of rust.
If desired will a HUSS technician
assist the evaluation.

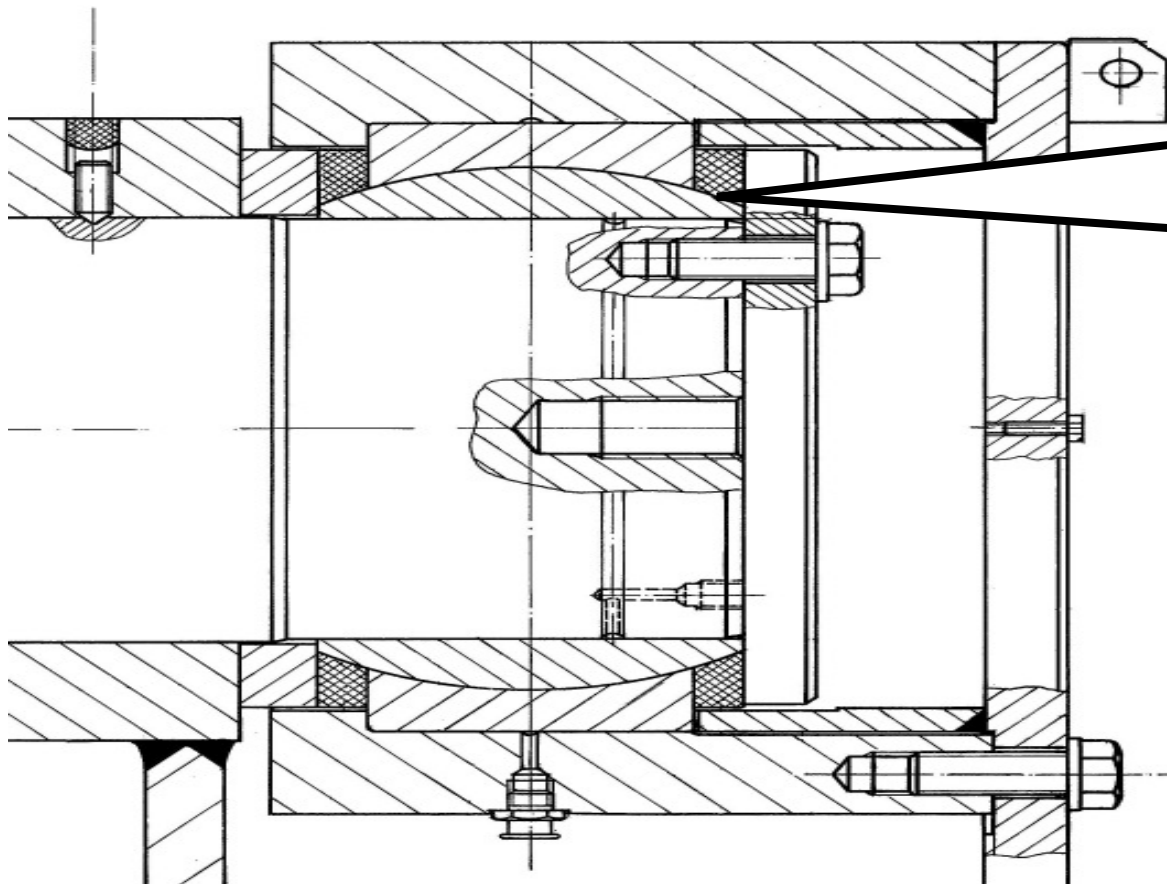
Boom arm hinge back / Drehträgergelenk hinten

Surface of the inner bearing
ring have to be free of rust.
If desired will a HUSS technician
assist the evaluation.
Die Oberfläche der Lager Innenkugel
muss rostfrei sein.
Wenn gewünscht, kann ein HUSS Techniker
bei der Beurteilung behilflich sein.

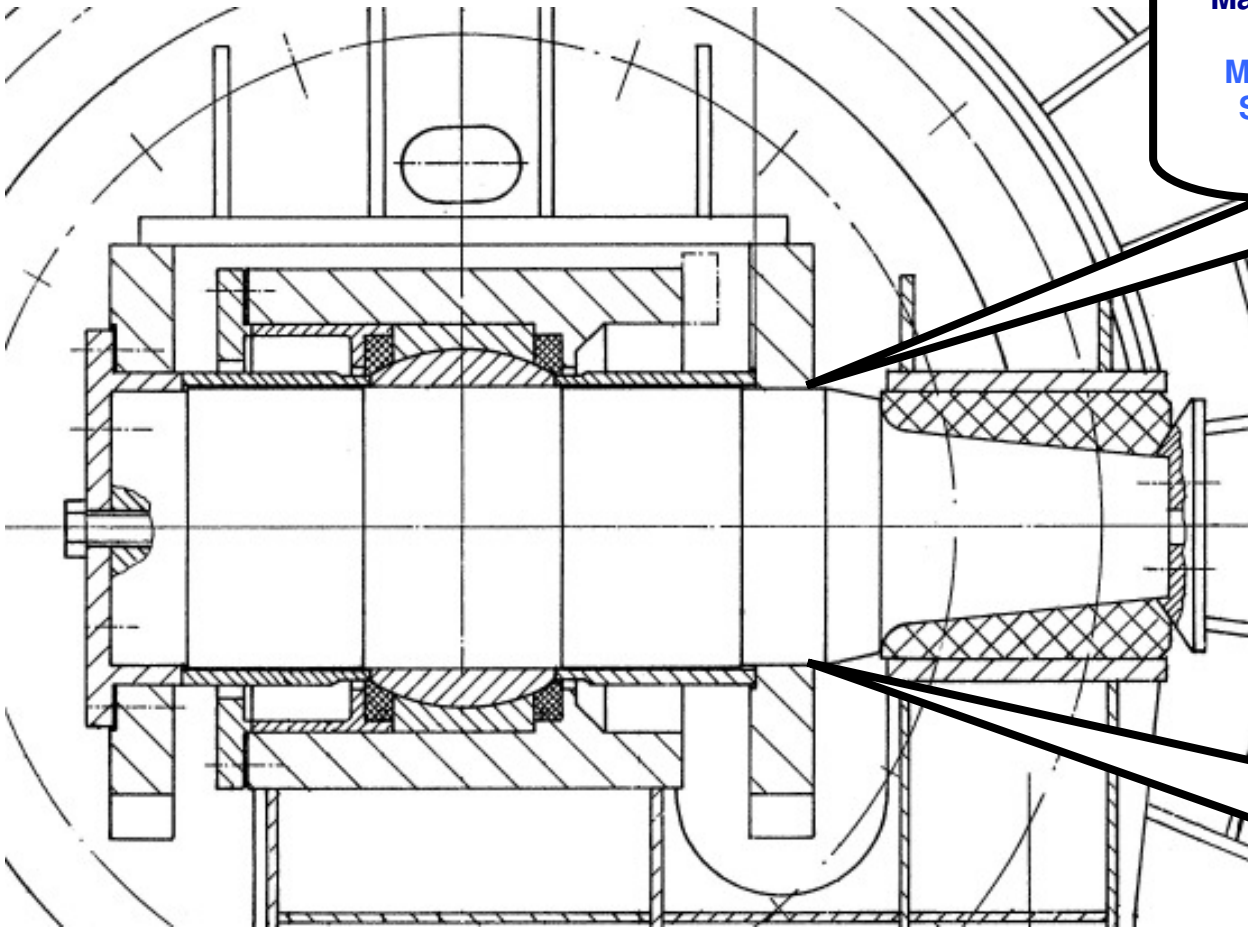
Gondola suspension left & right / Gondelaufhängung links & rechts

Maximum allowed gap between steel structure and shaft is 0.3 mm
Maximal zulässiger Spalt zwischen Stahlkonstruktion und Welle darf 0,3 mm nicht überschreiten
