SERVICE BULLETIN

Ride Name: Fire Ball

Bulletin No.: L03-006 Release Date: 7/5/06

Restraint Bumper Installation

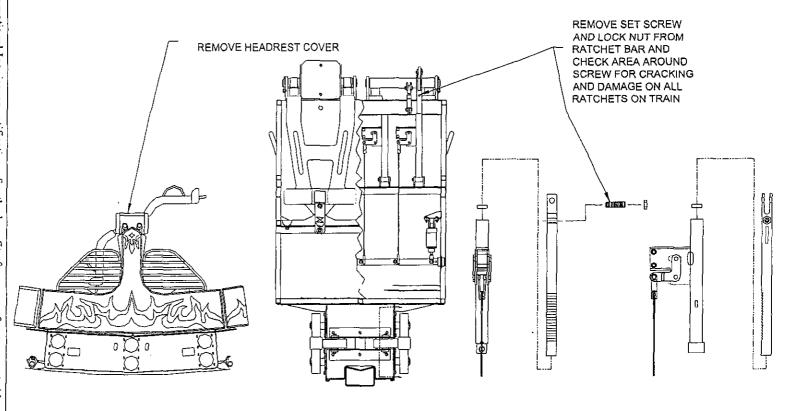
Larson International Inc. has learned that some parts of the Fireball over the shoulder ratchet assemblies on the passenger vehicles are being bent and or damaged causing safety concerns for the ride. The damage occurs when the restraint is "slammed" shut on an unoccupied seat. There is reasonable concern that this damage could result in a restraint failure.

- 2. Remove stop set screw and locknut from upper portion of ratchet assembly.
- 3. Add bumper assembly under over the shoulder restraint and weld in place. (see instructions)
- 4. Welding must be completed by AWSD1.1 certified welder.
- 5. N.D.T inspection of bar at the point where the stop set screw was located is required.
- 6. If upon inspection there are signs of bending and or cracking replacing the ratchet bar is necessary.
- 7. A copy of the inspection report must be sent to Larson Intl, Inc.
- 8. This modification must be completed no later than July 21, 2006. If modifications & N.D.T. are not complete by this date the ride must be taken out of service until testing & modifications are complete
