BULLETIN: BU-134 MC

ROUND-UP/PARATROOPER MAIN SPINDLE SHAFT SAFETY LIMITING RING

BULLETIN: BU-136 MC

ROUND-UP/PARATROOPER HUB INSPECTION

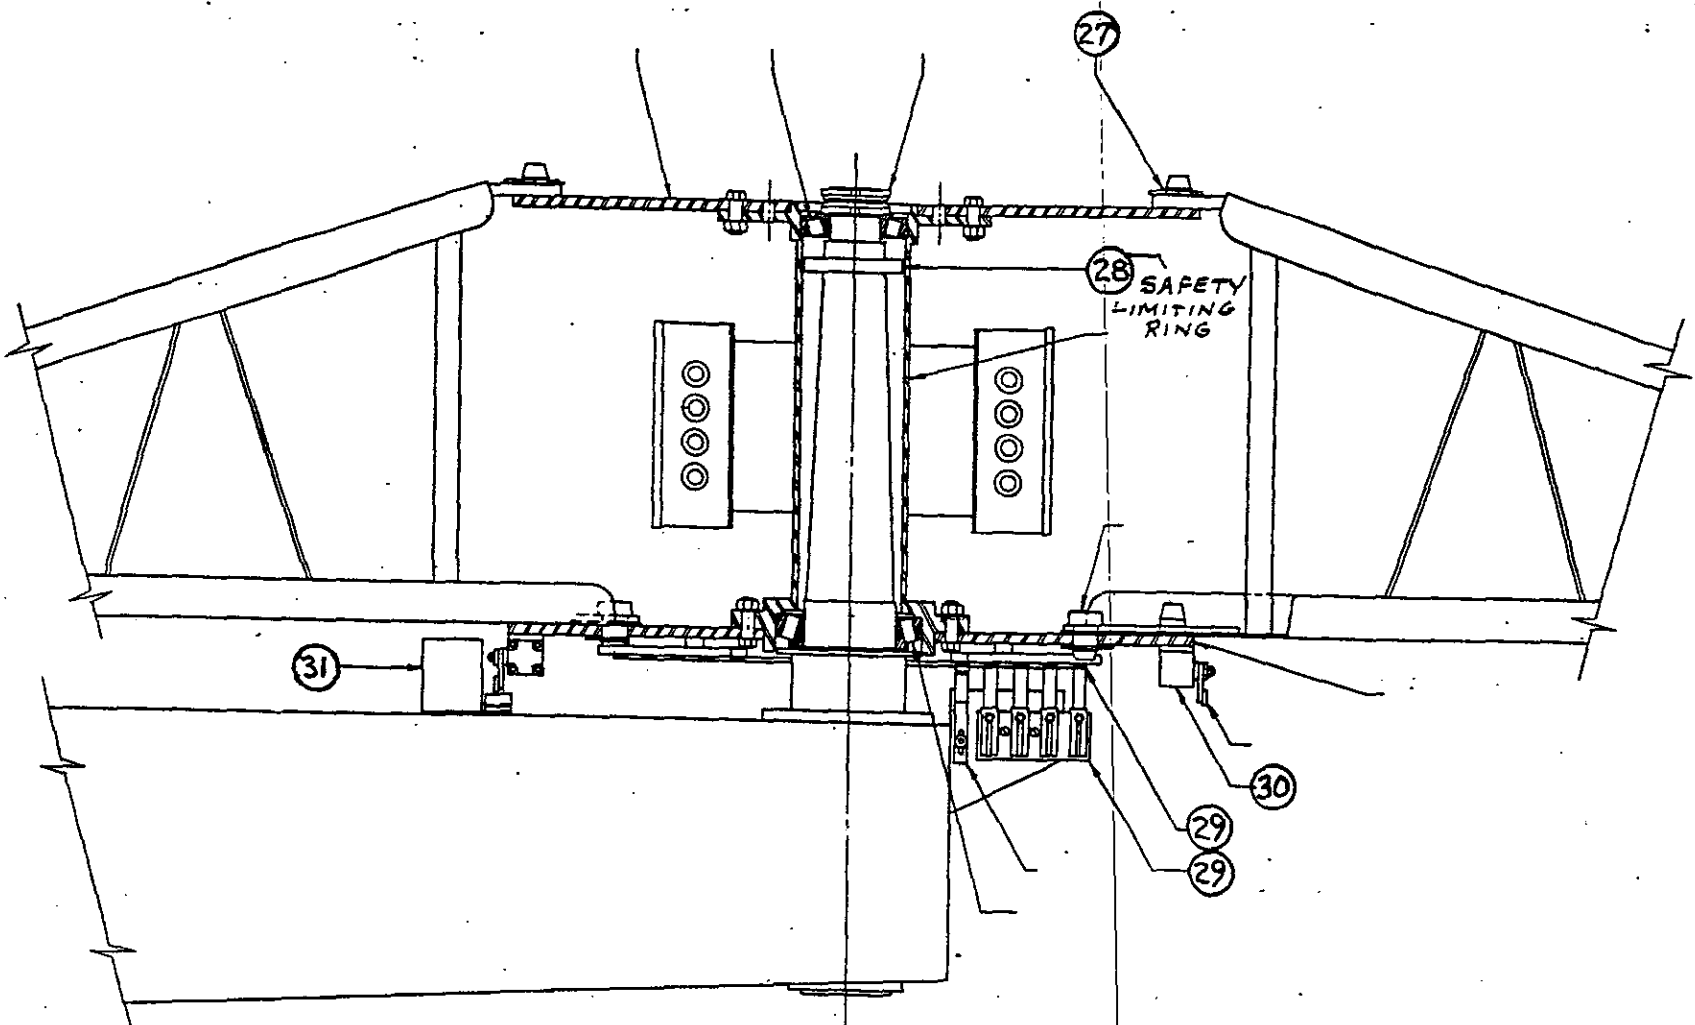
| CENTER HUB ASSEMBLY | | | |

A Round-Up manufactured by Frank Hrubetz & Co., Inc. has experienced a failure in the upper bearing in place on the main spindle. When this happened, support at the top of the spindle was lost making it possible for the rotating platform to tilt and contact the main boom.

This condition makes it possible for the pins and sweeps to hit the boom and bring the rotating platform to a sudden stop.

1. Remove the center ornament and inspect the weld on the hub (shown in drawings RD-35R and FR-503S) for cracks. If there are cracks, ship the hub to Man-Co Mfg.. We will repair, using the design presently being used.
2. Remove the top bearing and visually inspect the bearing and make sure there is a safety limiting ring in place. If there is a limiting ring on your ride, it will be plainly visible on the upper portion of your main spindle shaft. If it is not present, we highly recommend that you add this part immediately. (Part #STD 353)

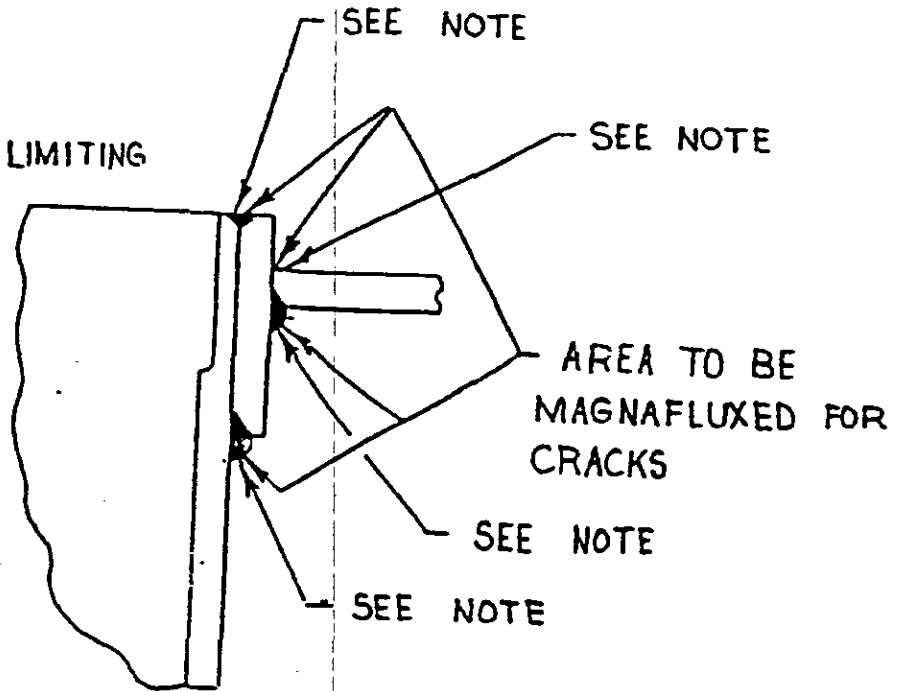
CENTER HUB - INSPECTION OF WELDS

The main spindle shaft hub housing on the Round-Up and Paratrooper amusement rides that were manufactured by Frank Hrubetz Co., and Kilinski Mfg. Co. (KMC) have shown some sign of fatigue cracks in the weld areas of the hub assemblies.

AREA TO BE MAGNAFLUXED FOR CRACKS

IF CRACK IS
NOTED IN THIS
AREA, CENTER HUB
SHOULD BE REPLACED

We at Man-Co feel that this is something that should be inspected on a more regular basis and so we are recommending that the welds shown in the attached drawing (BU-136-MC) be inspected annually. If any sign of stress or cracks are noted, then we recommend that the entire hub assembly be replaced for the safety of the ride owners and customers.

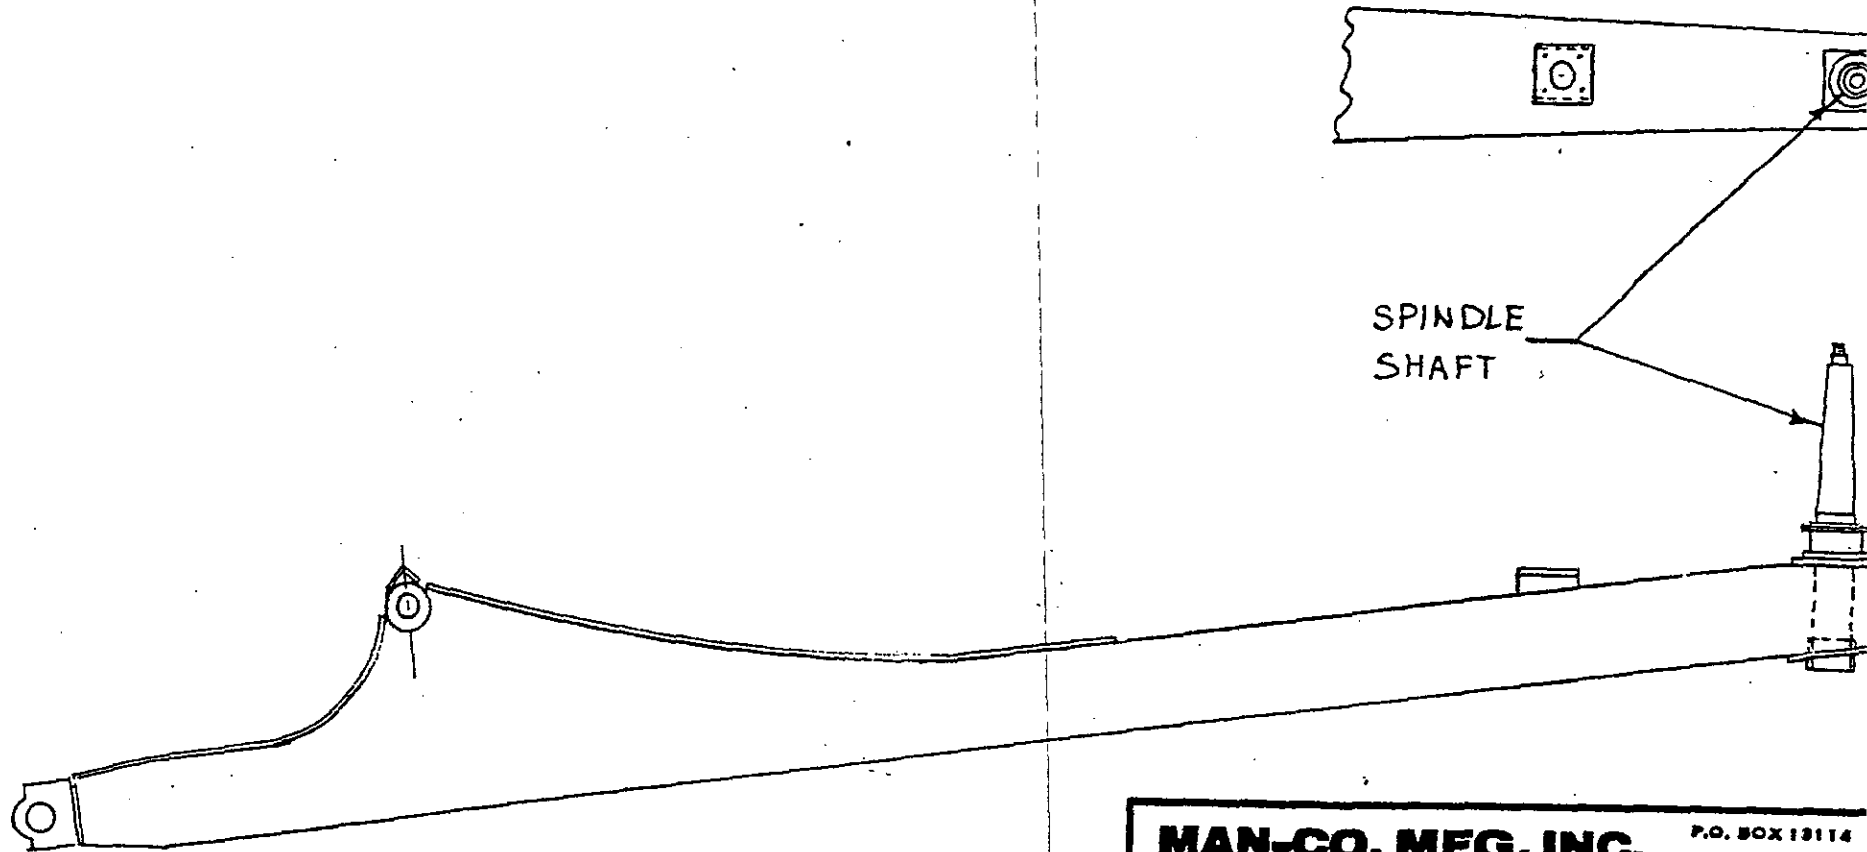
| SPINDLE SHAFT ON BOOM | | HYD. PART |

It has been brought to our attention that there have been recent failures of the shafts and spindles of the above mentioned rides that were manufactured by Frank Hrubetz Co. and Kilinski Manufacturing Company (KMC). For various reasons, these failures have only occurred in those rides that have the shafts and spindles welded directly into the boom. Newer rides and replacement shafts and spindles that have used shrink collars for installation (therefore no direct welding to the shaft) have not experienced these failures and with proper maintenance and regular testing should provide years of safe operation.

- 1) Inspect your ride and determine if the shafts and/or spindles are welded in directly, or if shrink collars are used. (See Drawings BU-138-A through F for information on how to determine the installation method used on your ride.)
- 2) If shrink collars are used on your ride, there is no need for replacement. Please note: All shafts and spindles still need to be tested annually according to the procedures outlined in BU-135-MC (QC-UI-1 - Rev. 3).
- 3) If the shafts and/or spindles on your ride are welded directly to the boom, then replacement is needed.

Due to the time element involved to manufacture and install these shafts and spindles, we recommend that a time period of one year be allowed to make these replacements. However, if your ride is a 1970 model or older, we recommend the replacements be installed as soon as feasibly possible.

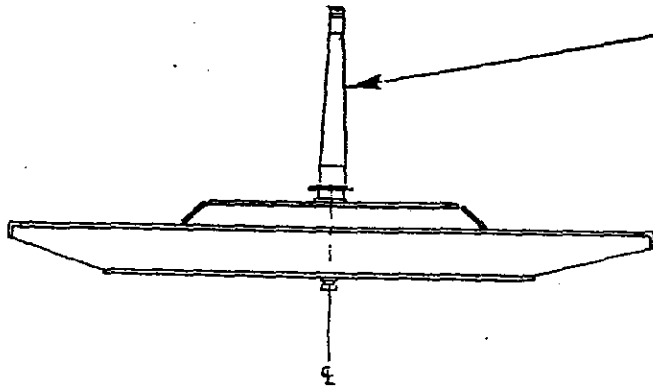
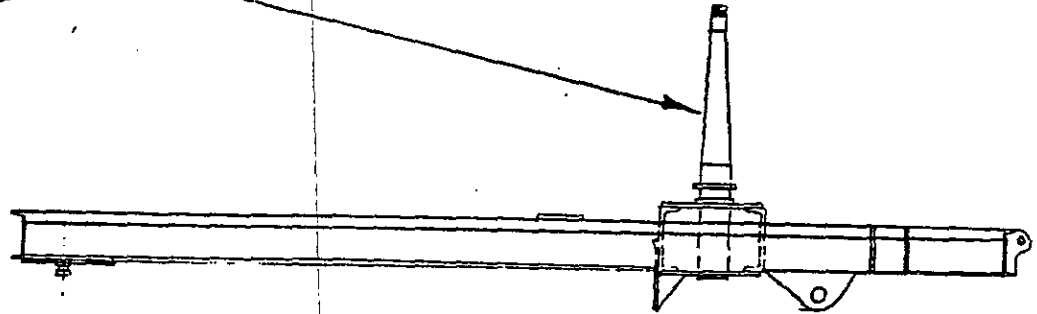
FIREBALL SPINDLE SHAFT

*NOTE: IF NO SHRINK COLLAR IS VISIBLE AT BOTTOM OF BOOM, THEN REPLACEMENT OF SPINDLE SHAFT IS NEEDED.

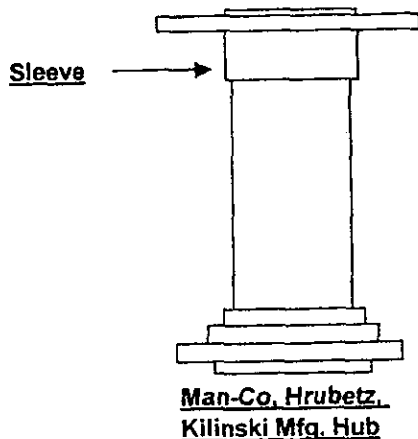
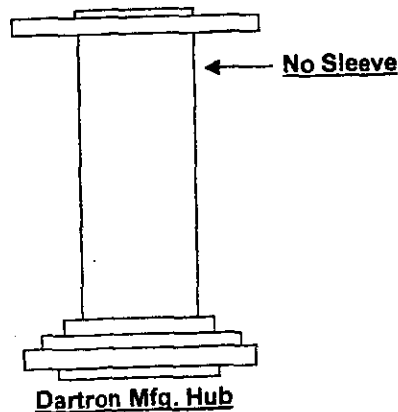
It has come to the attention of Dartron Industries that unnecessary inspections are being performed on new Paratrooper and Round-Up hubs. Dartrons position on this matter is that Round-Up and Paratrooper hubs manufactured by Dartron, do not require an annual NDT inspection.

Below is the sketch indicating the difference between the old style hub and the Dartron hub.

To determine whether a Round-Up or Paratrooper hub was manufactured by Dartron conduct a visual inspection. If the hub is on a Paratrooper and is a "split type" it does not require the NDT inspection. A "split" type hub allows all sweeps to be rotated to the rear of the trailer for transport. If it is not a "split" type hub inspect for the sleeve as shown below.
