**DATE:** March 2, 1999  
**TO:** CPSC, CARES MEMBERS, NAARSO MEMBERS & Others  
**FROM:** Mike Rinehart, Investigator/Operations & Management Consultant II  
**SUBJECT:** "Rodeo Rider" by S&S Accident of 1/24/99, King Richard's Fun Park

This accident occurred on 1/24/99, at King Richard's Fun Park in Naples, Florida. The ride consists of a tower-boom, permanently mounted on a pad, supporting five fiberglass seats via two 1/4" wire ropes. The ride also comes on a trailer mounting for temporary shows.

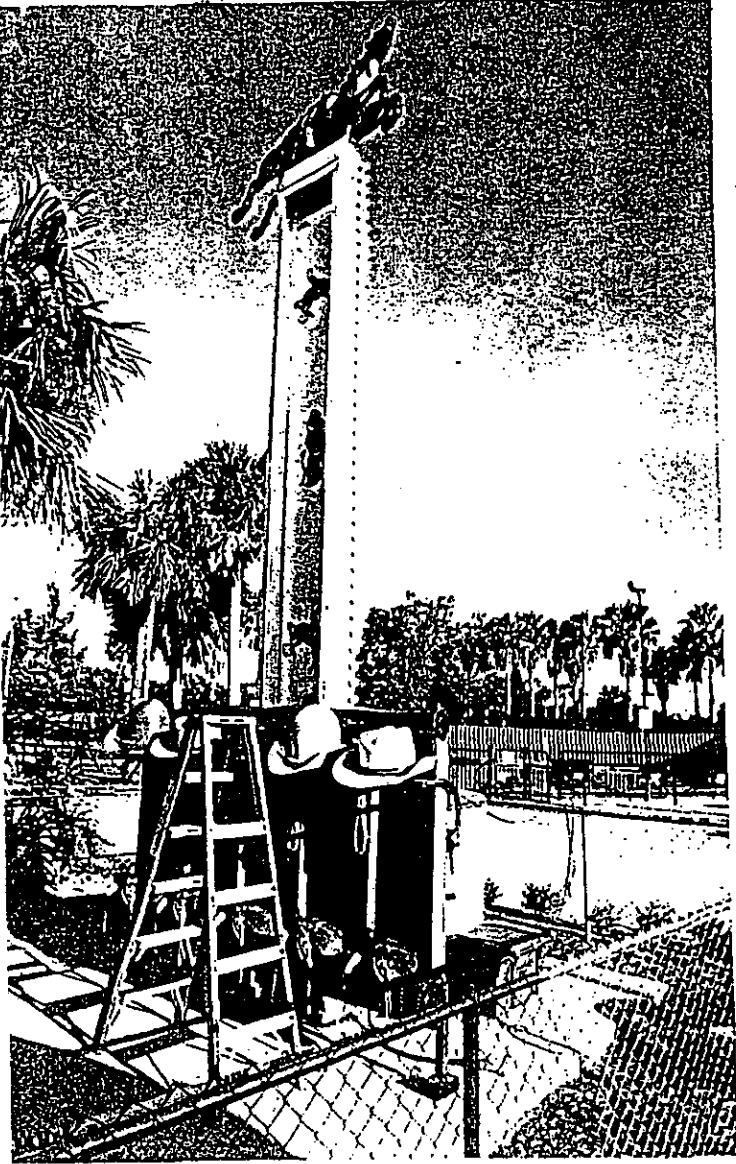
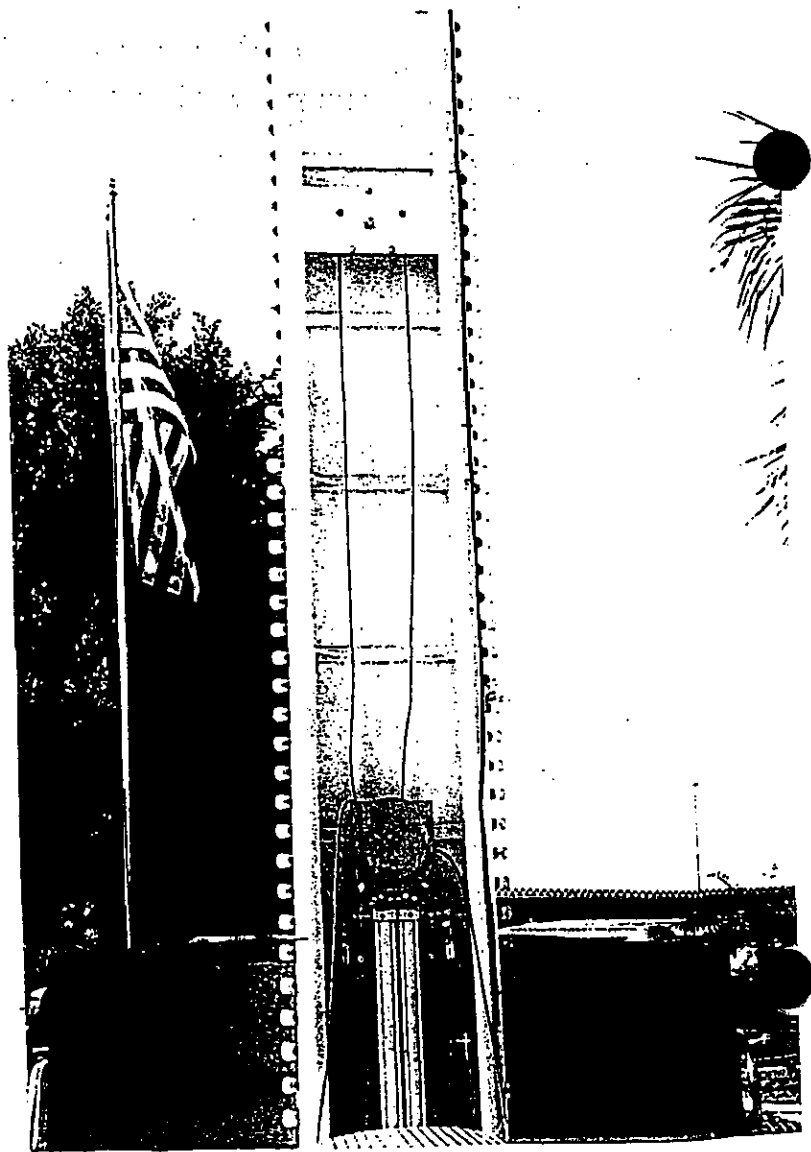
Photos 2, 3, Ride Condition as found.

- The cause of the failure was overload of the ride.
- The probable cause of overload was excessive patron weight, possibly shortly before final failure. Further laboratory analysis may provide a more precise history.

- Had the ride been inspected on the day of the accident, the degraded condition of the wire rope along its length should have been apparent. If degradation was not apparent during the morning's inspection then high overload of the ride occurred on the date of the failure but prior to the actual failure.

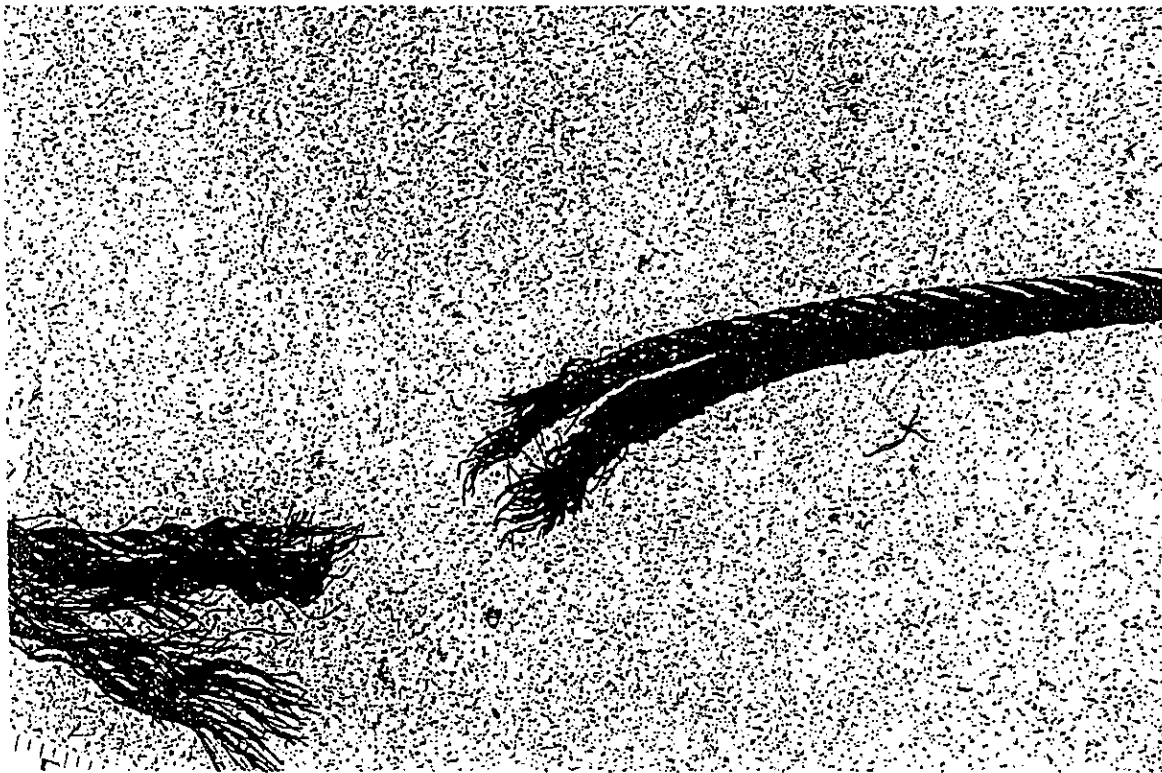
- At the actual failure site more advanced degradation was possibly present due to a wearing action and higher shock loads from ride use.
- The area of the failure at the capstan is difficult to access for inspection and requires removing the ride car itself and removing the wire rope from the capstan.

Photo 22: East cable fracture
