SAFETY BULLETIN

RISE: ORBITER

SUBJECT: CAR ATTACHMENT PINS

BULLETIN NUMBER: 00120

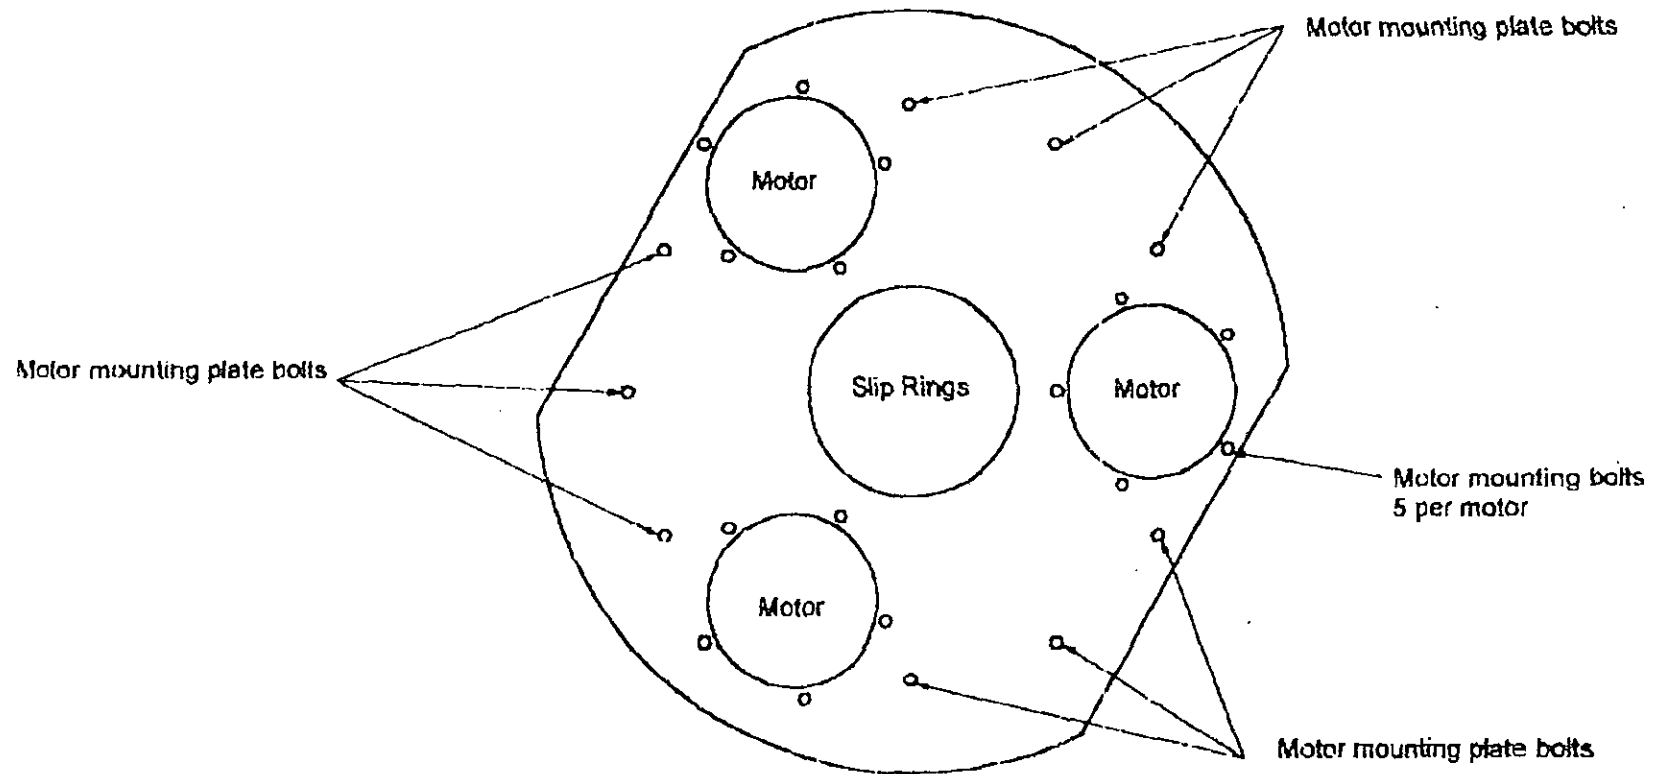
Drawing: ORSA002A

On February 1, 2004 an Orbiter amusement ride caught fire while operating at a fair in West Palm Beach, Florida. The fire originated in the top center hub area of the ride. A fire was initiated when bolts securing the motor mounting plate became loose and over a long period of time eventually sheared allowing the motor plate to turn causing one or more hydraulic hoses to pull loose from their crimp, spraying fluid into the top hub area. An electrical short presumably ignited this oil. The source of ignition is still under investigation at this time. As a precaution Tivoli Mfg. Ltd. requires that the inspection recommendations described below be carried out as soon as possible on all Orbiter rides in operation.

Orbiter center sweep motor mounting plate.

Motor mounting plate bolts 9 pcs.

Motor mounting bolts 5 bolts per motor, 3 motors.

- Inspection of B10 hydraulic motor pinion mountings. The pinions on the orbiter are attached in one of two ways, a bolt and washer screwed into the end of the output shaft or two allen set screws threaded into the top shoulder of the pinion gear. These fasteners are to be checked for tightness and assured that they are properly secured with loc-tite (242). Note: If applying loc-tite the threaded areas must be free of grease or oil before installing.
- Inspect all bolts securing motors to mounting plate.
 - 5 - 12 mm x 45mm bolts for each hydraulic motor.If loose, damaged or show signs of reuse, replace immediately with new bolts and tighten to correct torque.
- Replace all nine (9) bolts securing motors mounting plate to hub.

- 9 – 12mm x 45mm bolts spread equal distance around outside parameter of plate. See Attached drawing ORSA002A.

Tightening Torque Requirements: Tighten bolts to 65 ft / lbs.

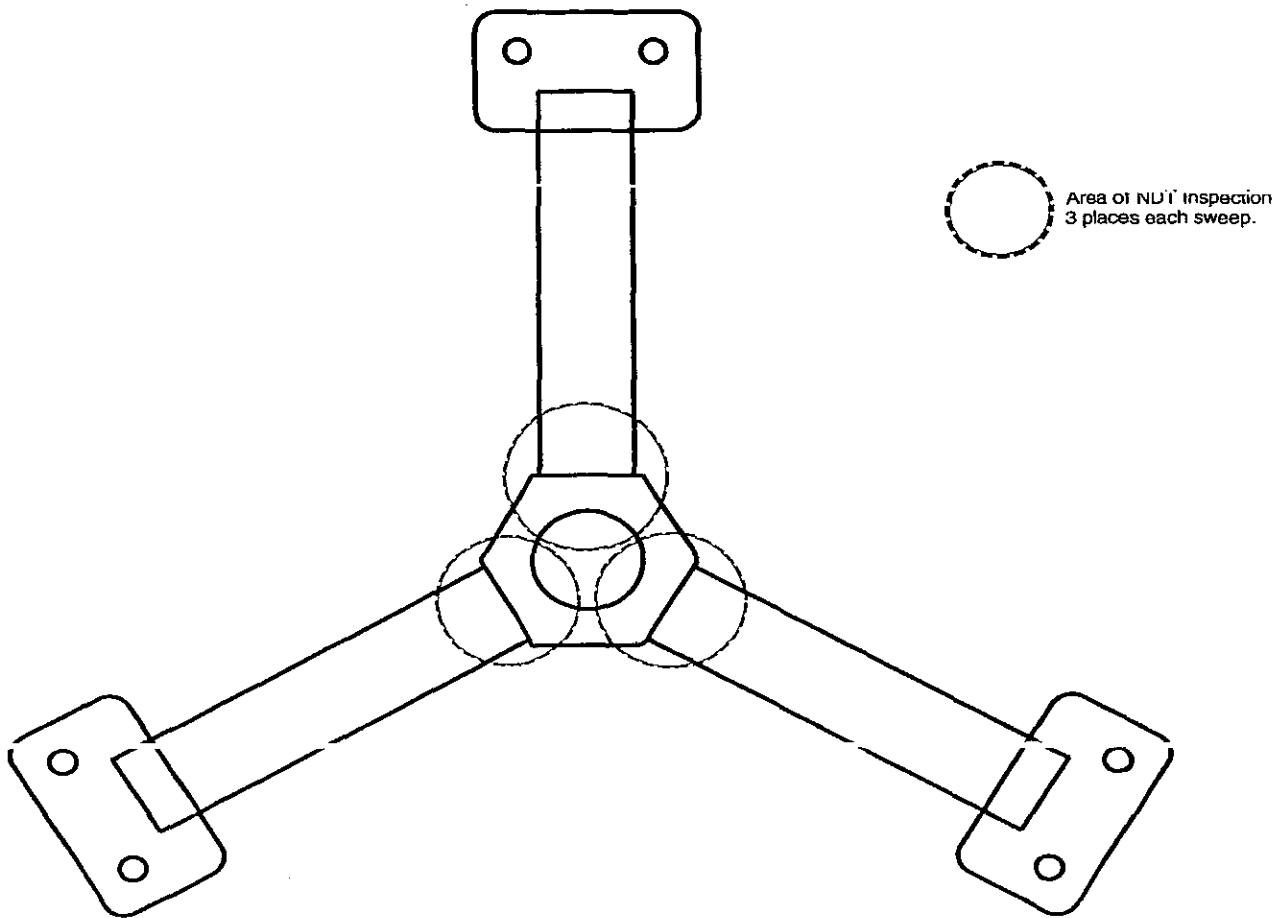
Vehicle Connection Frame

The cause of the separation of the vehicle was caused by a combination of corrosion and cracking of the welded tubing at the weld joint of the attachment frame as indicated in the accompanying drawing.

Tivoli requires that the welded connection and tubing in the area noted in the drawing be tested by magnetic particle NDT testing and visually checked for corrosion. Any additional testing or change in procedure will be at the discretion of the testing technician.

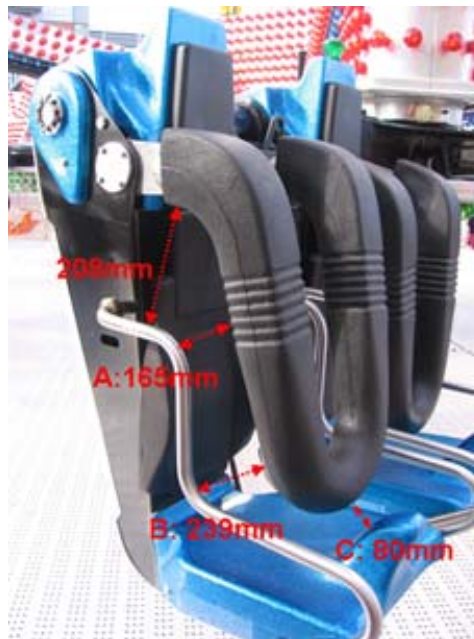
Fig 1:

Experiments on the ride involved with this seat configuration have shown that it is possible, given the movement characteristics of the ride and the rail positioning, for ejection to occur through the gaps in the containment. The gap in the containment marked A in Fig 1 (165mm) corresponds to the chest depth of 14-year-old boy, whose equivalent stature (with shoes) is estimated at 1750mm. The gap marked B in Fig 1 (239mm) is large enough for all children 16 years of age and under, and 17% of all adults to fit through and so possibly be ejected from the ride through this route, especially during the start up phase. In order to eliminate the risk of ejection through this gap, an estimated height restriction closer to 1950mm would be more appropriate (i.e. to eliminate all but large adults).

1. Until physical changes are made to the seat restraint bars and those changes have been reviewed and approved in accordance with the design review procedures in HSG 175, with immediate effect, no person under the height of 1.8m (one point eight metres) is to be permitted to ride this machine. The design review should be carried out by an appropriately qualified person and can be limited to the seat restraint bar system if that is the only part altered. It should be noted that there remains a slight possibility that persons of certain builds over 1.8m may still be ejected from the ride so a high level of operator vigilance is required.

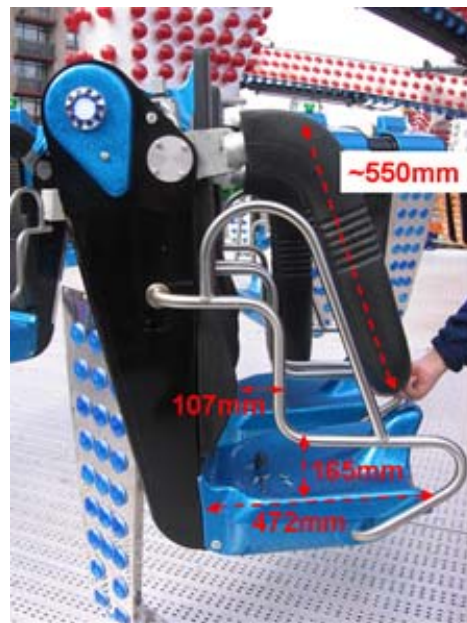
Fig 2:

It can be seen that the original side restraint bars are retained and the new piece welded to it. This addition should be capable of withstanding the weight of the upper torso of a large male rider, an approximate sideways force of 150 kg during all phases of the ride.

2. By 21 August 2009 the seat rails must be adjusted so that the gap between the overhead restraint and the new rail is not greater than 50mm and should fill the gap from top to bottom as shown in Fig 2. The 50mm measurement is to be taken with the overhead restraint at the 'first click' only and not utilising the pneumatic system. Tivoli have completed this work on at least one ride so far, an example of this work is below:

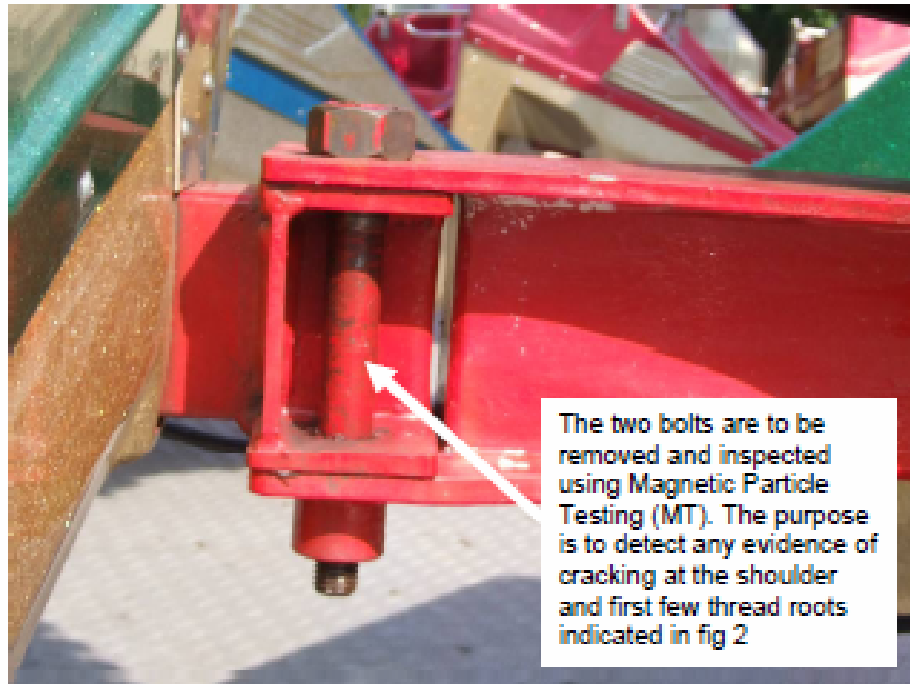
Fig 1: General view of the seat retaining bolt in position on the ride.

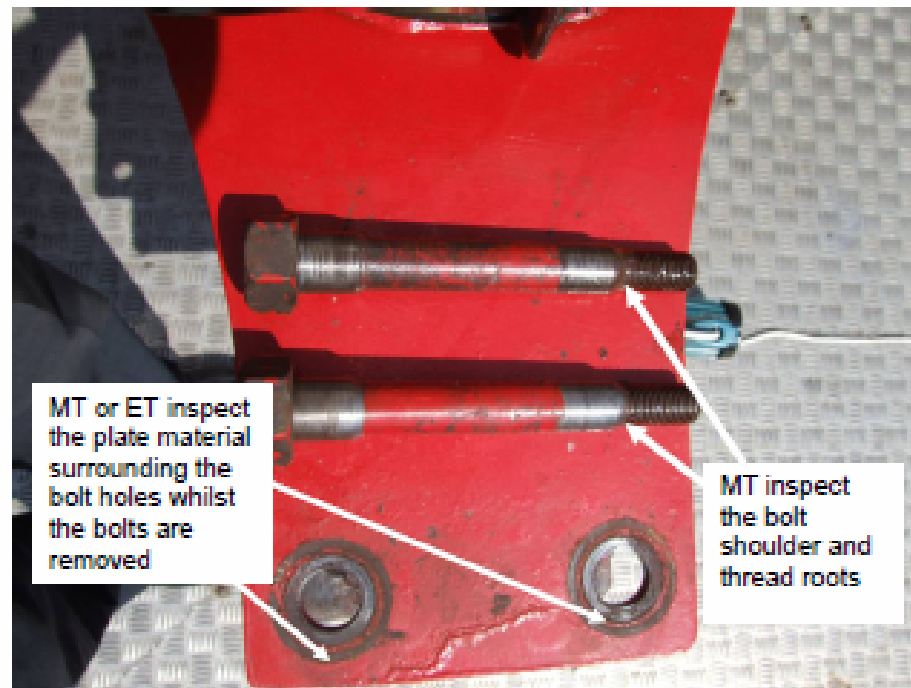
Fig 2: View looking down on the seat attachment arm with the seat assembly removed.

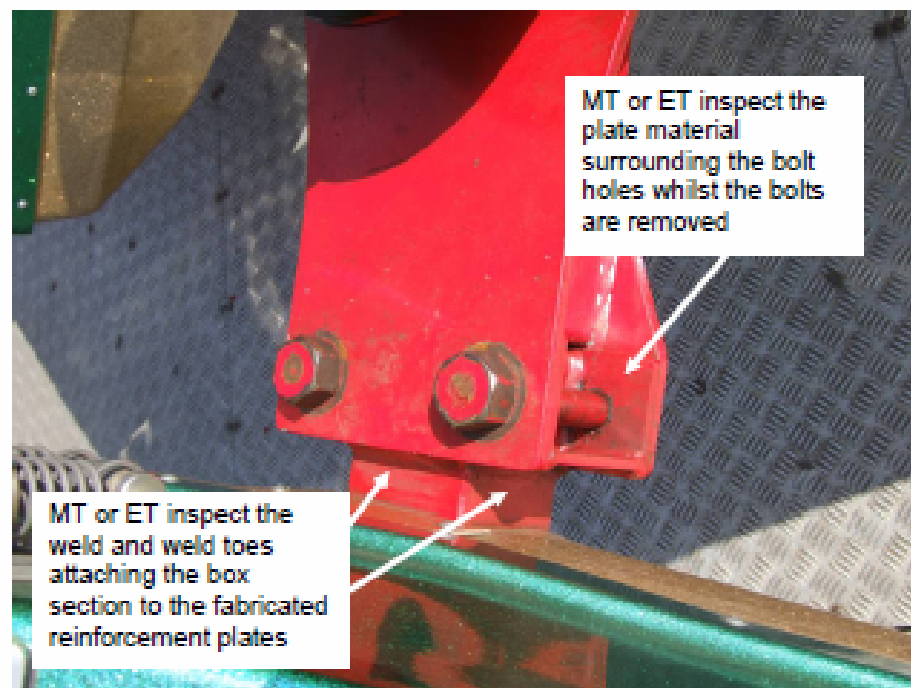
Fig 3: View from above the seat attachment bolts with seat in position.

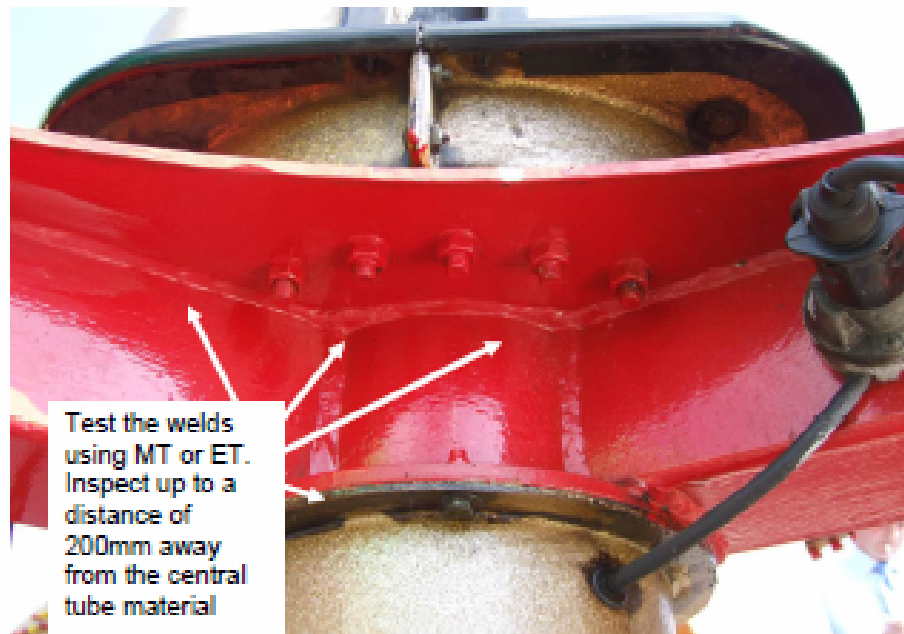
Fig 4: View of the welded fabrication attaching the three legs holding the seat assemblies to the slew ring (later design).

Note: This later design is reinforced by adding a profile cut plate fully welded across the top edge of all three box section legs.

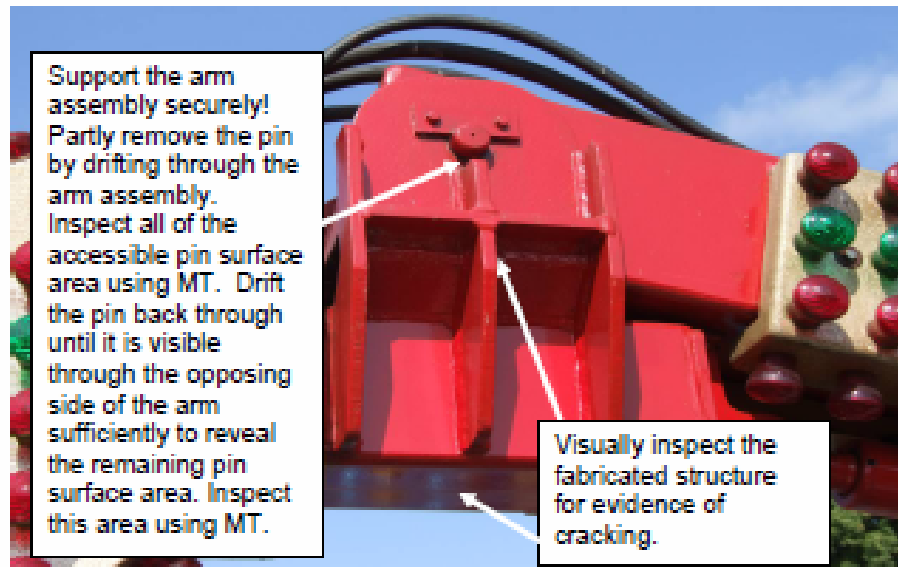
Fig 5: Magnetic Testing of the pin.

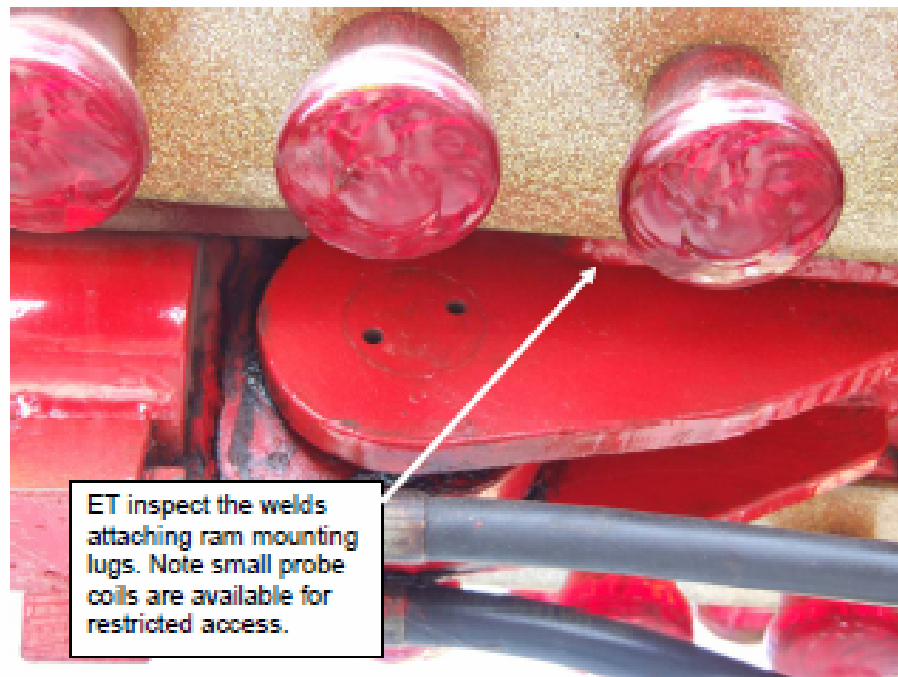
Fig 6: Attachment welds retaining the hydraulic ram on the arms.

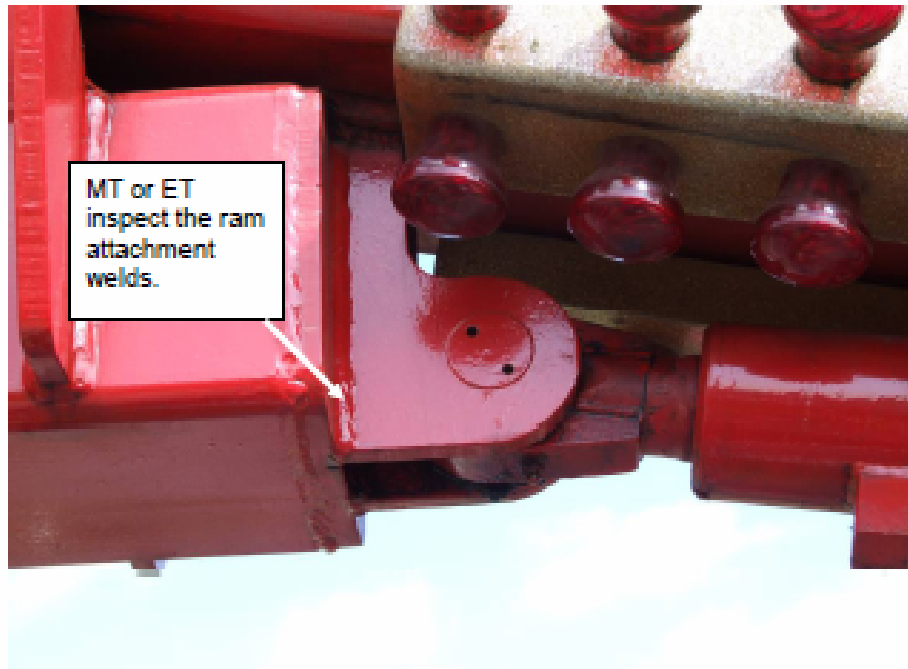
Fig 7: Welded brackets holding the hydraulic ram on the arm assembly.

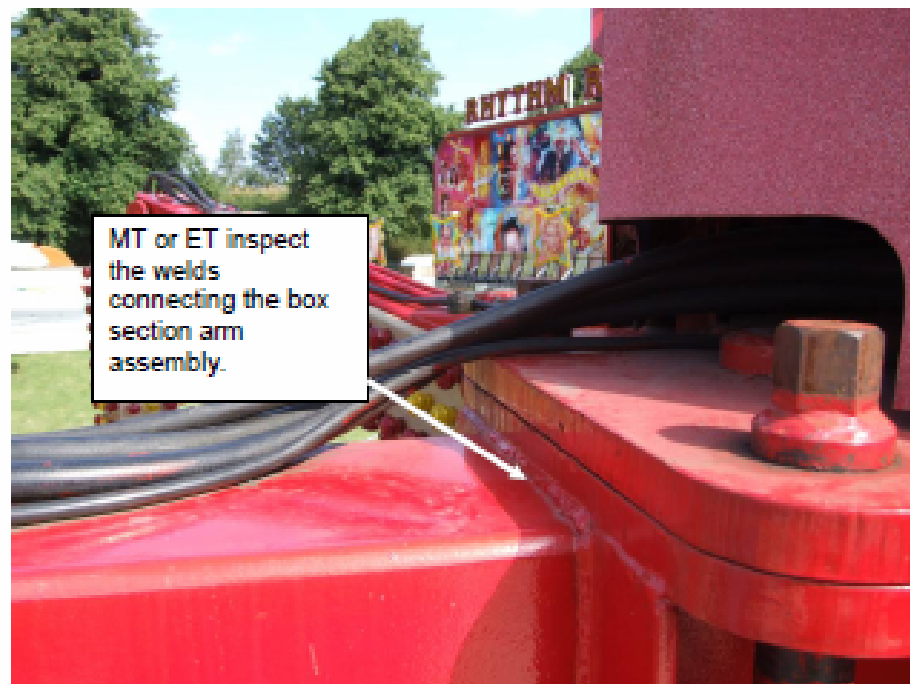
Fig: 8 Intersection of the arm assembly to the central tower fabrication.

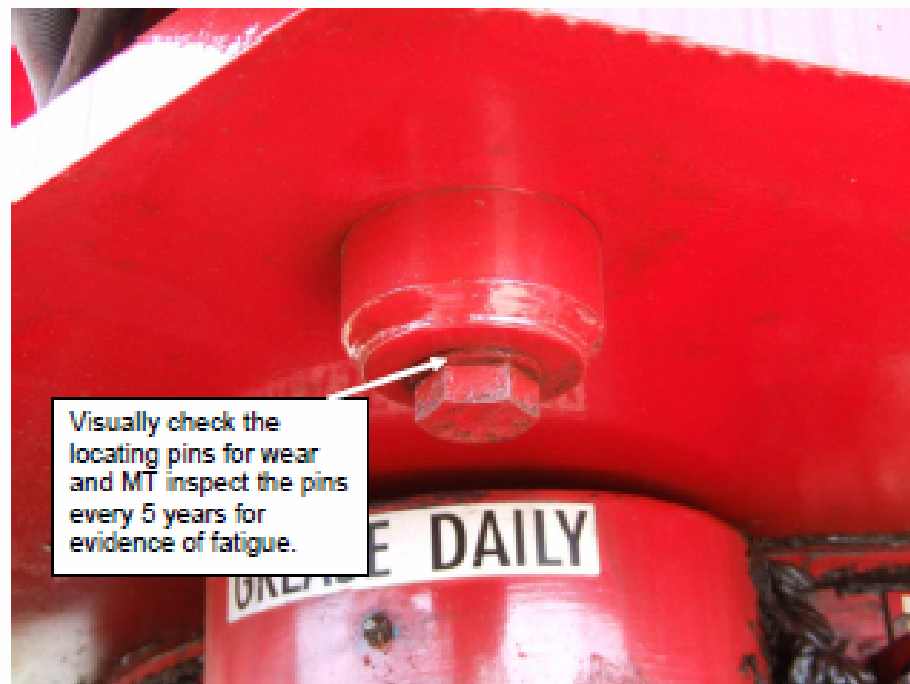
Fig 9: Retaining pins that prevent the arms folding.

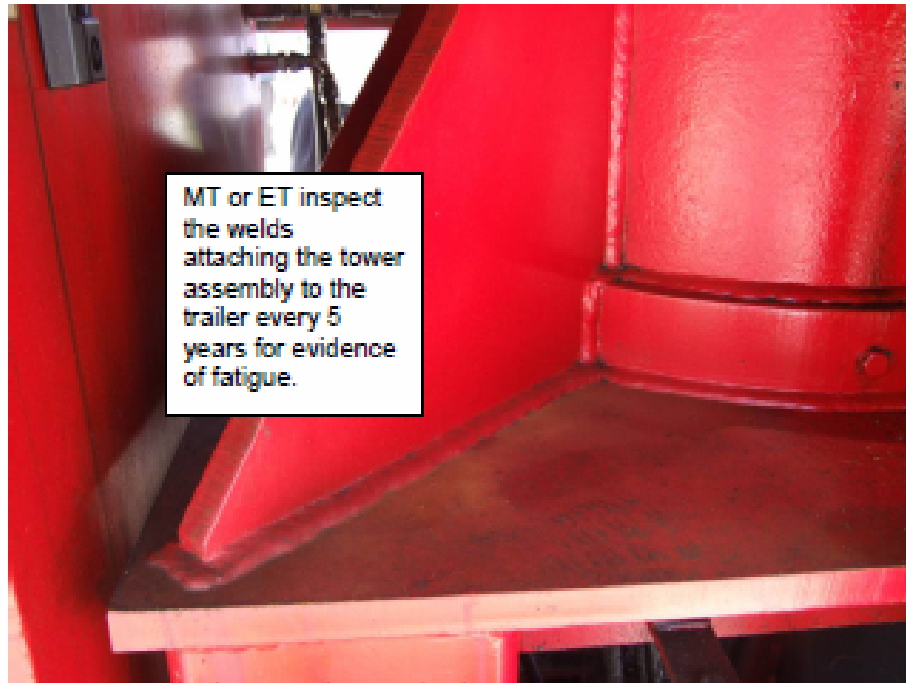
Fig 10: General structural inspection mounting the central tower to the trailer chassis.

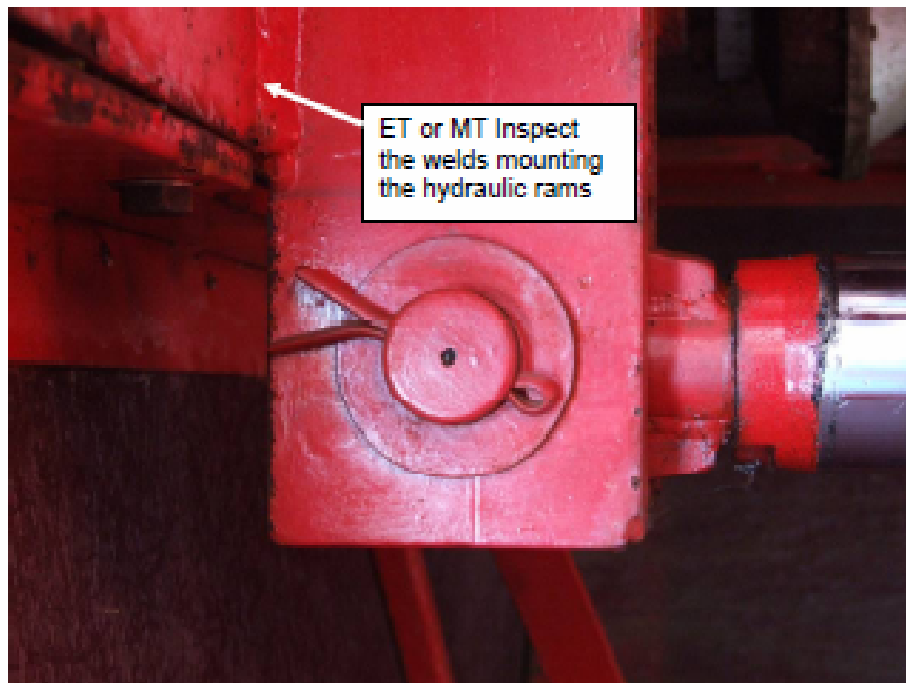
Fig 11: Welded brackets holding the central tower elevation rams.

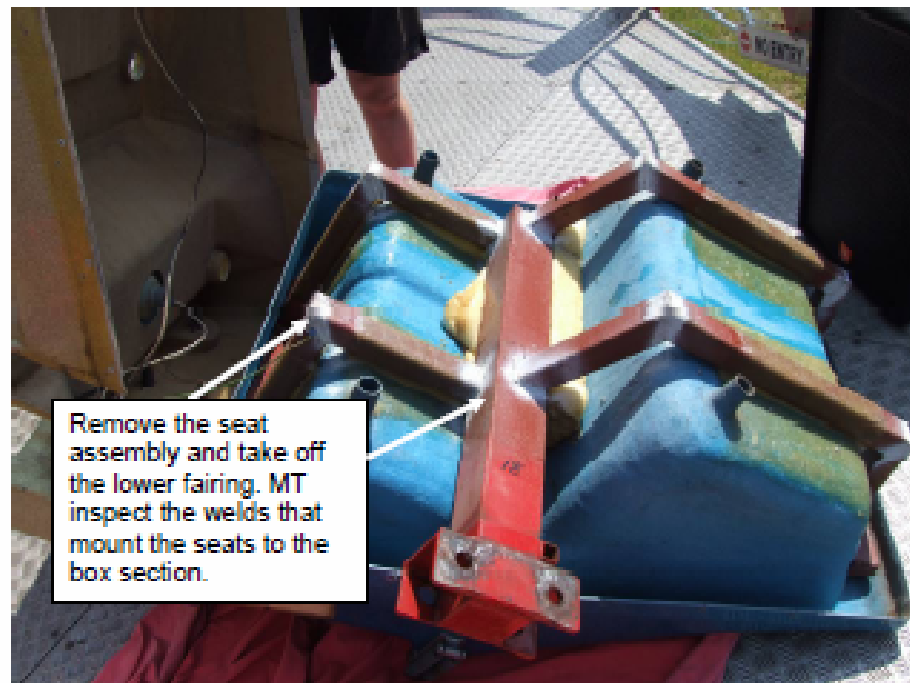
Fig 12: View of a chair assembly with lower fairing removed to gain access to the structure.

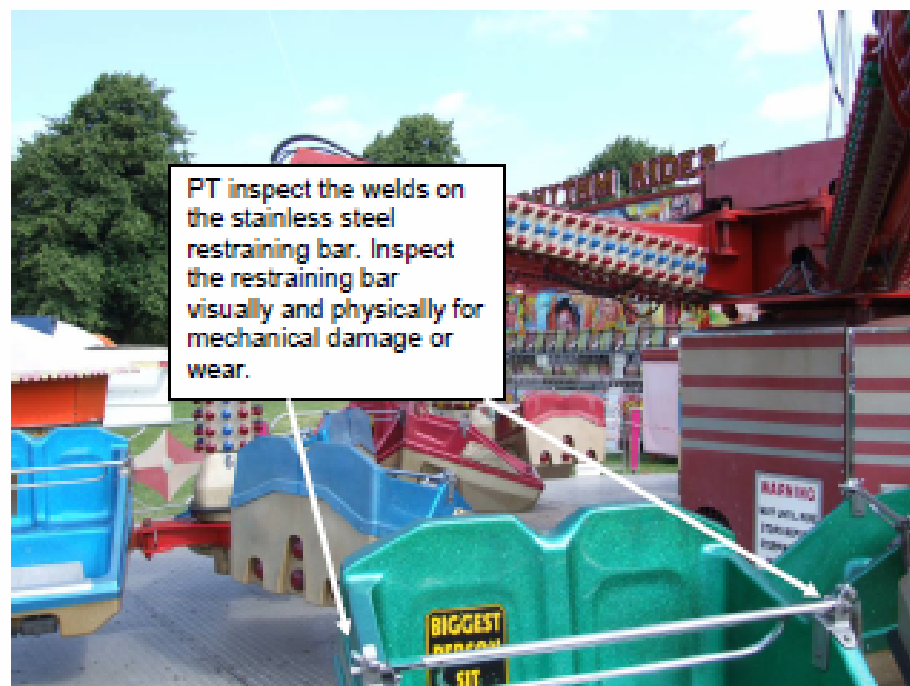
Fig 13: Passenger restraint bars fabricated from stainless steel.
