COMMONWEALTH OF PENNSYLVANIA DEPARTMENT OF AGRICULTURE BUREAU OF RIDE AND MEASUREMENT STANDARDS AMUSEMENT RIDE SAFETY DIVISION

- TO: Owners and Inspectors of Sizzler rides Manufactured by Wisdom, registered in Pennsylvania and interested parties.
- FROM: Joseph G. Filoromo, supervisor
- SUBJECT: Safety Alert Possibility of deteriorated structural members
- DATE: February 23, 2005

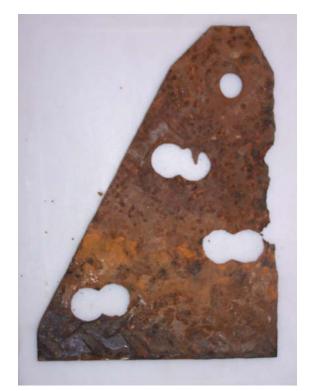
This badly damaged part was still inside the fiberglass and could have gone undetected. This part is unacceptable.

Please do a detailed inspection of the areas outlined below before further operation of Sizzlers. Look closely for swelling of the fiberglass or rust weeping from the designated area. If there is any question about the integrity of steel parts that are encapsulated in Fiberglass, non destructive testing is recommended. All repairs must be done in accordance with the manufacturer's specifications.
