**Report on Cracks Found in Tornado Amusement Ride
Submitted to CARES November 3, 2004
Bob Cate, Louisiana State Fire Marshal Office**

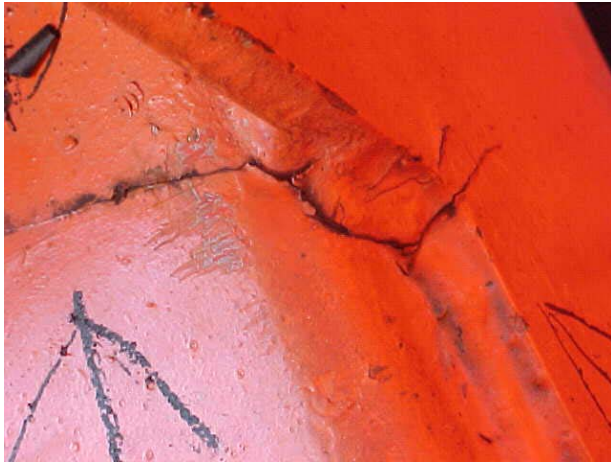
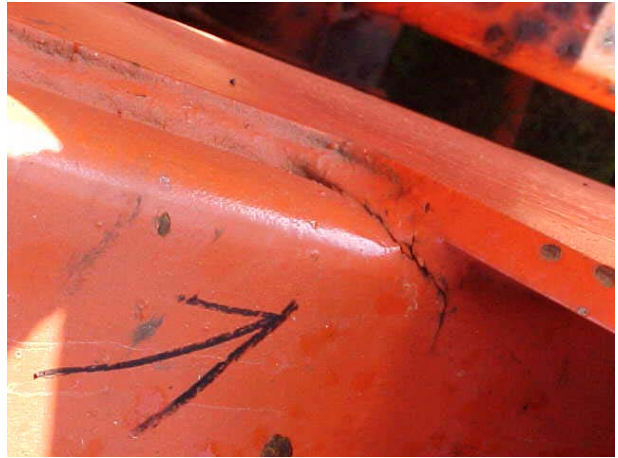
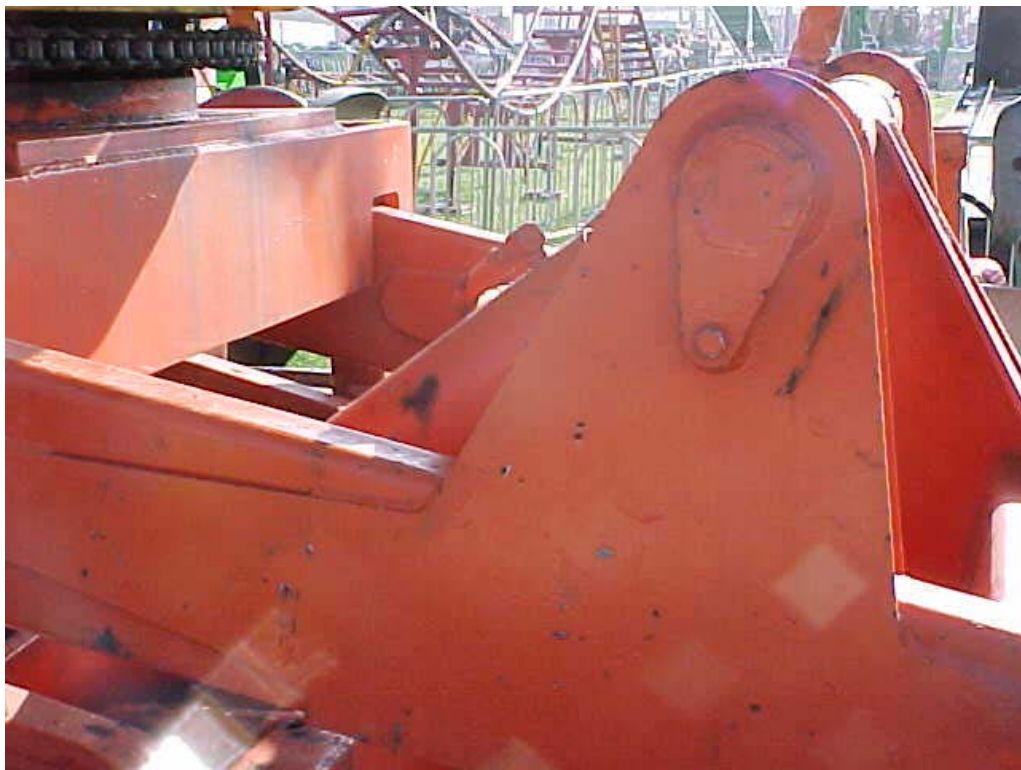
This is to serve as a "heads-up" message. Last week two of my Inspectors were doing setup inspections. While doing the Tornado, they discovered cracks on the main center lift arms of the ride. These cracks are located on the inside of the main lift arm gusset plates. These cracks may be seen by standing on the fender of the trailer looking down at the support arm gussets. The manufacturer has a reinforcement gusset kit available, but no bulletins have been issued for this problem/repair.

It may be a good idea to check this area out on any Tornado you may have in your jurisdiction. Here are three photos of the crack found:
