NAFLIC

TECHNICAL BULLETIN - FEBRUARY 1993

053. Sellner-Man Tilt A Whirl

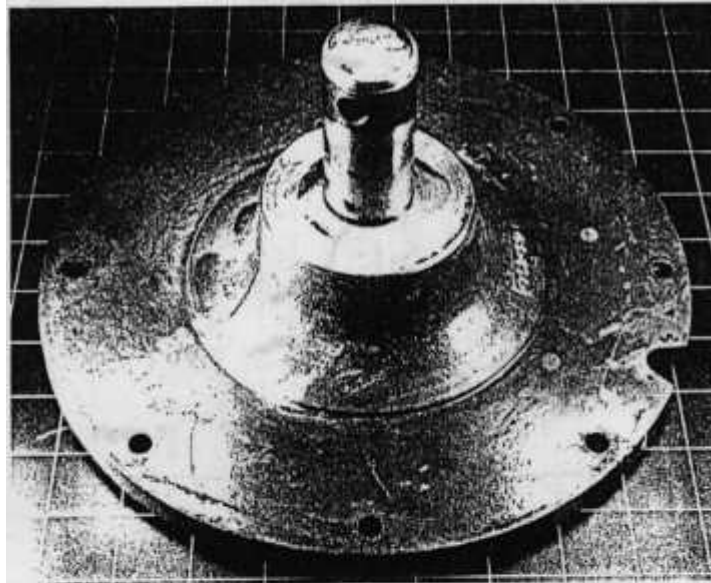
The component consists of a flange (grey cast iron) into which a bearing post is inserted with an interference fit. It is further pinned to prevent rotation. Several cracks were observed on the flat surface on the top of the raised neck region of the cast flange, emanating radially from the hole into which the bearing post was fitted. The largest crack was measured to be 12mm in length, the others between 1 and 2mm. It was also noted that the flat surface on which the cracks were found was deformed in the region of the aforementioned defects, the surface being raised up, in some instances resulting in evidence of wear from the rotating bearing above. The bearing surface of the post showed evidence of spalling, confined to a region opposite to the cracked region of the flange.

Figure 1 General view of the assembly

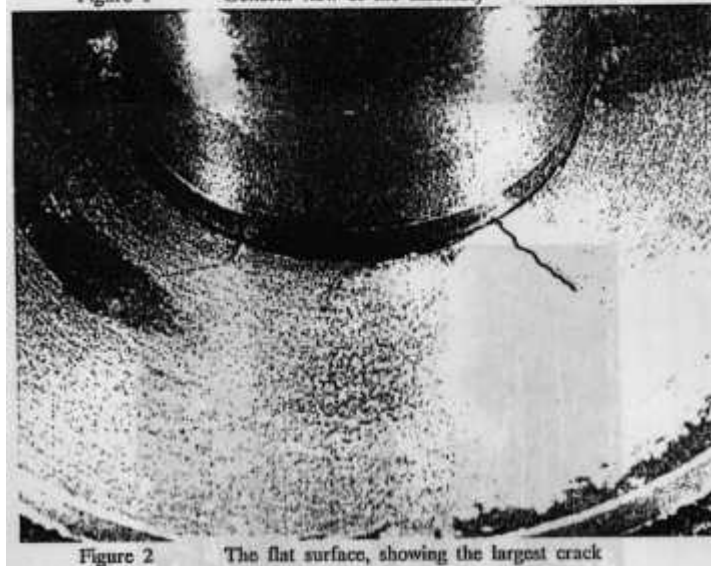
Figure 2 The flat surface, showing the largest crack
