# NAFLIC

### **TECHNICAL BULLETIN - OCTOBER 2002**

#### **254. Fabbri Fabricated Ratchet Restraints**

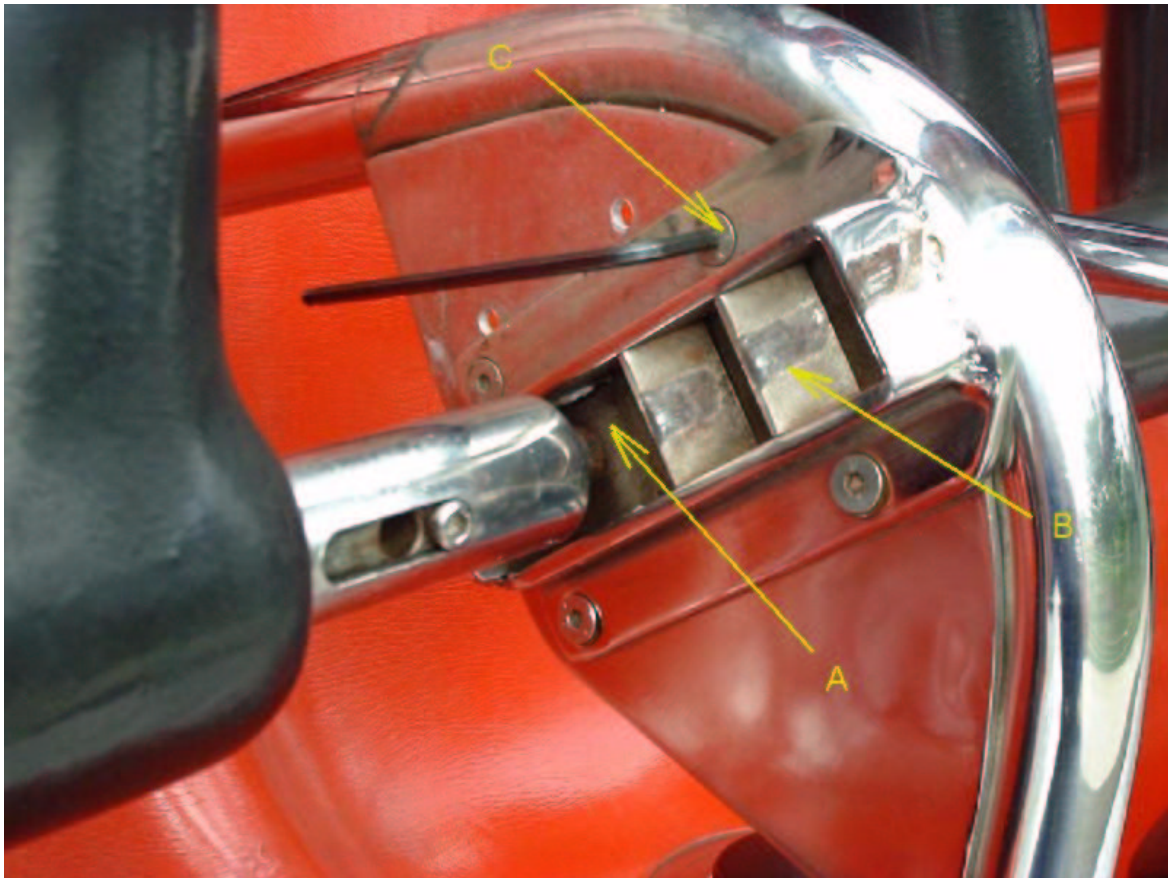
**254. Fabbri Fabricated Ratchet Restraints**

One of the teeth of the passenger restraint locking ratchet was found to have been broken off. This can be seen at the position marked "A" of the photograph on page 2 of this bulletin.

The ratchet teeth, e.g. "B" in the photograph, are simply pieces of plate welded in position at a suitable angle to mesh with the pawl. The weld is a single fillet weld along the inner rear edge of each plate only. We have not seen the design specification, calculations, etc., so we remark only that this single, straight, weld would not normally be a particularly strong arrangement for the resistance of the tooth load.

The location of the tooth weld is such that it is not normally visible and, although for maintenance / inspection purposes a small dentist-type mirror may be useful, more reliable examination is achievable by removal of the ratchet unit by unfastening the 4 socket screws "C".
