SAFETY ALERT/ACTION NOTE

KMG BOOSTER

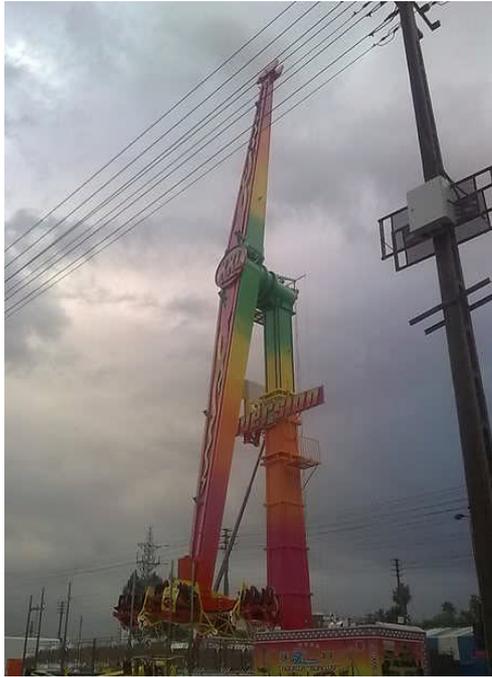
Fig 1.

There have been at least two serious accidents in the last 24 months involving these rides. Both have resulted in serious physical injuries to the operator and both appear to have the same root cause. Examples of the KMG Booster, one set up to run and another ready for transport can be seen at Figs 1 and 2.

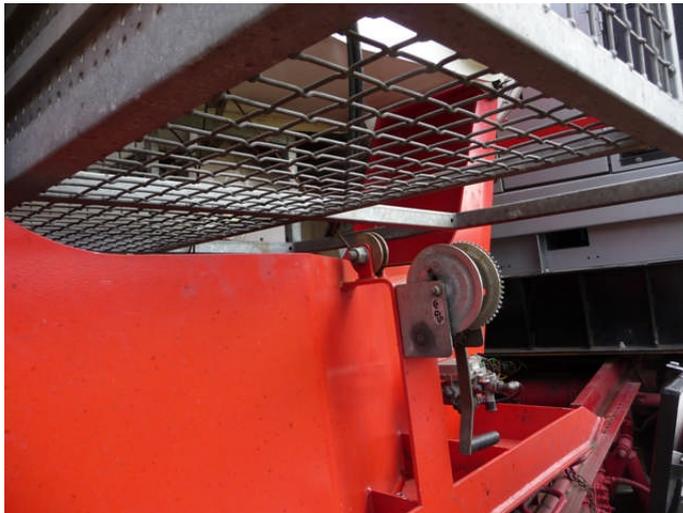
During both erection and dismantling of the ride a 5.56mm steel wire rope (SWR) runs between a winch fitted on the ride's king pin frame and the main arm and is used to lift the frame into place before pins are fitted to secure it. This SWR is under considerable load during this procedure. The winch fitted to this machine was a manual Dutton-Lainson version with a rating of 545kg with one winding. This rating decreases as more windings are run onto the drum. A photo of the winch attached to the king pin frame is at Fig 3.

During the lifting/lowering operation the operator is required to be very close to the machine to insert/remove pins when the SWR is under greatest load. In both of the recent accidents it was reported that the SWR snapped and the frame fell onto the operator causing serious injuries. Some similar machines have been retrofitted with electrical winches which allows the operator to stand away from the machine whilst the actual lift is in progress, an obvious improvement in safety standards for the operator. The fitment of such a winch is recommended. The Operator will still be required to approach the machine to insert/remove the pins and the condition of the SWR should be examined before and after every use to ensure it is in good condition e.g. not frayed or twisted. The way SWR runs back onto the winch should also be observed to make sure it does not twist or become damaged.

These types of winches (manual and electrical) are known to cause deterioration and damage to the SWR spooled onto them when they are loaded unevenly under pressure. It is also possible that damage to the SWR could have been caused or made worse if it had been left under tension whilst the machine was being transported. Whilst it is possible that in both accident cases, the SWR was in a damaged/poor condition prior to its failing, there is no evidence to support this as it has not been possible to recover the SWR for observation/testing.

Ride controller action required: The SWR used in this operation suspends a large piece of metal in a position where it becomes a potential threat to life if it breaks. It is imperative that controllers ensure that the condition of the SWR is checked before and after each use to ensure it has not become damaged. If damage is apparent they are to check with their ride inspector whether its continued use is acceptable or whether replacement is required.

It is the recommendation of the HSE Specialist Inspector involved in the accident investigation that the SWR be replaced at least at 12 monthly intervals. This is based on the fatigue bending life calculations made by SWR manufacturers when such ropes are passed around pulleys.

Ride examiners are to ensure however that they conduct thorough examinations of individual winches and SWRs to the standard required in LOLER as part of the annual thorough examination and a DOC should not be issued if either are in poor or unserviceable condition.

Ride Examiners are to check that the controller has replaced the SWR at least in the previous 12 months.
