CHANCE
MANUFACTURING CO., INC.

Service Information

Ride: TWISTER

Subject: INSTALLATION OF RESTRAINING BELTS

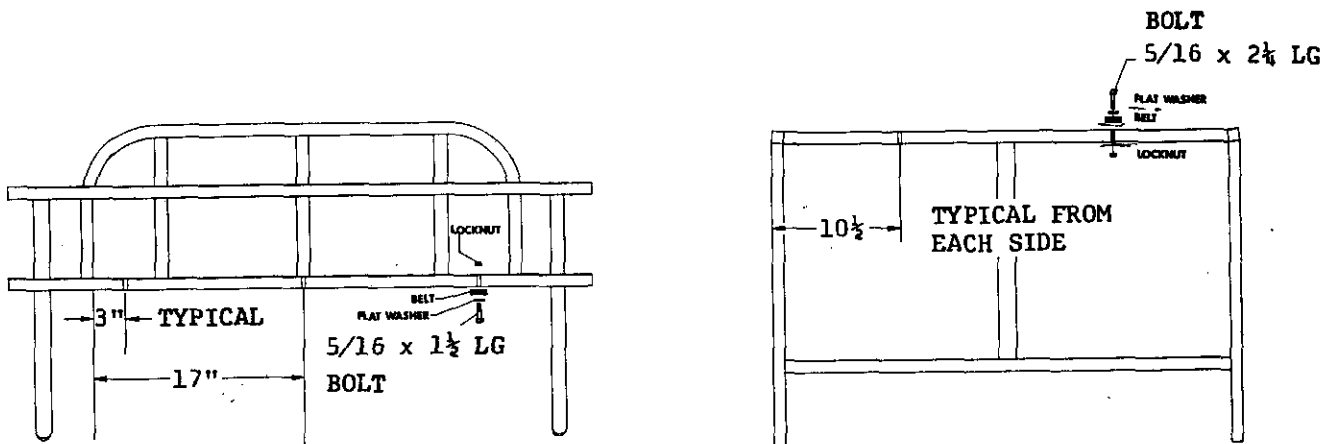
FRONT SEAT BACK

Should a ride patron reach his or her limit of endurance, blackout could possibly result. If this were to happen, they could possibly slide down and out of the car seat.

1. Remove the headrests from the cars and drill three 5/16" diameter holes in each one as shown.
2. Install 5/16 x 1½ LG bolt, flat washer and restraining belt from bottom side of tube on the headrest and secure with locknut.
3. Drill two 5/16" diameter holes down thru the square tube that supports the back of the front seat of each car.
4. Install 5/16 x 2¼ LG bolt, flat washer and restraining belt from top side of tube and secure with locknut.

When installing belts make sure they are not twisted before bolting.

Do not start ride until all passengers have slipped under the Restraining Belts so the belt rest around their mid-section and under arm pits.

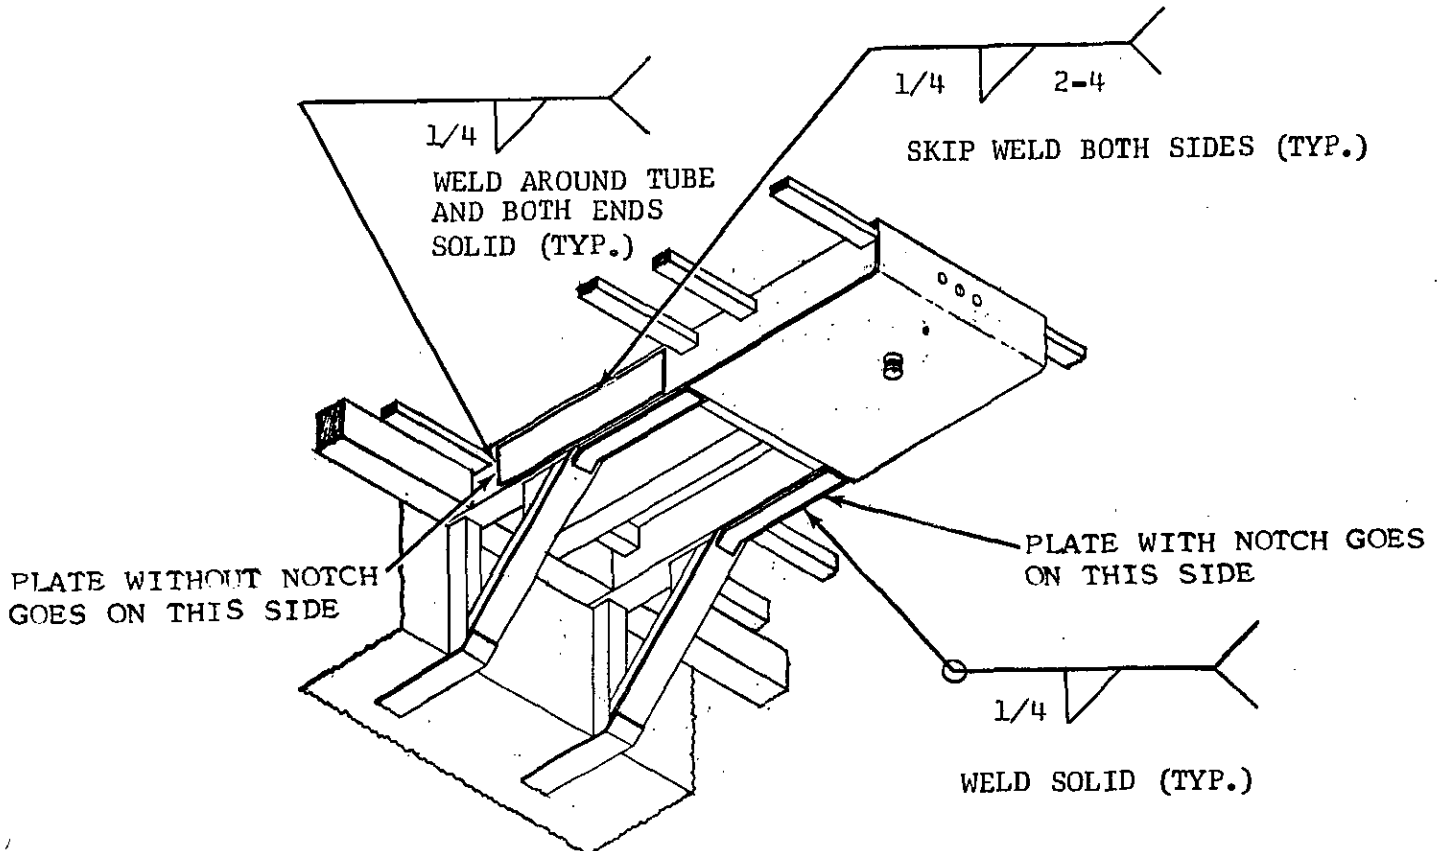
We wish to inform all Twister owners of an area on the Twister trailer that could be termed marginal as far as strength goes. Should the trailer become bogged in mud and you try to jerk it free, it is possible that the main support tubes could bend. This could also happen if the trailer were bouncing severely on a rough highway. Enclosed is a print showing details of some plates. We are recommending that these plates be added to the trailer immediately. The print calls for 3/8" thick plate and this is recommended. However, if the 3/8" plate is not available, 1/4" plate could be substituted.

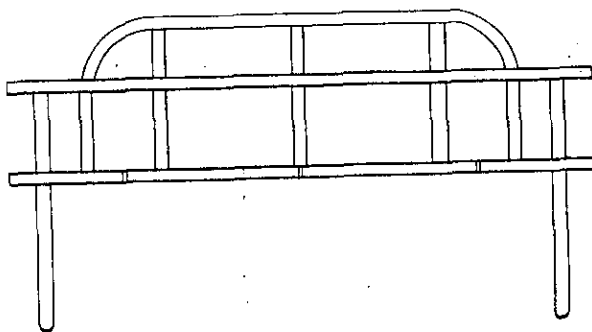
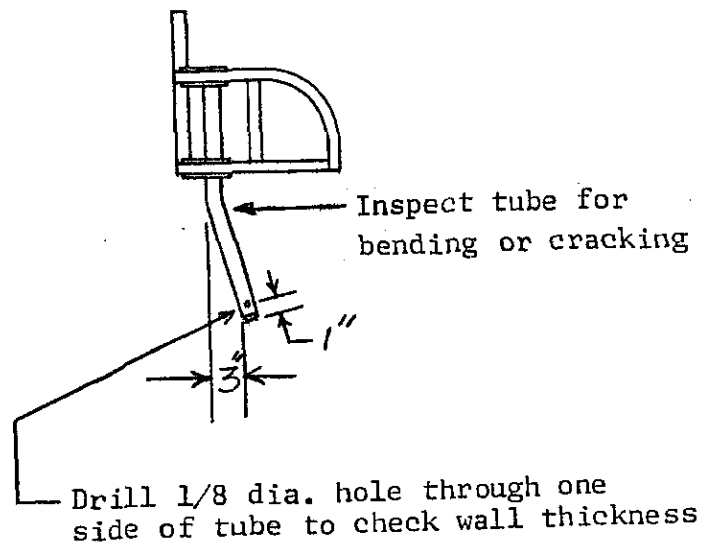
We are asking all TWISTER owners to inspect the head rests on all TWISTER cars immediately. Remove each head rest and inspect the support tubes that fit down in the sockets on each car. Inspect for any signs of physical damage, such as bending or cracking. Next, drill a small hole, 1/8 inch, near the bottom of the support tube approximately 1 inch from bottom. Drill hole through one side of tube only. Check wall thickness of tube. It should be 1/8 inch thick.

If any of the tubes show signs of bending or cracking, or if any tube has less than a 1/8 inch wall, report such condition to Mr. Richard G. Chance, General Manager, Chance Manufacturing Company.

Any of the afore-mentioned conditions could result in a serious accident if the head rests are not inspected, and any faults corrected immediately.

Inspect the head rest support tubes on a regular weekly basis as an added
Factory and General Office: 4219 Irving, Box 2397 Wichita, Kansas 67201 Area Code (316) 942-7411

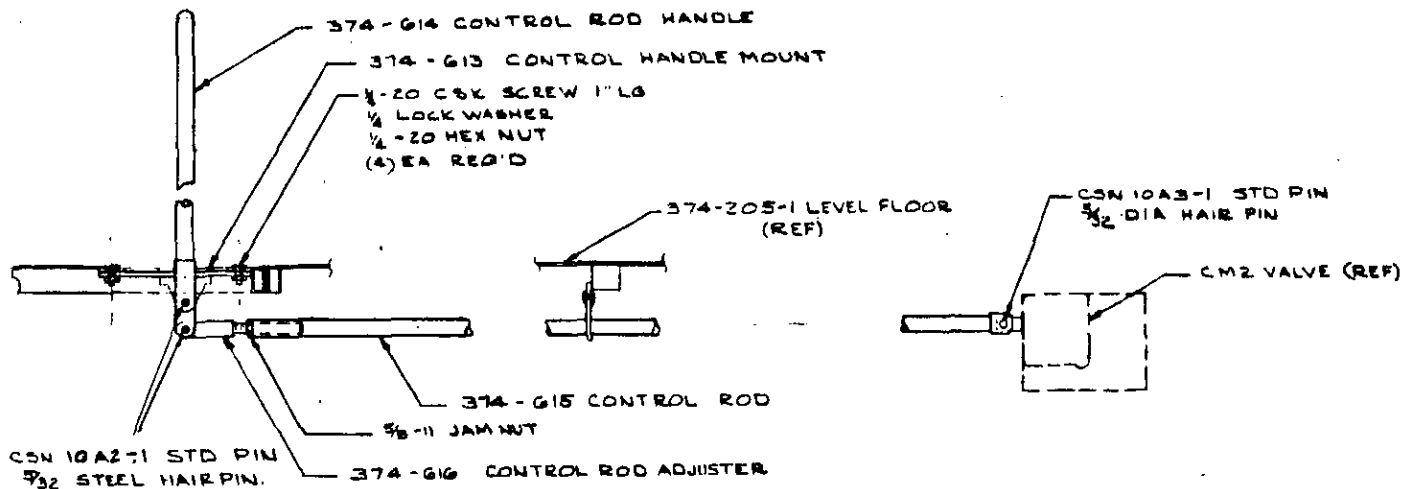
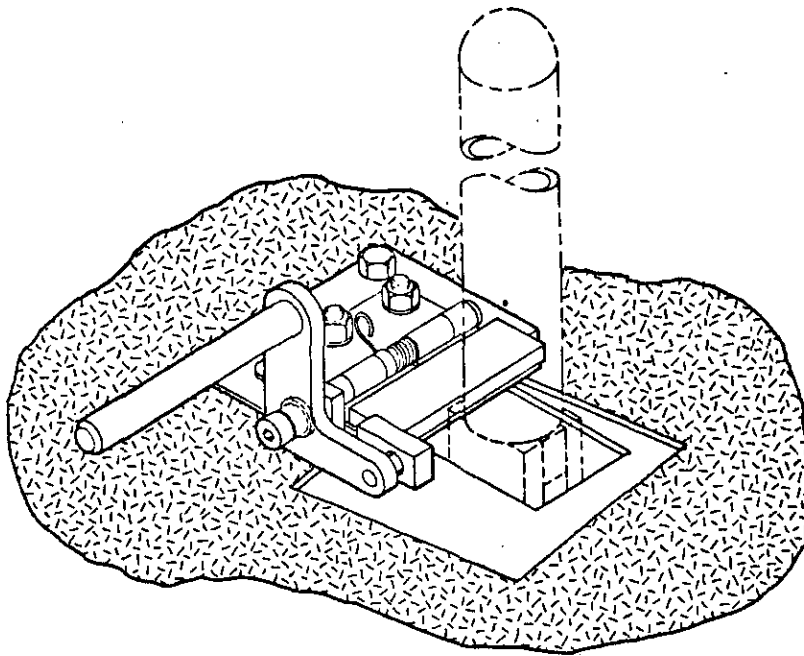
The detent will prevent an accidental engagement of the Control Lever during loading or unloading of the ride.

Position Detent Assembly in front of the Control Handle, centering it with the travel of the Handle.

If there is any slop or play in the travel of the handle, push it forward gently until it is at the point of engaging the control valve.

Now, position the detent so that it is up against the Control Handle

Mark and drill holes to match Detent Base Plate, securing with bolts provided.

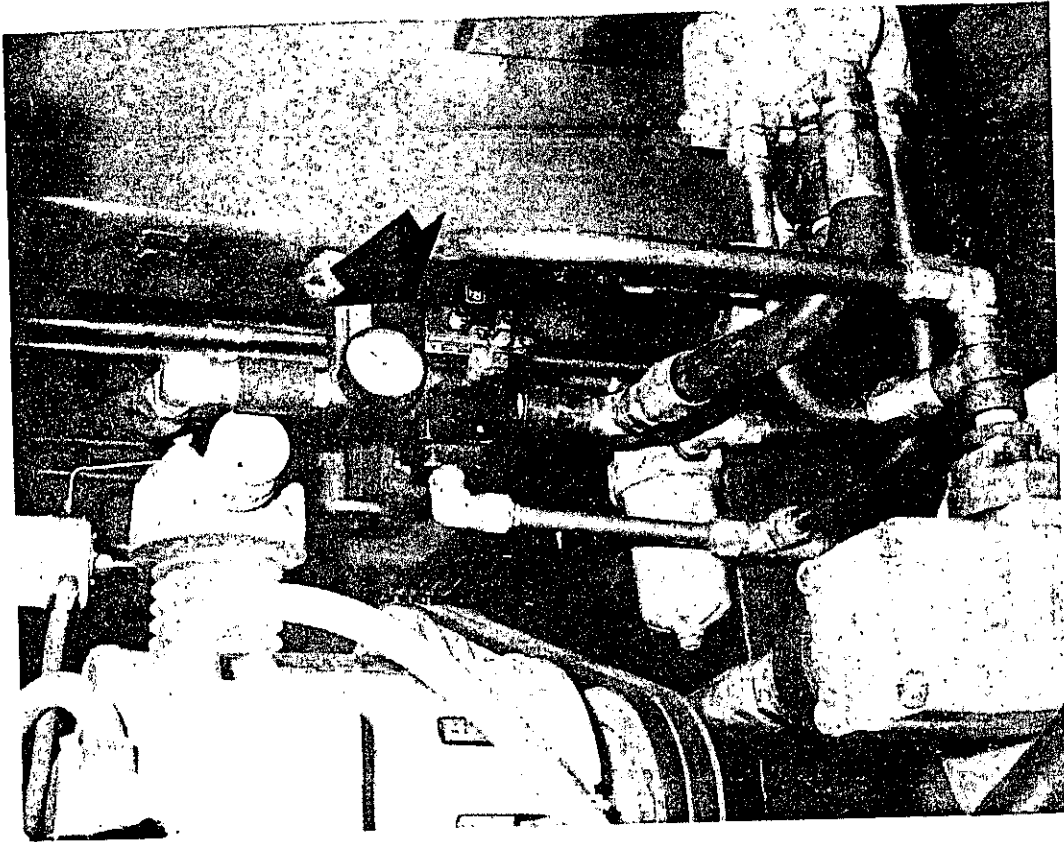
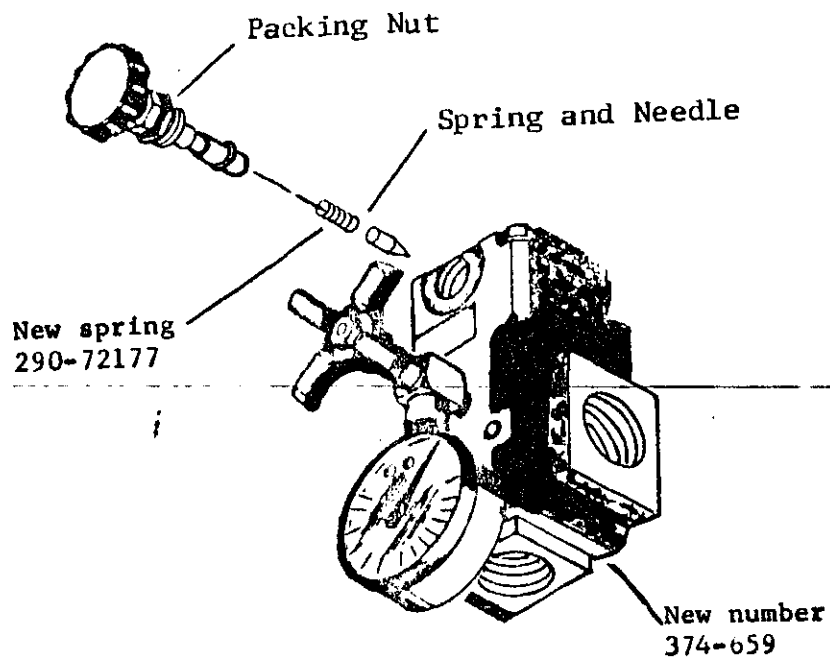
From field observations, it has become apparent that a number of TWISTER Rides are being operated with the "Brake Pressure Relief Valve" set at a higher pressure setting than the recommended 700 P.S.I. maximum.

This results in a severe braking action causing discomfort to ride passengers. In addition, it subjects the ride structure to undue stresses.

To eliminate this, we have enclosed a new spring that is to be installed in the relief valve. This will limit the valve to a maximum setting of approximately 700 P.S.I.

Remove the left rear possum belly door to gain access to hydraulic components.

The Relief Valve is readily accessible as can be seen in photograph.

To replace spring, loosen the packing nut behind the Adjustment Knob, and carefully remove Adjustment Knob and Stem.

Replace spring and assemble in reverse order.

Run the ride and adjust Relief Valve to approximately 600-700 P.S.I.

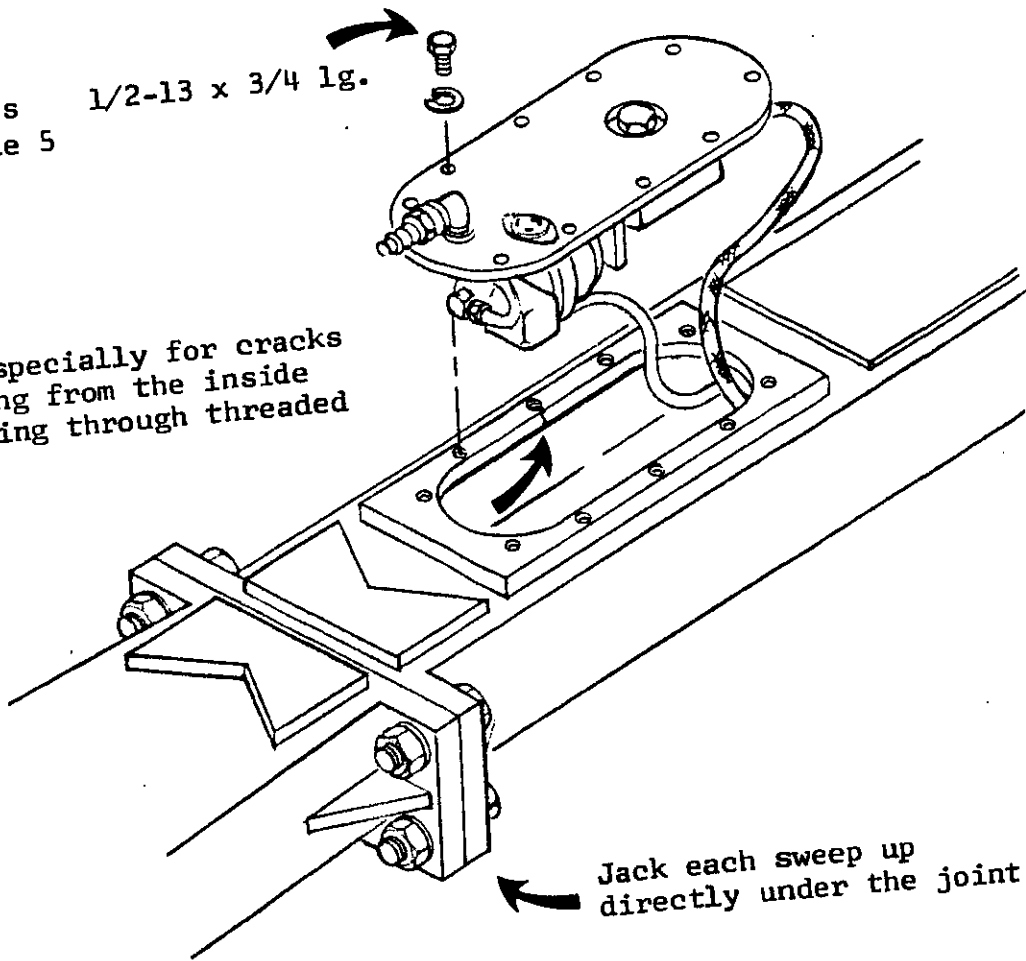
One of the Outer Sweeps on a TWISTER has developed a crack in it. The crack developed across the top side starting from the access hole for the Master Cylinder. This has only shown up on one sweep and could be attributed to any one of several possible causes.

However, the most logical cause for the crack is simply that the cover plate was not bolted down tightly.

The cover plate, when tightened down, adds the necessary strength needed in this area of the sweep because of the access hole.

Look especially for cracks starting from the inside and going through threaded hole.

If no cracks are found, install cover plates, torquing bolts to 75 ft. lbs.
If bolts are greasy or oily, torque to 55 ft. lbs.

Check length of bolts before installing cover plates. The six bolts along sides should be 3/4 inch long grade 5 bolts. Longer bolts will bottom out against the sweep channel not drawing the cover plate down tight.

If any cracks are found, consult Chance Manufacturing Company before attempting to repair or operate ride.

Check torque values on bolts securing cover plates weekly. Remove Cover Plates and visually inspect sweep monthly.

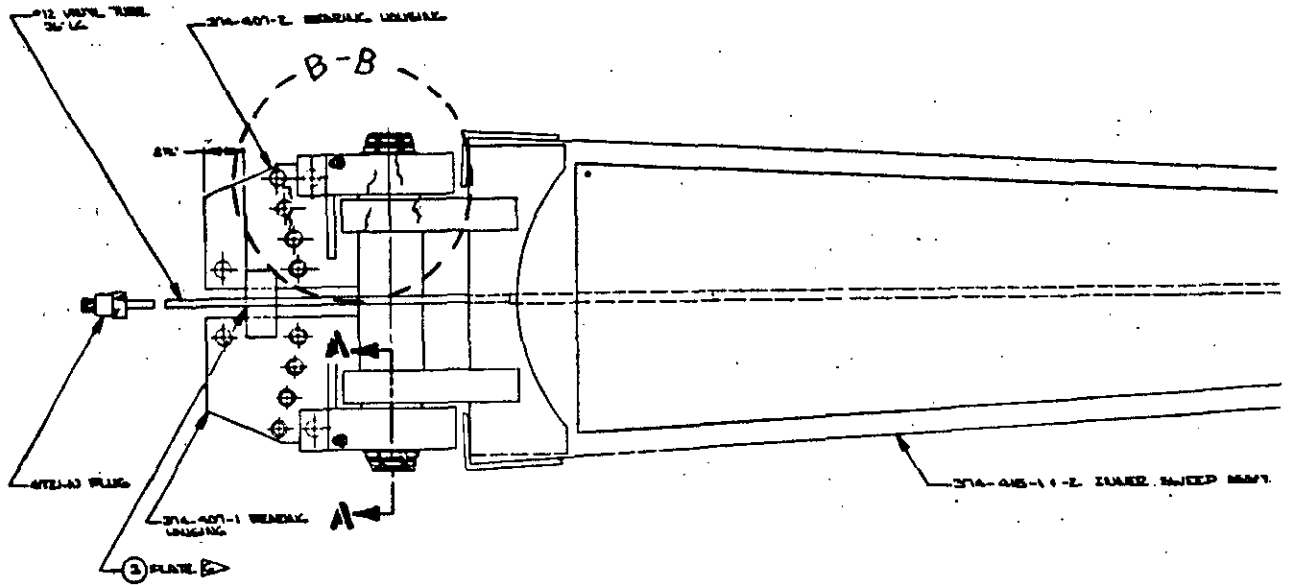
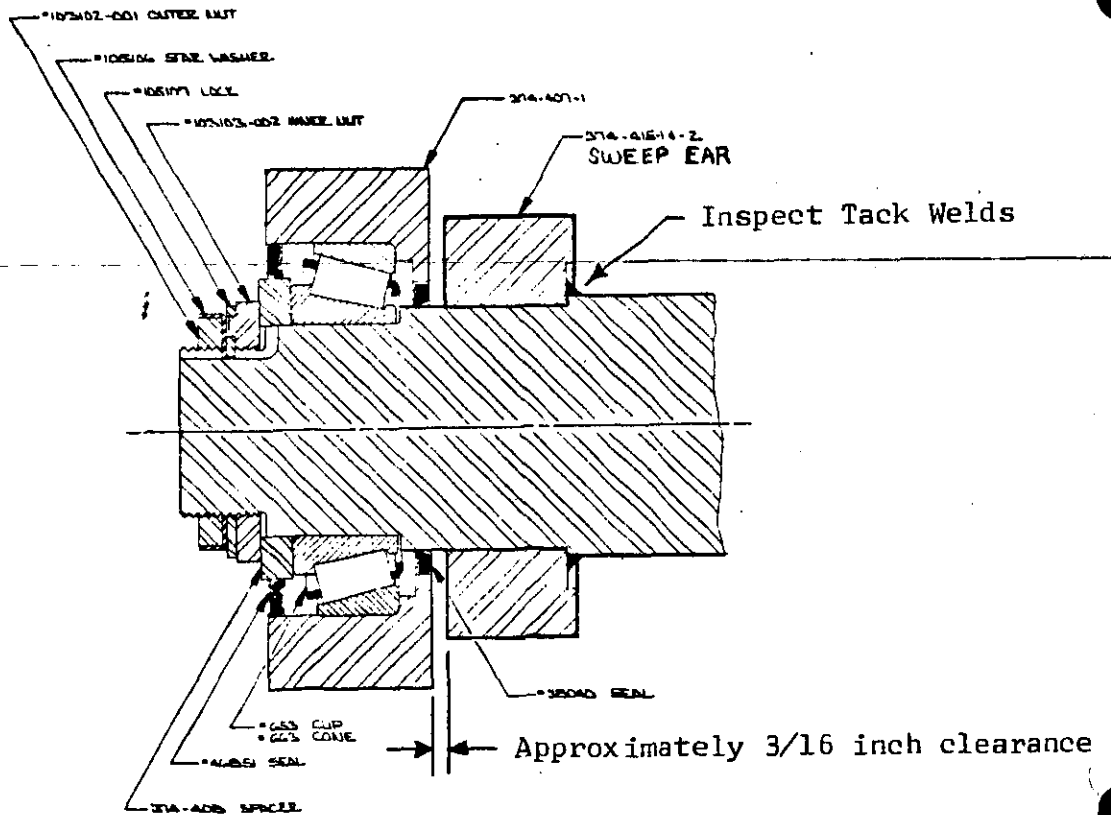
SECTION A-A

One ride has reportedly developed some problems with the sweep joints where they attach to the center hub. In order to evaluate the precise area and cause, more information is needed from the field.

1. Inspect the plate and ears that bolt onto the Center Hub, paying particular attention to the area around the bolt holes. "B-B" and ears that house the Bearings shown in section "A-A".

Look for any signs of cracks in ears, plate or welds. If the ride has recently been painted, look for signs of cracking or stretching in the paint.

2. The sweep shaft is tack welded to the sweep ears as shown in "A-A". Inspect this area very carefully to see if welds are holding.

Also, check clearance between sweep ear and the bearing ear. There should be approximately 3/16 inch between the ears.

If an area is suspected of having cracks, clean area with solvent and apply thinned-down paint or dye penetrant, wiping off excess. Cracks should then show up as fine dark lines.

IF ANY CRACKS, ETC. ARE FOUND
DO NOT OPERATE RIDE

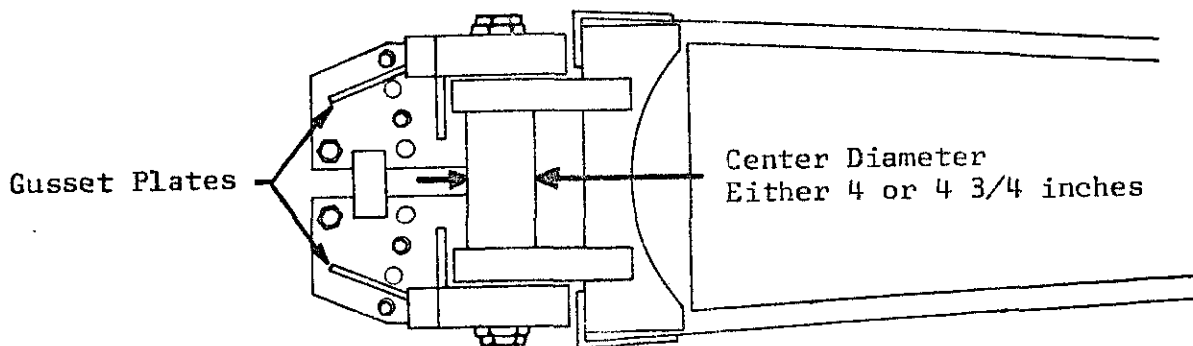
After evaluating the reports on the Sweep joints, Ref. Bulletin 104, it has been determined that it would be desirable to reinforce all existing sweep joints, that haven't already been done.

1. Center diameter of shaft.
2. Bearing housing (does or does not) have gusset plates as shown.

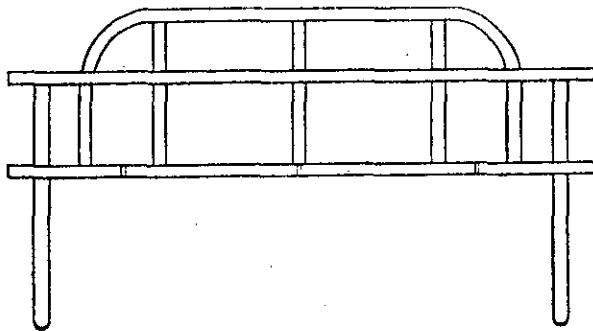
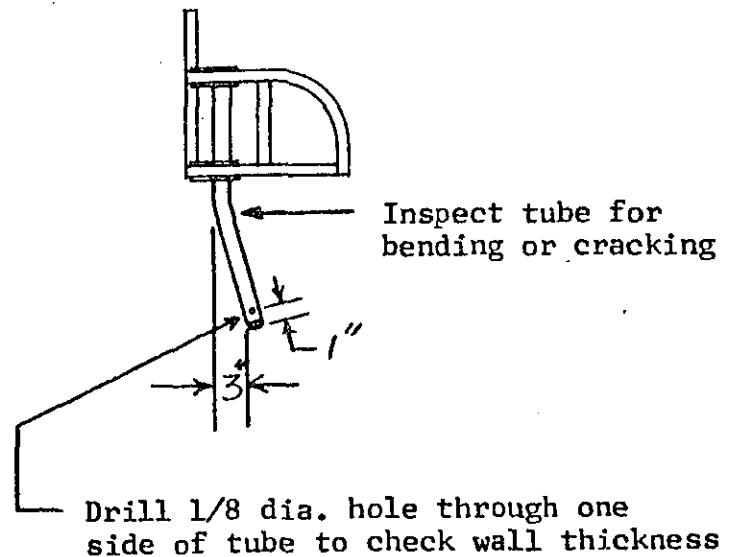
All TWISTER owners must inspect the head rests on all TWISTER cars immediately. Remove each head rest and inspect the support tubes that fit down in the sockets on each car. Inspect for any signs of physical damage, such as bending or cracking. Next, drill a small hole, 1/8 inch, near the bottom of the support tube approximately 1 inch from bottom. Drill hole through one side of the tube only. Check wall thickness of tube. It should be 1/8 inch thick.

If any of the tubes show signs of bending or cracking, or if any tube has less than a 1/8 inch wall, immediately report such condition to Mr. Richard C. Chance, General Manager, Chance Manufacturing Company.

Any of the afore-mentioned conditions could result in a serious accident if the head rests are not inspected, and any faults corrected immediately.

Inspect the head rest support tubes on a regular weekly basis as an added measure of safety.
