TRAMWAY COMPANY, INC.

SERVICE BULLETIN # 1993 - 127

APPLICABILITY: Riblet chairlifts furnished 1984 thru 1987 using tension-drive terminal with #5599 strut. (see attached sketch "A")

SUBJECT: Inspection and replacement of #5599 strut

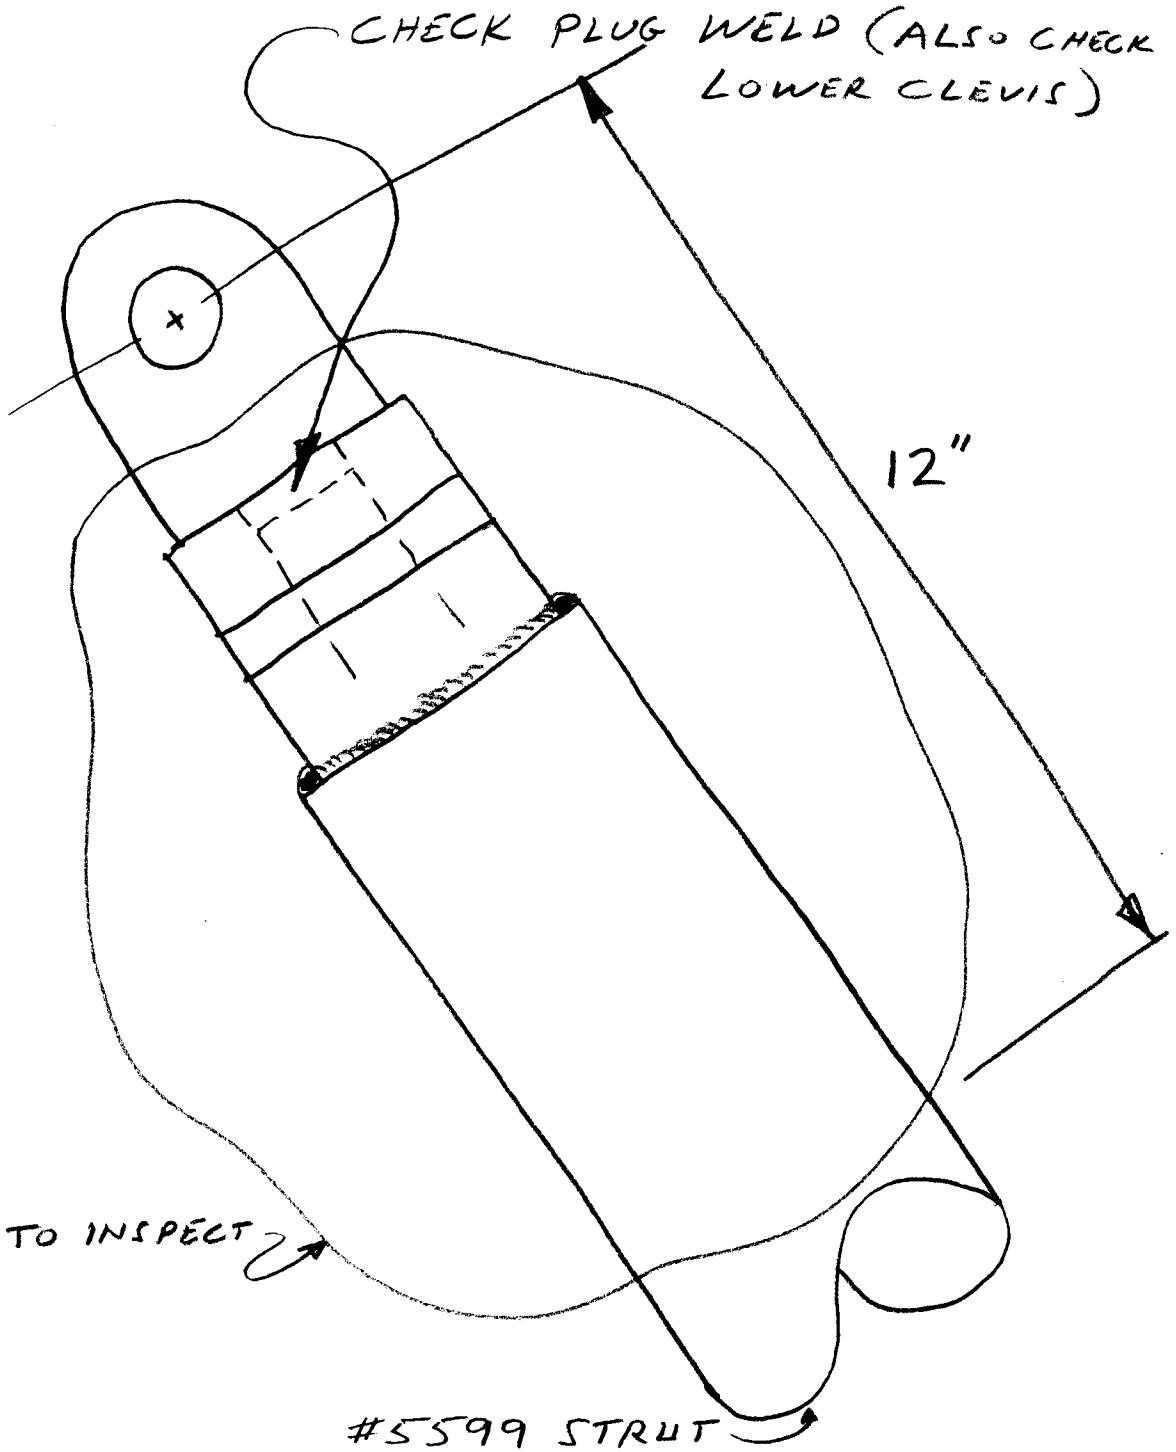
TITLE SKETCH "B"

Immediately (that means right now) conduct a visual inspection of the area circled on attached sketch "B". Use a magnifying glass and good lighting conditions, remove paint if necessary, and pay special attention to the plug weld in the center of the clevis. If any cracks are found, do not operate the lift. Contact Riblet Tramway Company for help. Repeat this inspection at two week intervals for the remainder of this ski season.

AREA TO INSPECT

#5599 STRUT

Check the 1" bolt through the upper end of the strut. It should not be tight. If necessary, back the self-locking nut off a turn so that lateral rocking of the cross arm will not impose bending moment of the strut. We want some "slop" here.

At the end of the 1992-1993 ski season, the Riblet Tramway Company will ship to you, a modification kit to replace the single strut with the later "V" strut arrangement as used on more recent Riblet lifts. This "V" strut eliminates the rocking motion of the cross arm. We will furnish these parts at cost, and installation is relatively simple.

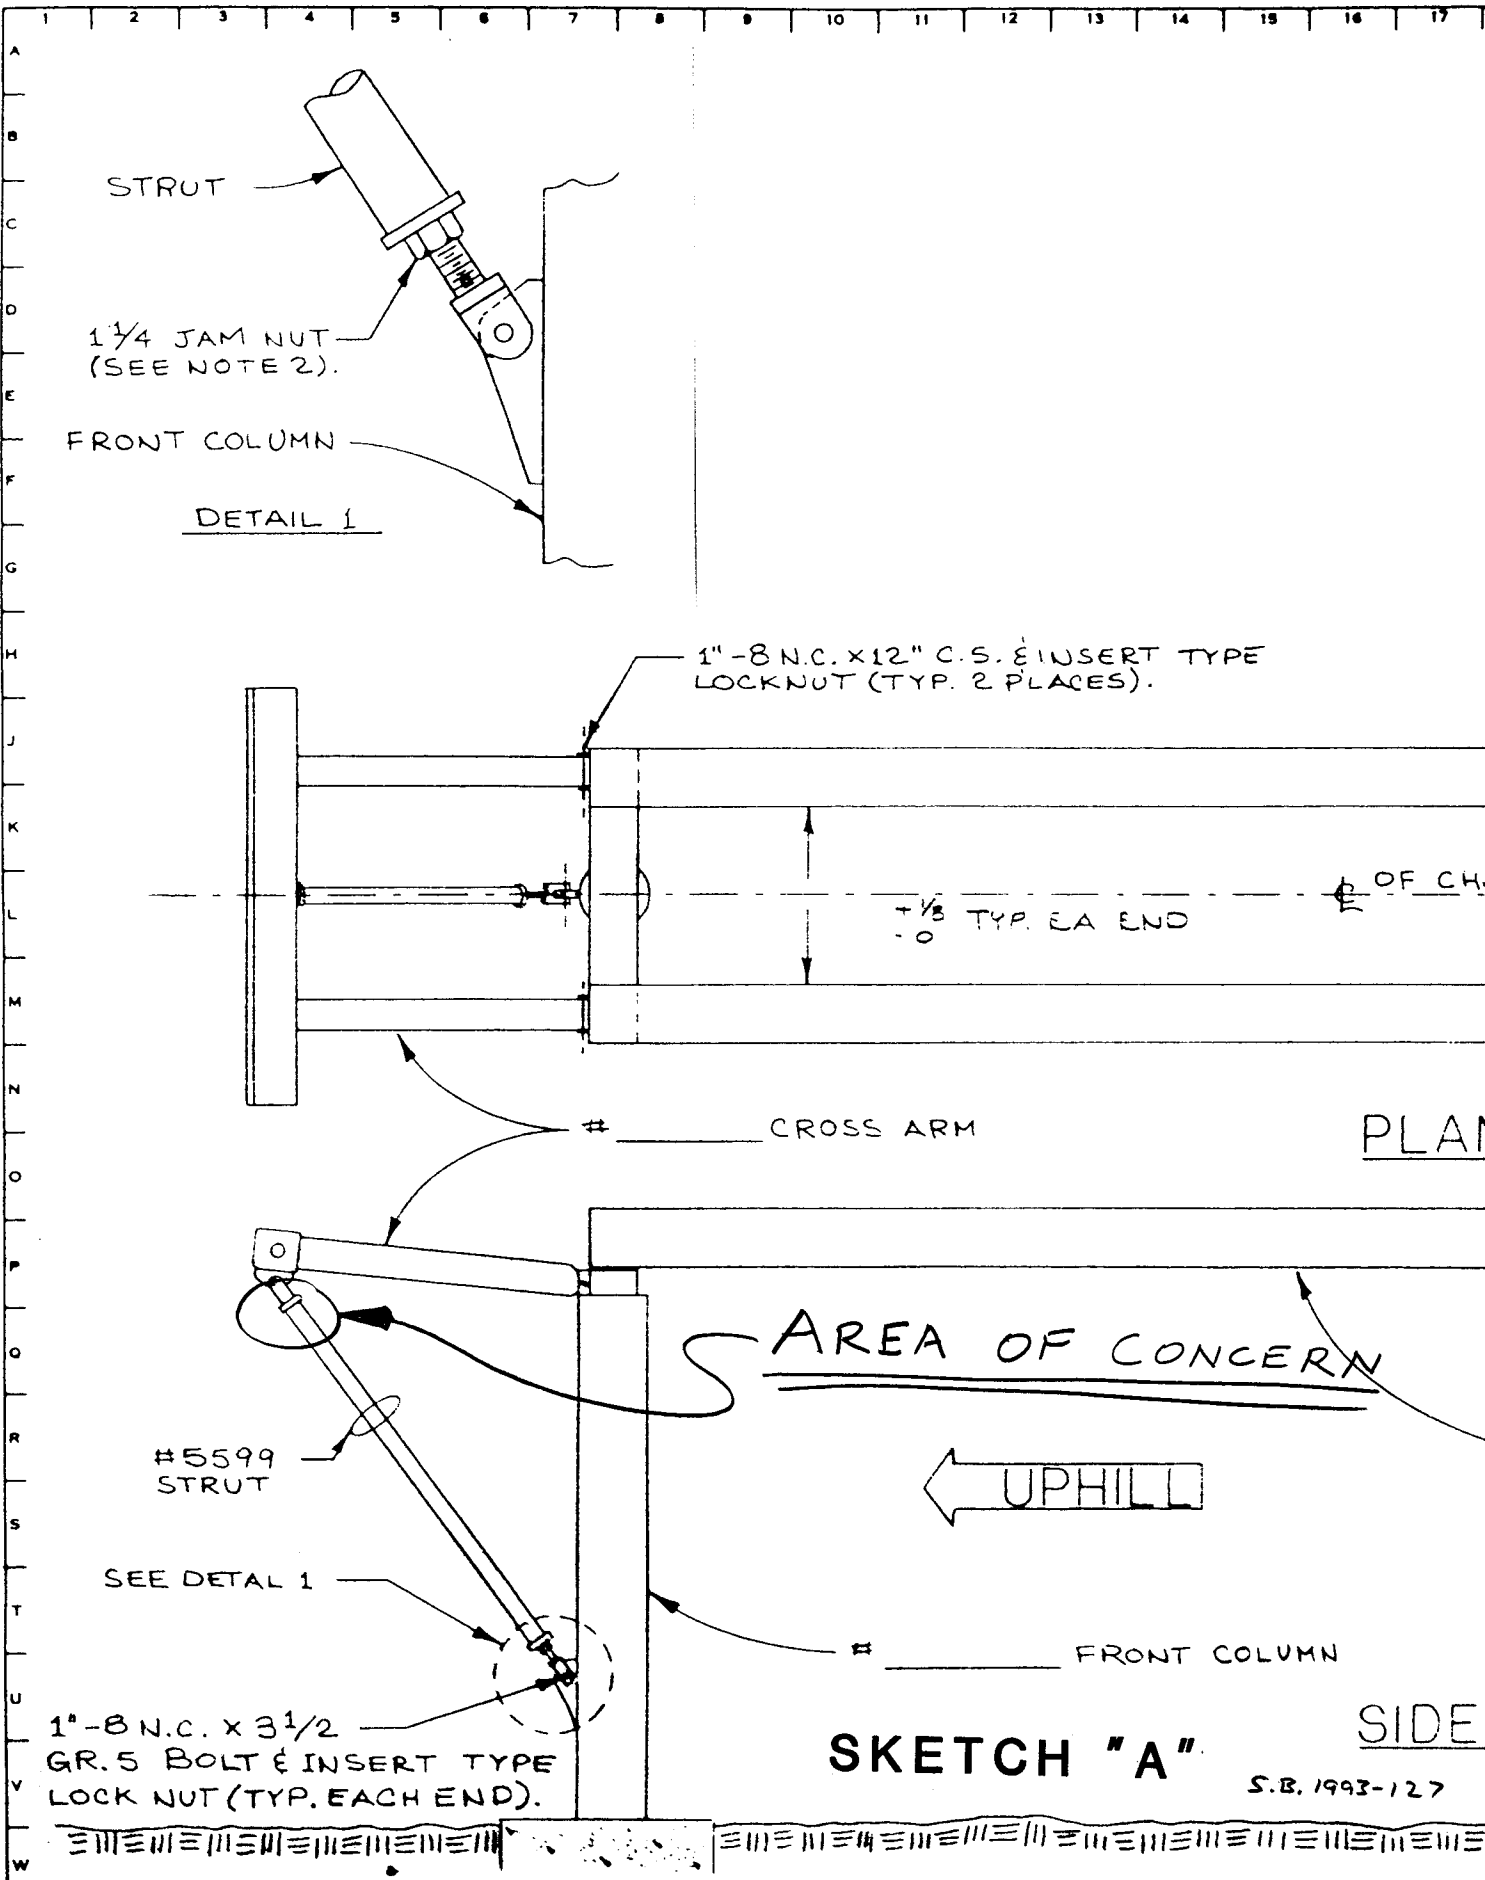
SKETCH "A"

The subject strut is used to support the "portal" line machinery cross arm at the uphill end of certain Riblet tension-drive terminals. The machinery load on this strut is normally upward, imposed by the traction rope as it departs the lower terminal area. One of these struts has failed, fortunately resulting in no injury.

We have determined that the cause of this failure was lateral rocking of the machinery cross arm, which imposed a bending moment at the upper end of the strut. In order to prevent any future failure of the subject strut, the following three-part program is mandatory:

AREA OF CONCERN

#5599
STRUT
