ACTION NOTE - UPDATE

SAFECO CRAZY FROG

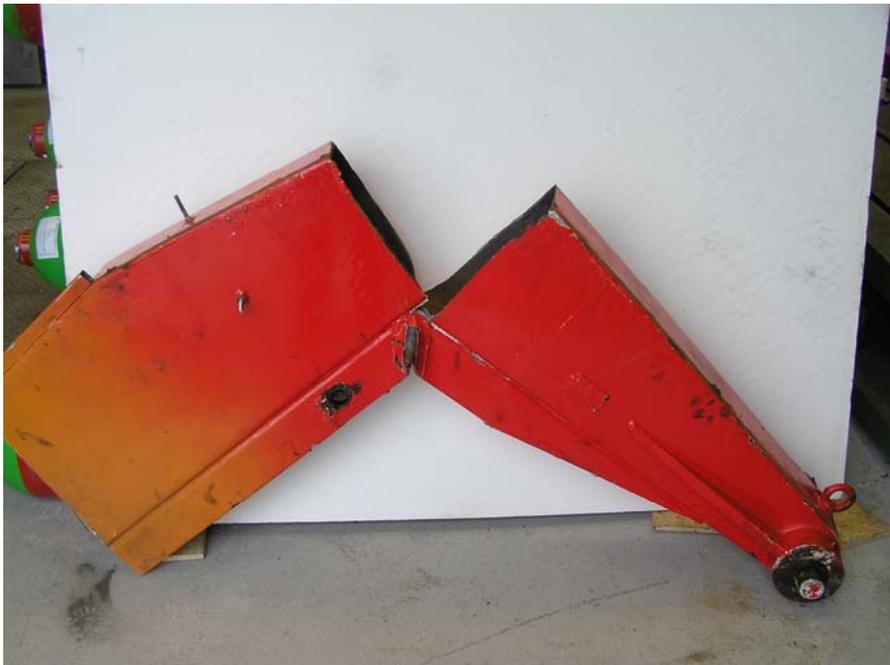
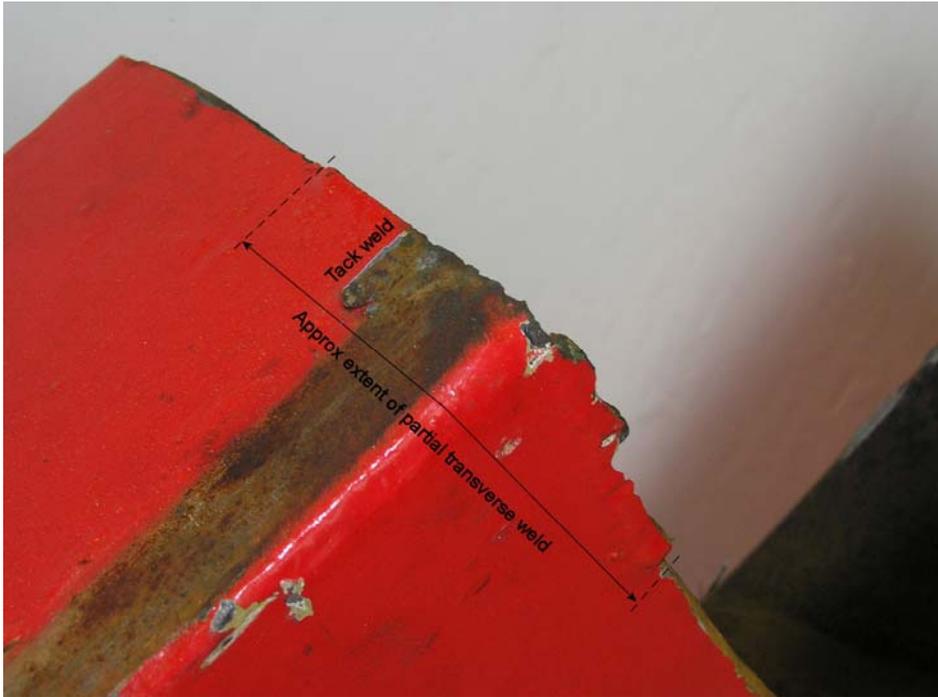
- The failure occurred at a partial transverse weld at the upper right corner of the box section arm, looking down the arm towards the pivot.
- The presence of the partial transverse weld in the incident arm suggests a weld repair of a previously identified defect. It is not clear yet when this weld was made.
- The nature and cause of this previous defect can only be speculated on at the present but it is possible that it may be associated with and have been possibly initiated by one of the tack welds to the cable conduit.

Further inspection of the affected ride has identified further cracking in another arm at approximately the same location (460mm back toward the pivot from the widest part of the arm) but this time through clean, un-welded material. This is not related to any tack welds for conduits. This was revealed during a thorough inspection where the light boards were taken off to reveal the suspect area and some paint was removed from the metal of the arm. The arm has been removed to HSL for examination.

1. As soon as possible, rides should be subject to an NDT test as per the ride's respective schedule. This should include the areas shown in the photographs.
2. Controllers are to consult their AIB about an ongoing, regular inspection regime to ensure that any crack is identified quickly and any subsequent propagation is picked up and stopped. It is stressed that the speed of propagation of any cracks is not known but is thought to be rapid.
