**WISDOM
INDUSTRIES, Ltd.**

SERVICE BULLETIN

DATE: NOVEMBER 1, 2005
RIDE: LASER SHIP
**SUBJECT: SWEEP INSPECTION
PROCEDURE**
COMPLIANCE DATE: IMMEDIATE

DESCRIPTION: SWEEP INSPECTION PROCEDURE

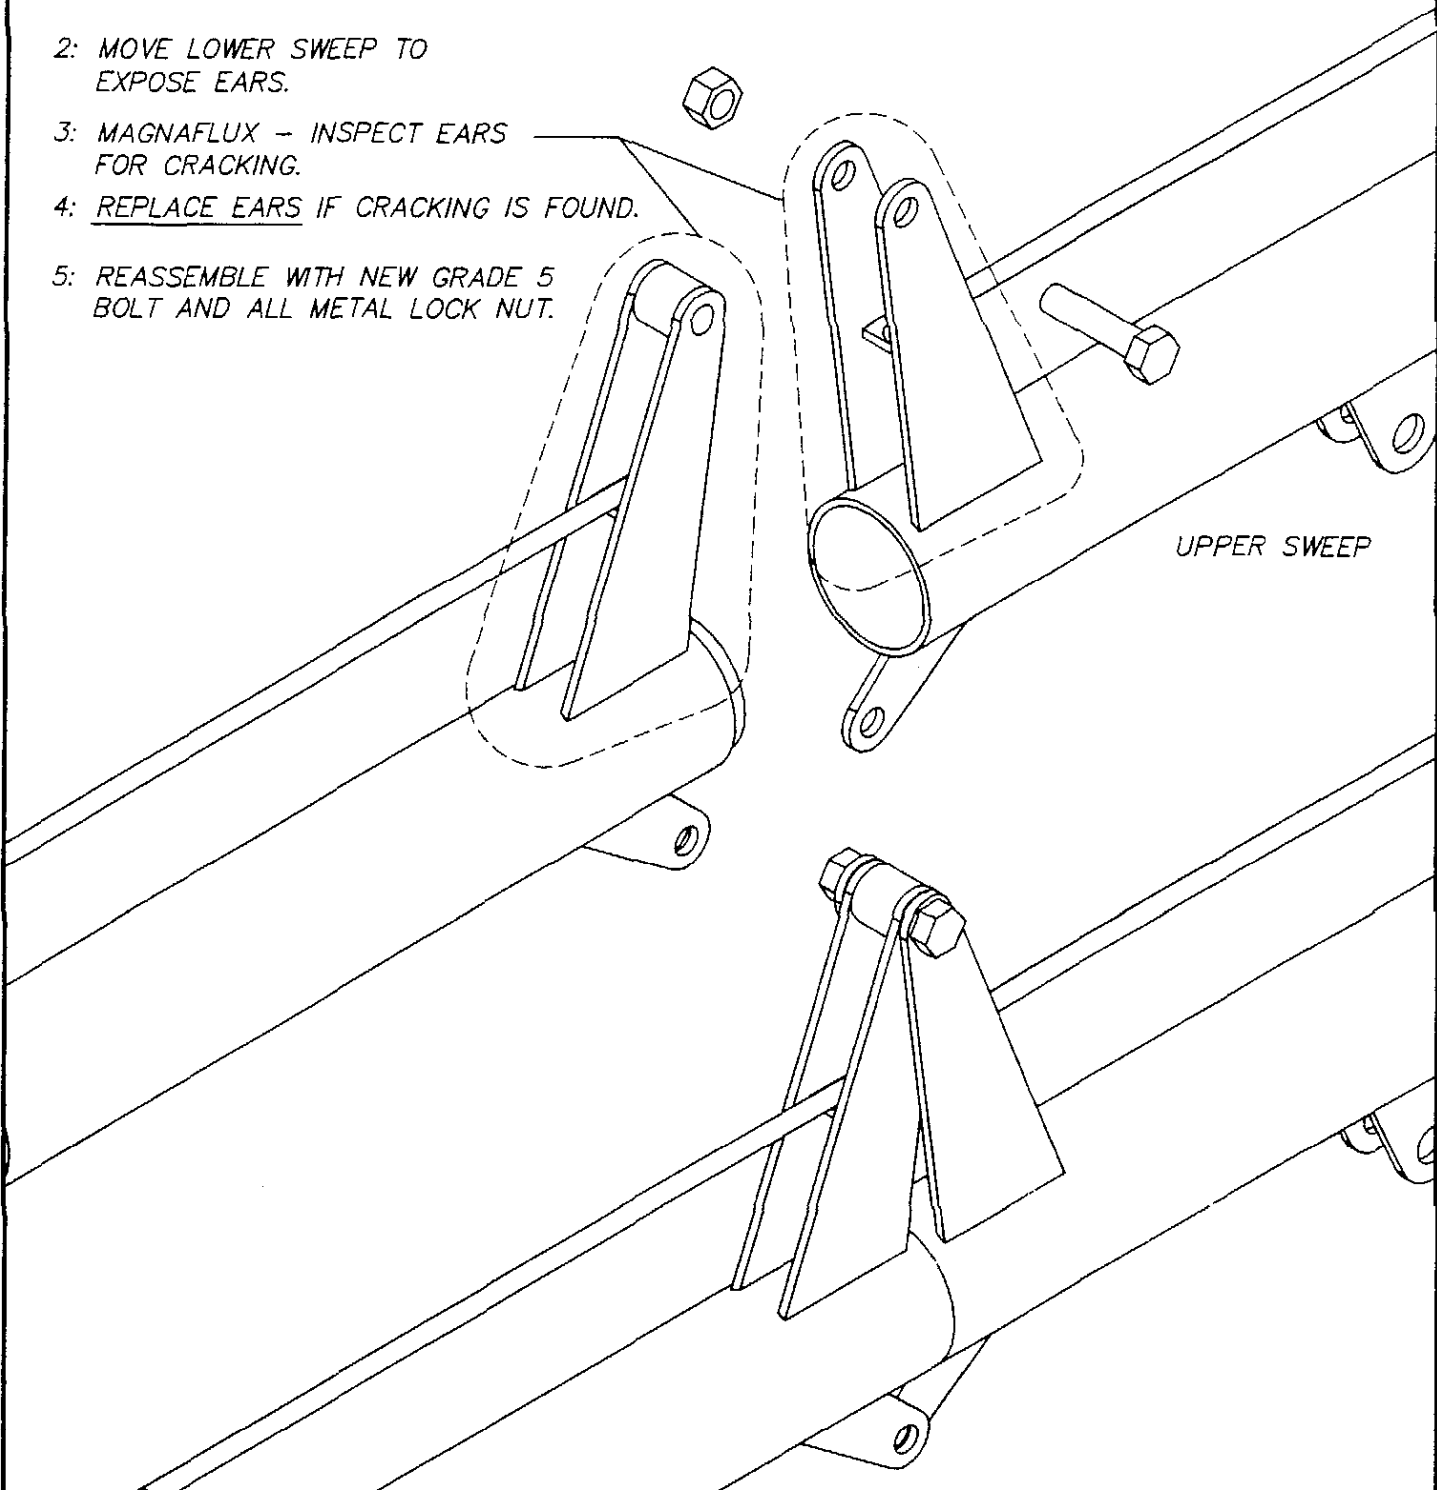
DRAWING NUMBER: SWEEP SAFTY

- **THERE HAS BEEN ONE INSTANCE OF A SWEEP MIDDLE HINGE EAR FAILING DUE TO CORROSION.**
 1. **Inspect the ears shown in the attached drawing using magnetic flux testing for cracks at the hinge point and at the weldment to the sweep tube.**
 2. **If cracking is indicated at the pipe to ear weldment "V" the crack.**
 3. **Weld with 7018 Low Hydrogen rod.**
 4. **If cracking is indicated at the hinge point the ear must be replaced.**
 5. **Weld new ear with 7018 Low Hydrogen Rod.**

- 1: REMOVE BOLT AND NUT.
- 2: MOVE LOWER SWEEP TO EXPOSE EARS.
- 3: MAGNAFLUX – INSPECT EARS FOR CRACKING.
- 4: REPLACE EARS IF CRACKING IS FOUND.
- 5: REASSEMBLE WITH NEW GRADE 5 BOLT AND ALL METAL LOCK NUT.
