(+49) 991 9106 83 Service
(+49) 991 9106 24 EngineeringE-Mail: service@zierer.comInternet: www.zierer.com**Service Bulletin**

Zierer Bulletin #	Revision:	Page	System	Description:	Date:	Issued:
SB-WS-1001_rev1	1	1 of 4	Wave Swinger	Service Bulletin	17.01.2013	wmt
Original Ride Manufacturer			Release Date	Affected Production Dates:	Ride Name:	
ZIERER – Karussell und Spezialmaschinenbau			18.12.2012	2011 and earlier	Wave Swinger

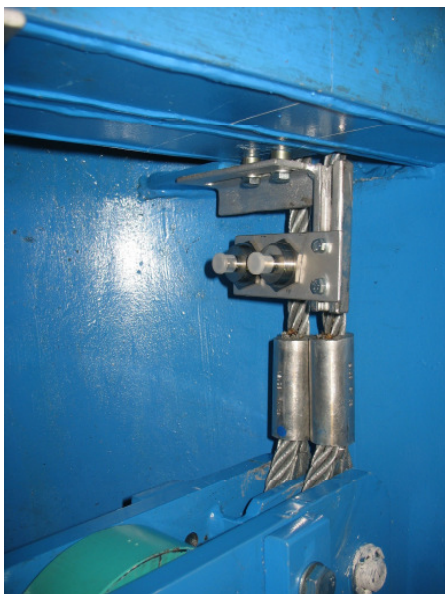
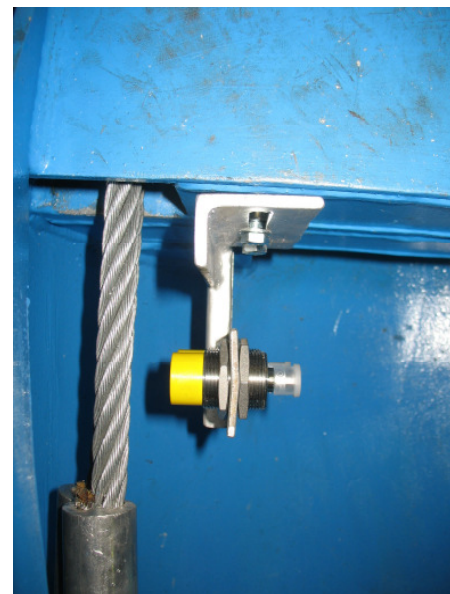
**Rope Monitor Zierer Article No.: VK080063**

2 sets of sensors monitoring the smooth movement of the lifting cables. The sensors are mounted on a bracket which is bolted to the bottom of the sheave compartment right next to the entry hole of the lifting cables. Their signals need to be integrated into the ride control system subsequently.

If for any reason a cable moves out of sensing range the control system will initiate a “Fast Stop” function .

To 3.1 – Rope Monitor:

This modification requires at least three additional slip rings at the slip ring assembly in the lower mast portion. If spare slip rings are available on your unit we recommend the addition of the rope monitor to your Wave Swinger on the next occasion (e.g. winter rehab).

It is no need to take any action if the slip ring assembly on your unit does not have this requirement. Just make sure a thorough daily visual inspection on both sets of lifting cables prior to public operation as well as the required monthly checks over the entire cable length gets carried out.

In case the slip ring assembly on your unit is worn and needs to be replaced soon we would recommend purchasing a slip ring assembly with more slip rings, so that the rope monitor can be added.

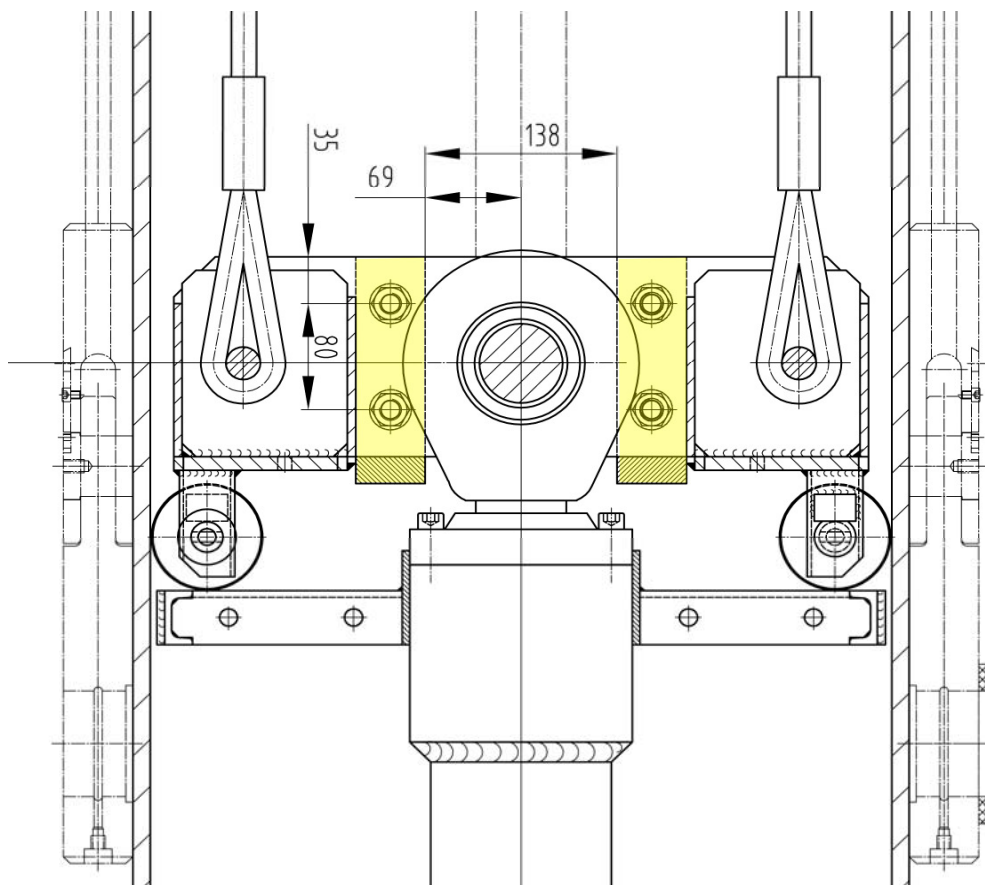
3.2 Lifting Cylinder Retaining Elements [Cylinder Rod] Zierer Article No.: HZ020078

In case of a break of the suspension pin 2 pieces of fork shaped retaining elements preventing the rod end from slipping through the guiding cross. The retaining elements are mounted axially at a distance of 138 mm with 4 bolts to each side of the guiding cross.

To 3.2 – Retaining Elements Cylinder Rod:

We recommend proceeding with this modification on the next occasion (e.g. next winter rehab), provided that the suspension pin has been inspected and documented as requested in the NDT requirement
