15th January 2021

Information Note: Crazy Frog Type Rides

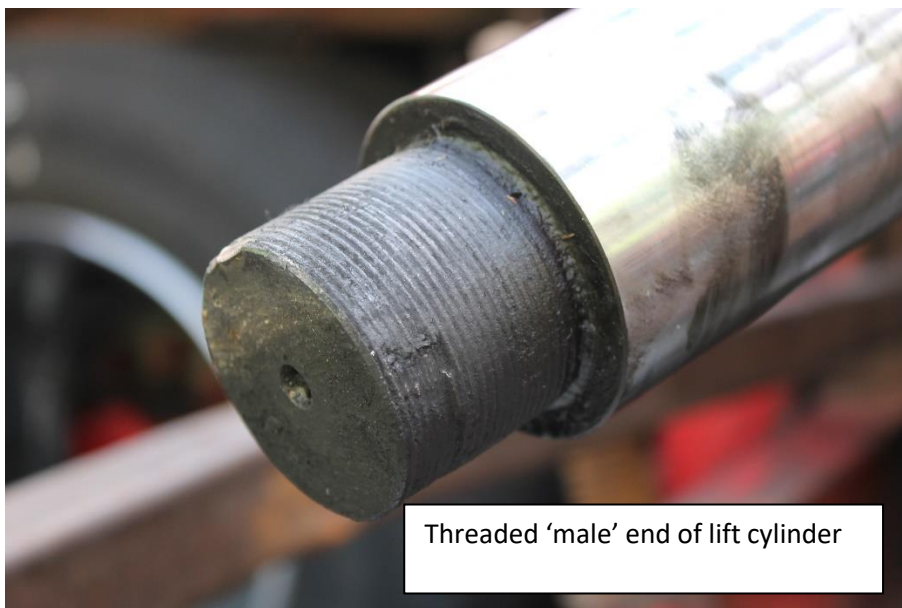
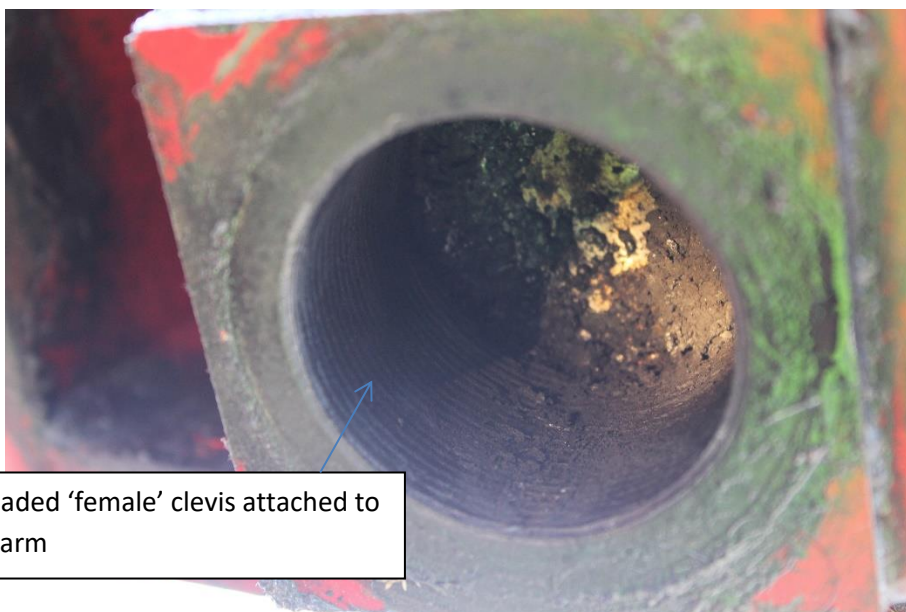
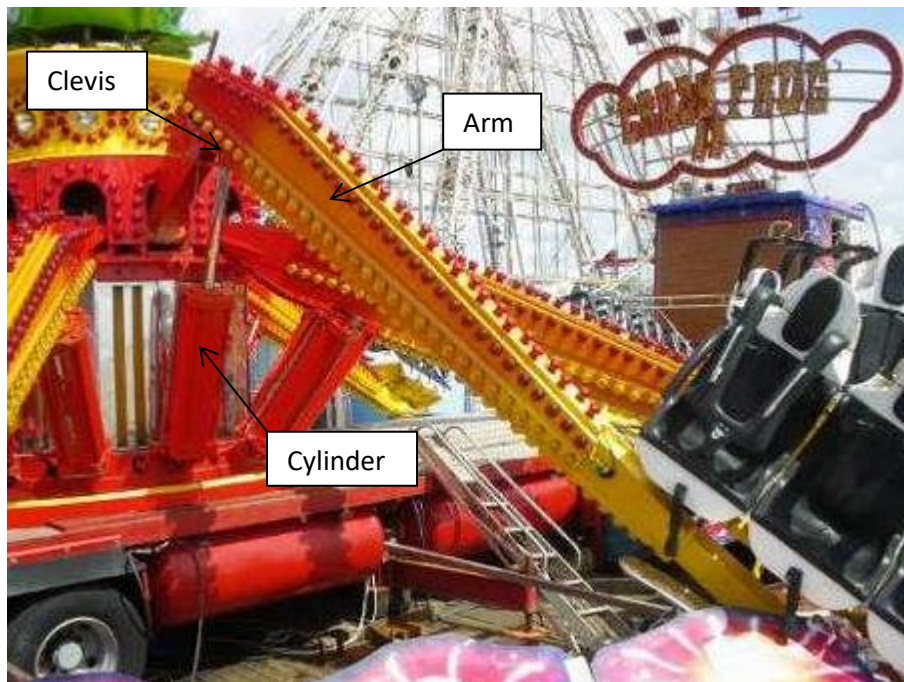
The incident involved a carriage arm lift cylinder becoming detached, causing the arm to drop. The connection between the arm and lift cylinder comprises a clevis mounted on a male thread at the end of the cylinder rod, with a corresponding female threaded hole in the clevis. The clevis is pinned to the carriage arm. Initial inspection of the affected ride identified that several of the connections between the clevis and cylinder rod were loose.

Inspection bodies, on inspecting such rides, should ensure that the connections between the arms and lift cylinders of these rides are secure and that there is no movement or play in the connection.

- Prior to further use all operators of crazy frog type rides should make an inspection of all lift cylinder rod/clevis connections. This can be undertaken by applying hand force to the clevis to check for any looseness, rocking or evidence of unwinding. This action should be undertaken with the clevis free of the arm.

- When using hand force there should be NO movement or play in the connection.
- Where play is discovered then this is an indication that the issue is already well developed. In this case the machine should have all of its cylinder/clevis connections inspected by a competent person prior to any further use.
