NAFLIC

TECHNICAL BULLETIN — June 2015

404. Gerstlauer EuroFighter train chassis cracking and seat post cracking

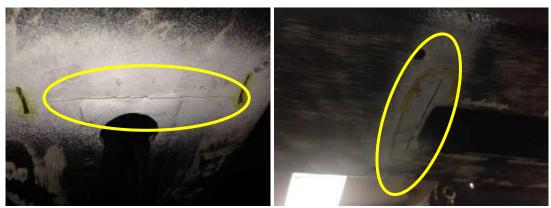
Gerstlauer EuroFighter - Chassis Cracking

We have received a report from a UK registered inspection body that numerous areas of cracking have been found on the train chassis of a Gerstlauer EuroFighter. The areas of cracking were found by both visual and NDE inspection. The manufacturer has issued a WPS (weld procedure specification).

These trains are used on a number of different track configurations. This particular one has a number of indications of cracks but the majority of these are hidden under drive plate materials. The extent of the cracks can therefore only be fully seen when the drive plate is removed. This may not be included in the normal NDT schedule so IBs are recommended to pay attention to all areas relating to this.

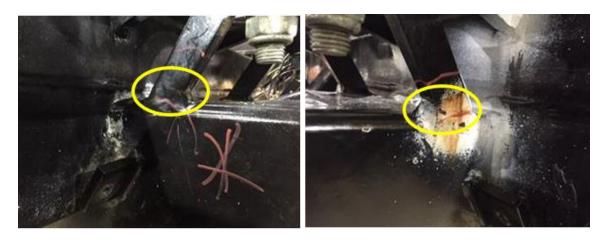
Strengthening gusset cracking below seat

The strengthening arms between the seat frame and chassis

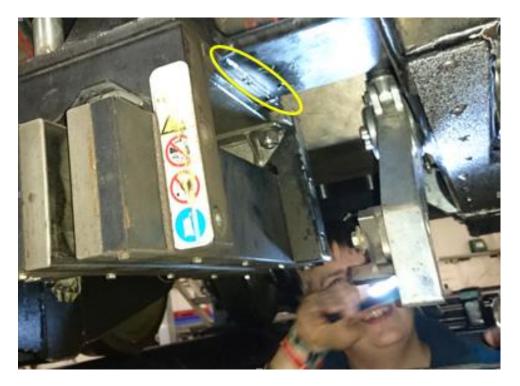
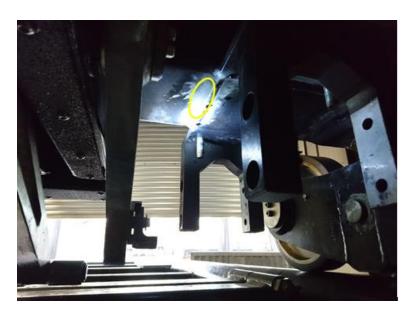
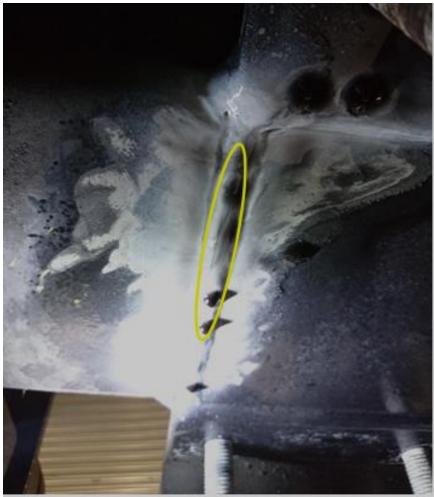
Additionally, again in relation to a Gerstlauer EuroFighter, the same IB has found an area of cracking next to where the magnetic brake is fixed to the chassis (see images). To fully inspect the area by MPI the magnetic brake requires removal.

An area of cracking was found next to where the magnetic brake is fixed to the chassis (see following three images)

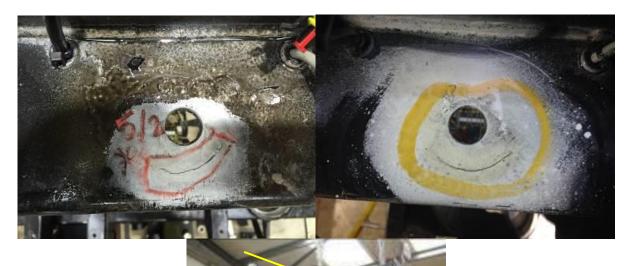
Gerstlauer Eurofighter - Seat Post Cracking

Also in relation to a Gerstlauer EuroFighter, we have received a report from the same IB that areas of cracking have been found on the top of numerous seat posts. These were found by both visual and NDE inspection. The manufacturer has issued a WPS.
