NAFLIC

TECHNICAL BULLETIN — June 2016

414. Huss Topple Tower cracking

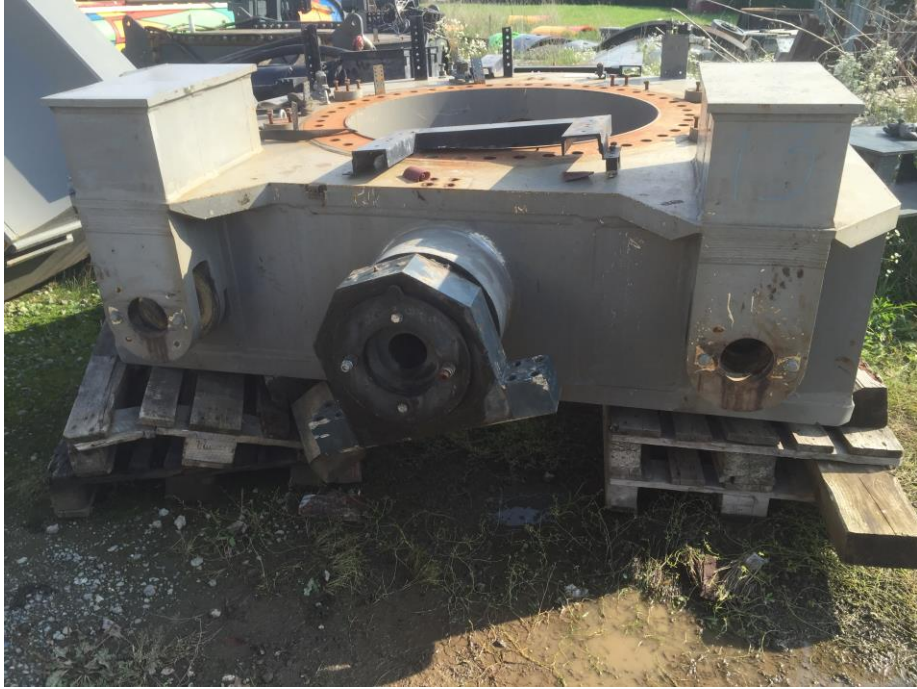
While undertaking dismantling and appraisal of the Topple Tower serious defects were found to the mast pivot block stub axle (hydraulic cylinder side) (See Fig. 1)

A repair procedure and NDT schedule is available from Huss.

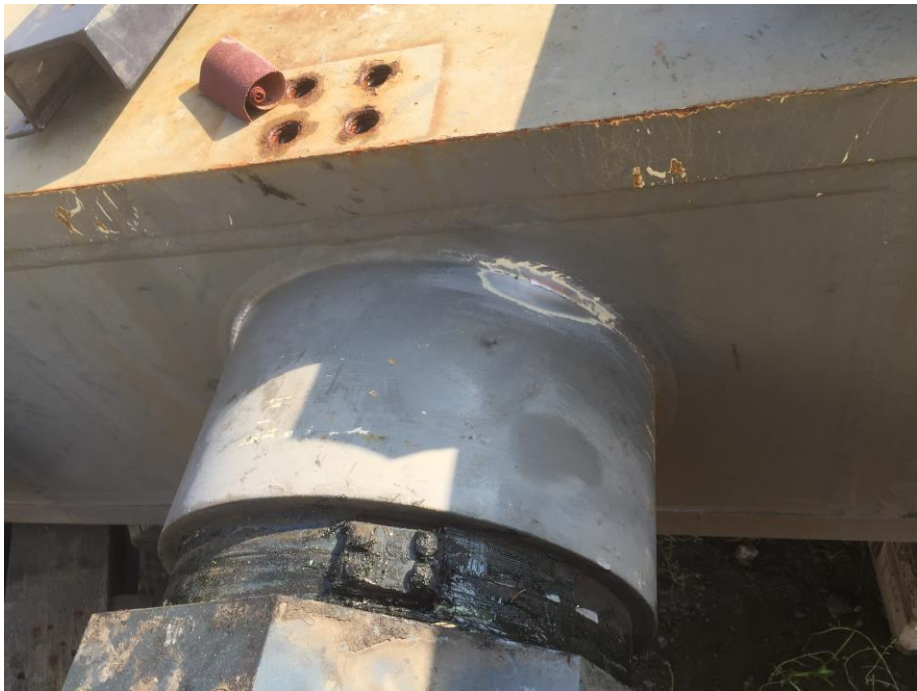
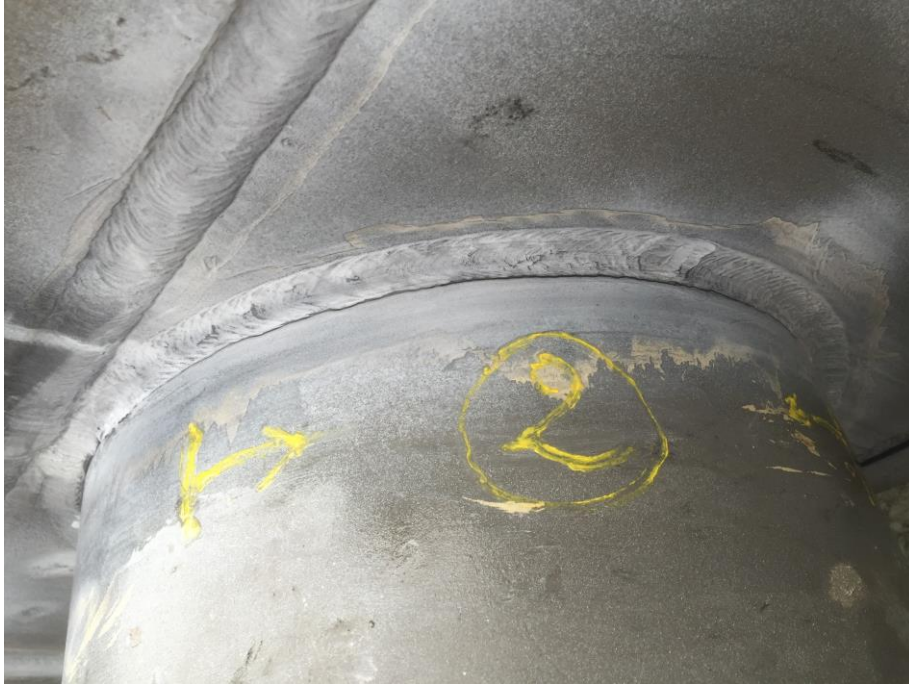
Initial visual inspection indicated cracking to the circumferential weld attaching the stub axle to the pivot block (See Figs. 2 and 3). Subsequent NDT (MPI) revealed two cracks, 1x250mm and 1x300mm (See Figs. 4 and 5).
