TECHNICAL BULLETIN — June 2016

406. Larson Flying Scooters

SERVICE BULLETIN

Ride Name: FLYING SCOOTERS Affected Serial Nos.: 14-26, 30

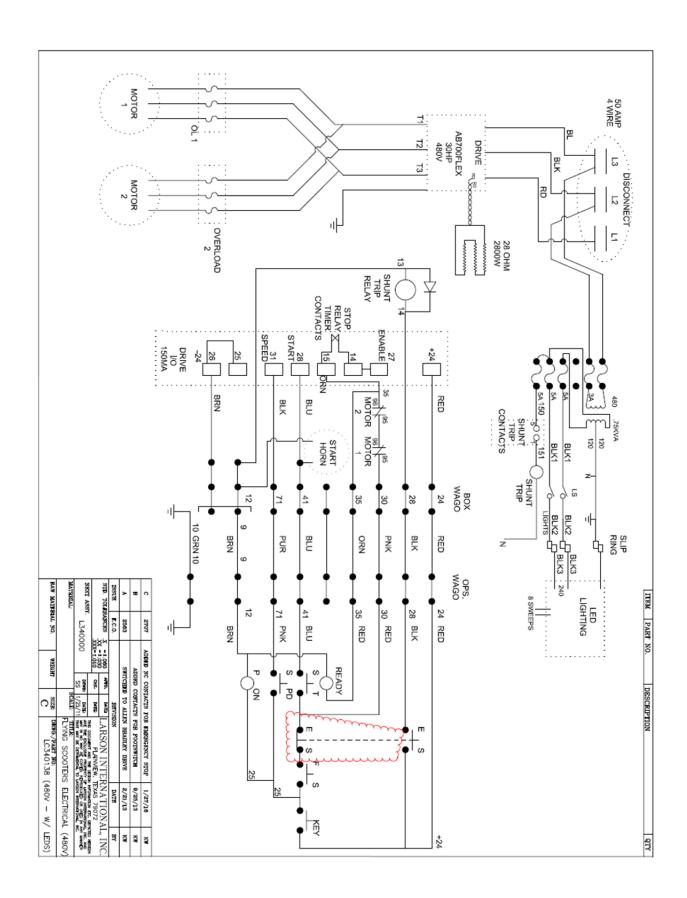
Revised Electrical Schematic on page 2.

Abstract Of Issue: Install a set of normally closed contacts in the E-stop button.

Reason for Release: A failure of the 120V power supply circuit can cause the E-stop to not

stop the ride when pressed.

Action To Be Taken: Install a set of normally closed contacts in the E-stop wired as

shown on page 2.

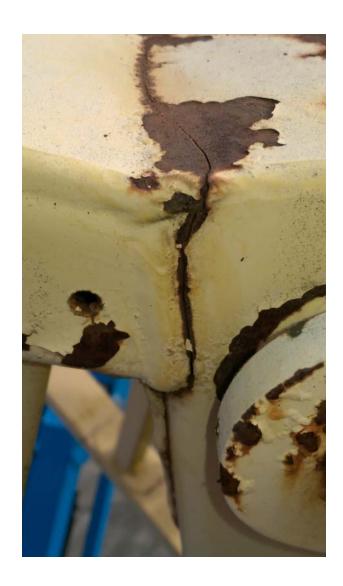
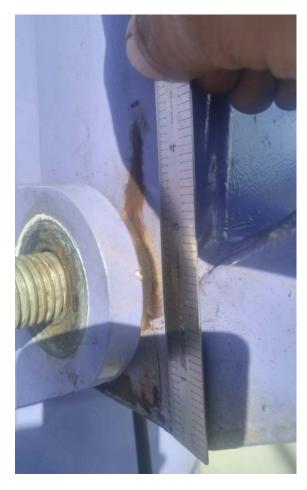
Abstract Of Issue: Inspection of the sweep assembly vertical tubes (L340000 item 1).

Reason for Release: Cracks have been found in these locations. These specific areas need to be examined during your daily and annual inspections.

Visually inspect the vertical tubes of all sweeps for cracks. Any visual indications shall also have NDT MT performed to determine the crack length. Contact Larson International to determine if the sweep can be repaired. Add this service bulletin to the ride manual as detail for the daily inspection and add an annual NDT MT inspection of these areas.

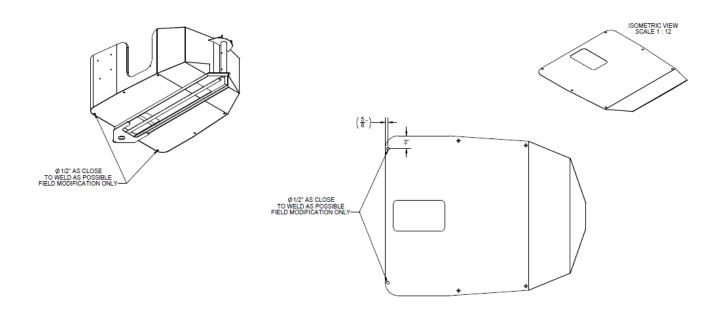
Vehicle drain holes drawing on page 2.

Abstract Of Issue: Monitor and address potential corrosion in the ride vehicles.

Reason for Release: Corrosion has been found on the inside of the ride vehicles.

Annual inspection of the inside of the ride vehicles and address corrosion as necessary to prevent reduction of steel thickness. Adding drain holes in the rear corners of each vehicle may help prevent future water entrapment (see drawing page 2).
