TECHNICAL BULLETIN — June 2016

## **411.** Zierer Wave Swinger service bulletin

# **Service Bulletin**

Zierer Bulletin #	Revision:	Page	System	Description:	Date:	Issued:
SB-WS-1004	1	1 of 5	Wave Swinger	Service Bulletin	15.01.2016	röt/hast
Original Ride Manufacturer			Release Date	Affected Production Dates:	Ride Name:	
ZIERER – Karussell und Spezialmaschinenbau			2016		Wave Swinge	er

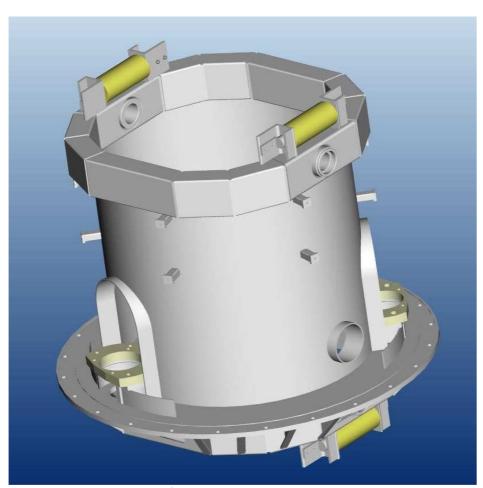
**Image 1:** 3-D model of the inner basket

The inner basket is one of the spots this service bulletin wants to focus on.

We want you to perform a visual check of the welding seams **once a month** and not like in the old revision of the NDT schedule once a year.

Please make sure that you clean the welding seams before each check.

At the bigger check (the first time after 12 years and than every 6 years (Y12 in testing schedule)) you have to check the welding seams either with magnaflux, paint penetration or ultrasonic method to make sure that there are no cracks.

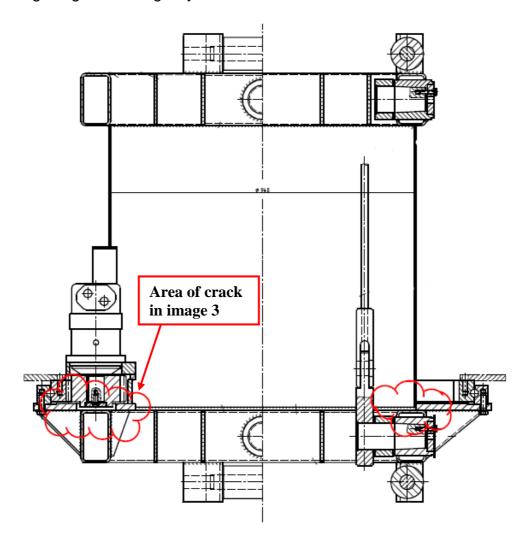
Image 2: Drawing of inner basket with highlighted areas

The following images should give you an idea where the most critical areas for cracks are

Check all of the welding seams on the basket, especially those in the highlighting clouds. Please inspect the seams in regular intervals and contact us if there are any complications.

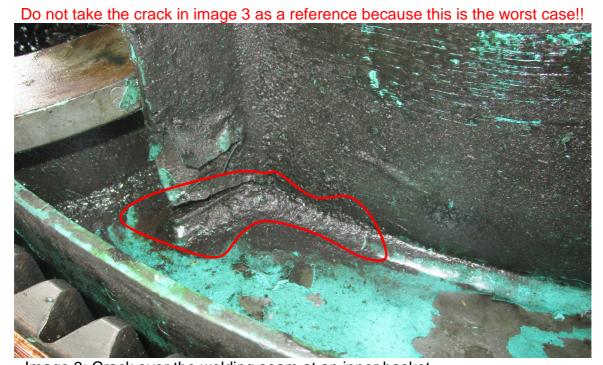
As a bad example we want to show you image 3, which displays an area of a basket which is cracked because of metal fatigue. Please note that this would not have happened if the owner of this ride would have performed regular checks.

Image 3: Crack over the welding seam at an inner basket

To identify a crack as soon as possible is very important according to the safety aspect. Another goal why you have to identify a crack as early as possible is the fact that fixing a little crack is a way more easy than a bigger one (Image 3).

If you see a crack it does not matter how big it is, you have to shut down your ride and fix all cracks by an expert in a proper way. To operate a ride with a crack is strictly not allowed!
