# NAFLIC

TECHNICAL BULLETIN — June 2016

## **413. Nottingham UK Miami - corrosion to over the shoulder passenger restraints**

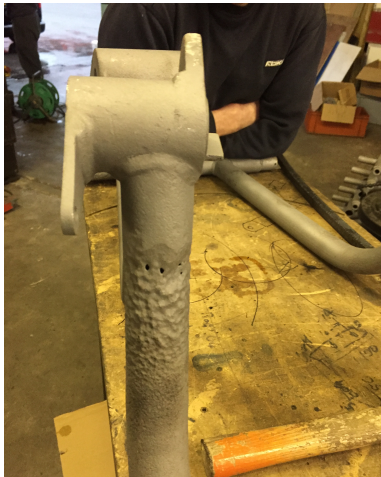
- 1) As part of the annual inspection, surface corrosion was noted at the hinge / tube connection point of the overhead restraint bars, the device has 16x single overhead units, the outer polyurethane (padding) covering was removed from 2x safety bars as a percentage strip down, the results can be seen from the 2x attached pictures, there is no documented history of this level of stripdown being carried out on this device- as such we shall assume this is a progressive corrosion over the life of the device – the padding once removed was found to have degraded and as such water and moisture was trapped – sponge like against the steel work.

- 1) miami; overhead lap bar stripped down – padding removed.

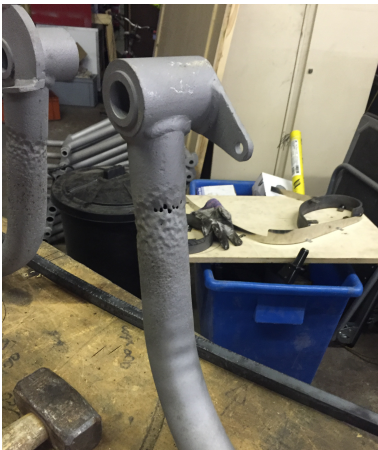
- 2) The remaining units were stripped down and 14 out of 16 were found to be in varying stages of extreme corrosion.
- 3) The manufacture has supplied 16x new units of which the steel work is galvanised.

- 2) showing corrosion of tube steel section.
- 3) Showing new safety restraint bars fitted.
