430.

## Huss Pirate Ship hub, axle, A-frames and main leg cracking

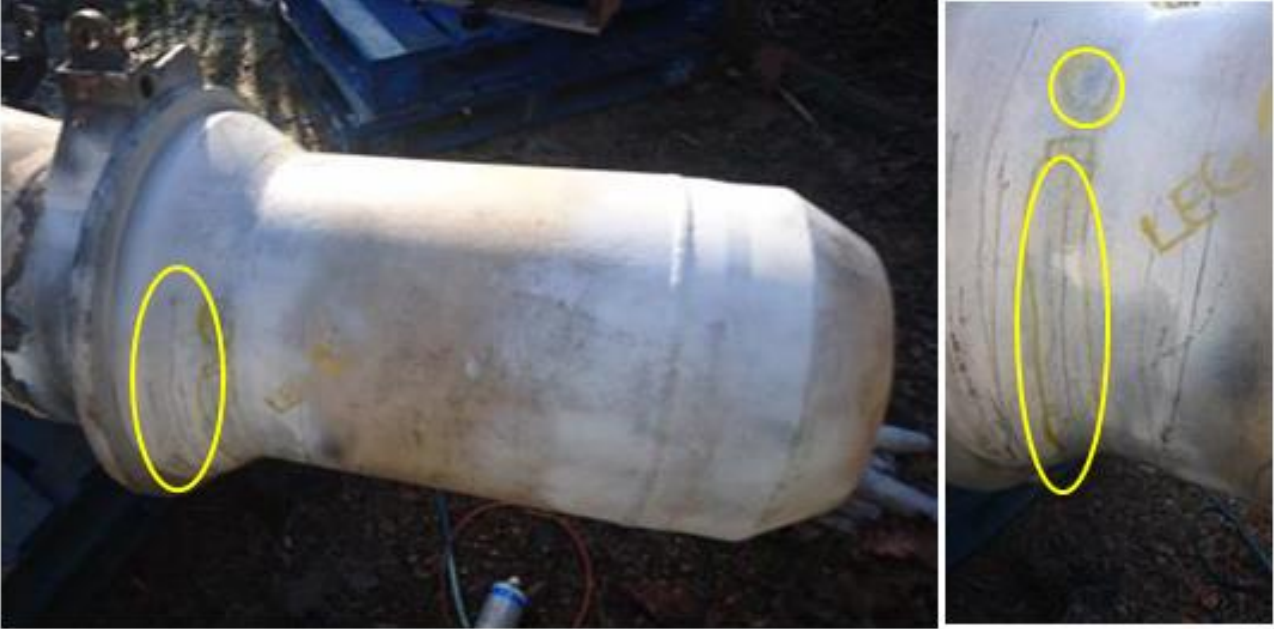
**Main leg spigot cracking (visual, mpi & UT)**

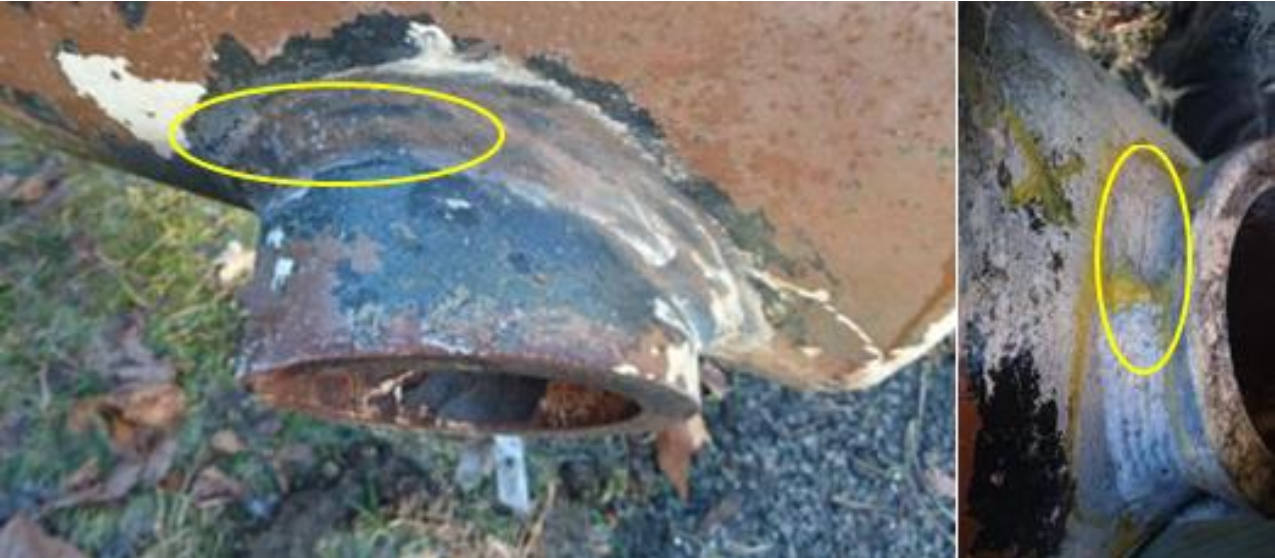
**Lower support leg bore circ welds cracking (visual & mpi)**

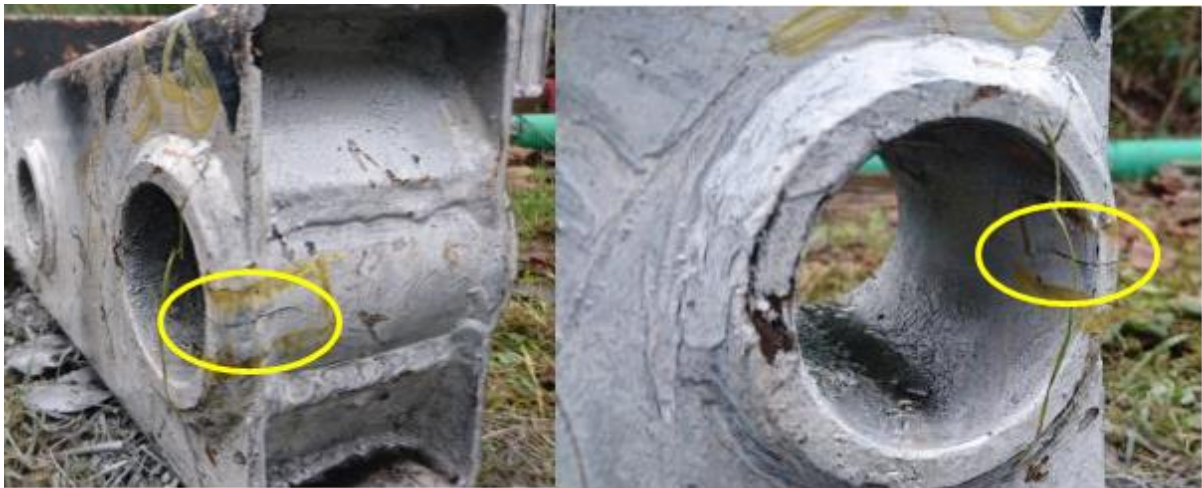
**A-Frame pin circular bore cracking. (visual & mpi)**

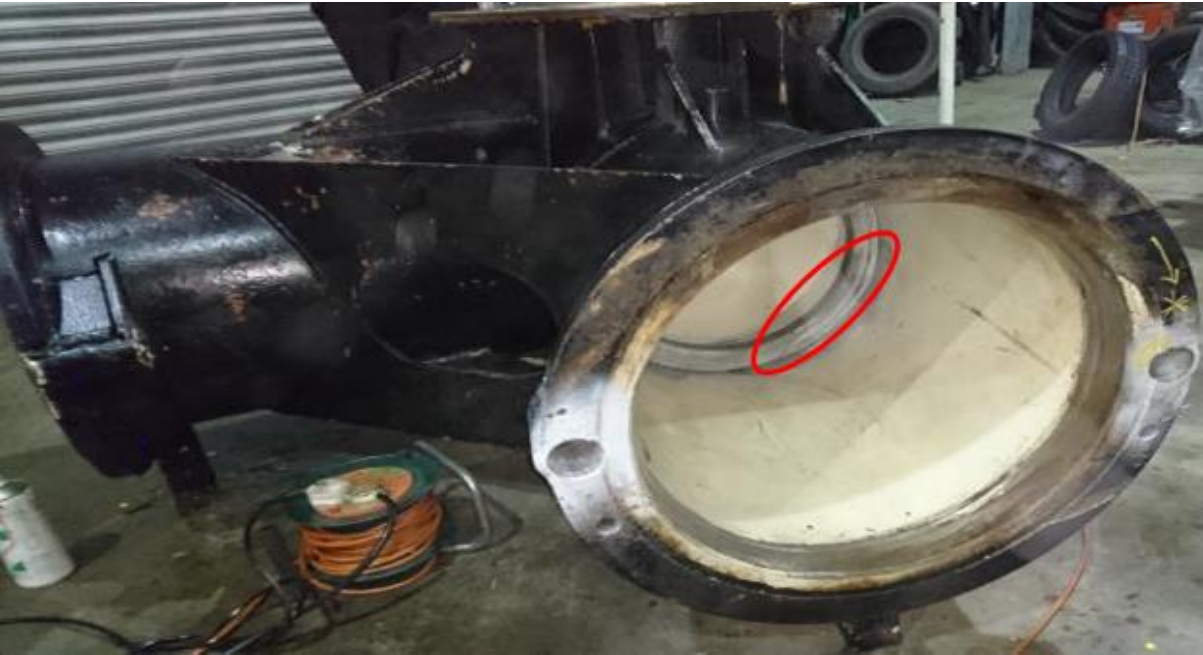
**Axle A-Frame** cracking on the internal spigot socket rings (visual, mpi & UT)

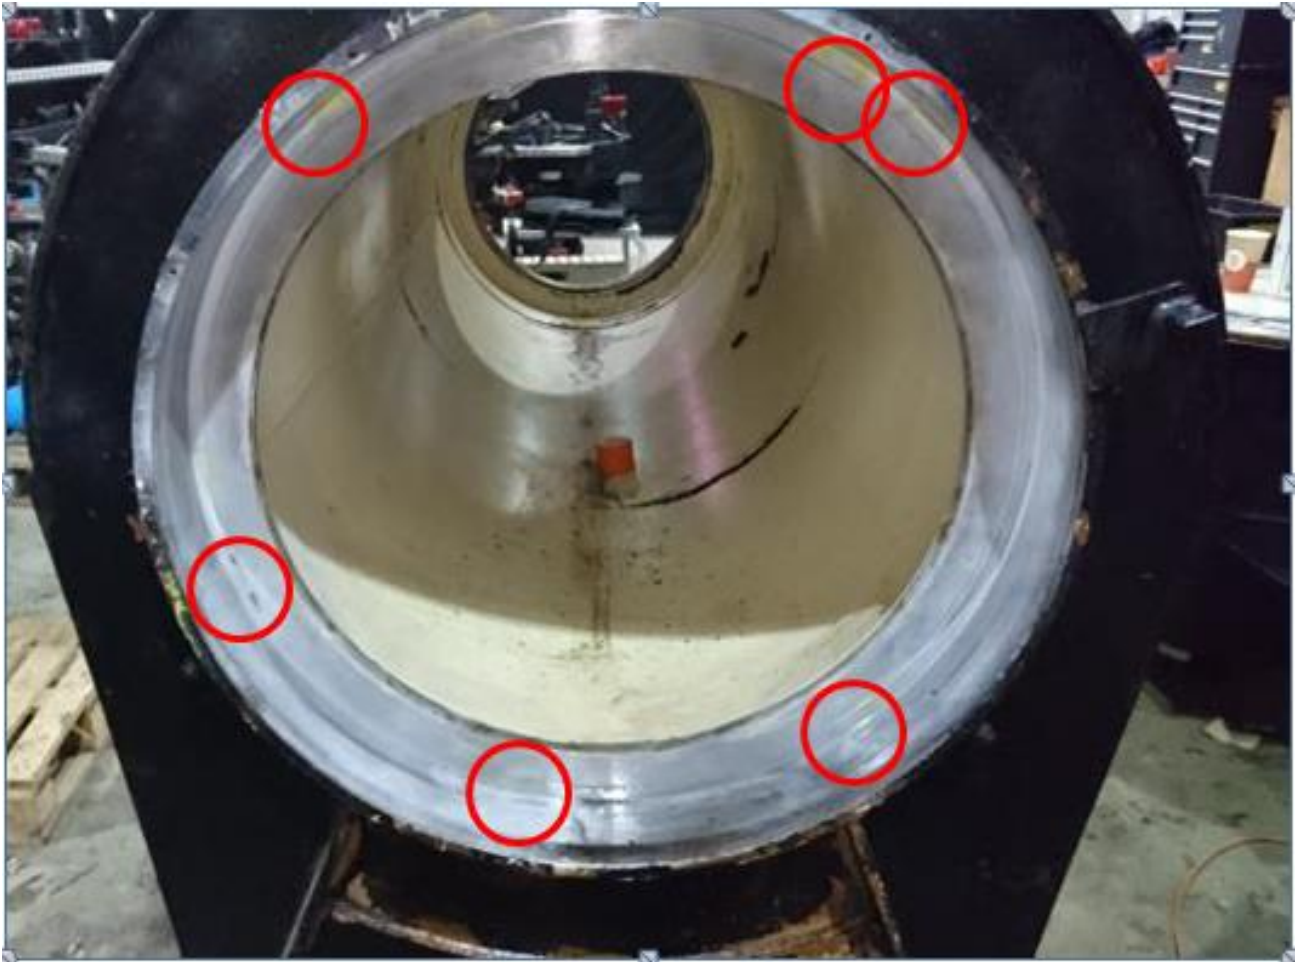
**Axle bearing face cracking (mpi)**
