450.

Climbing wall hydraulic cylinder failure

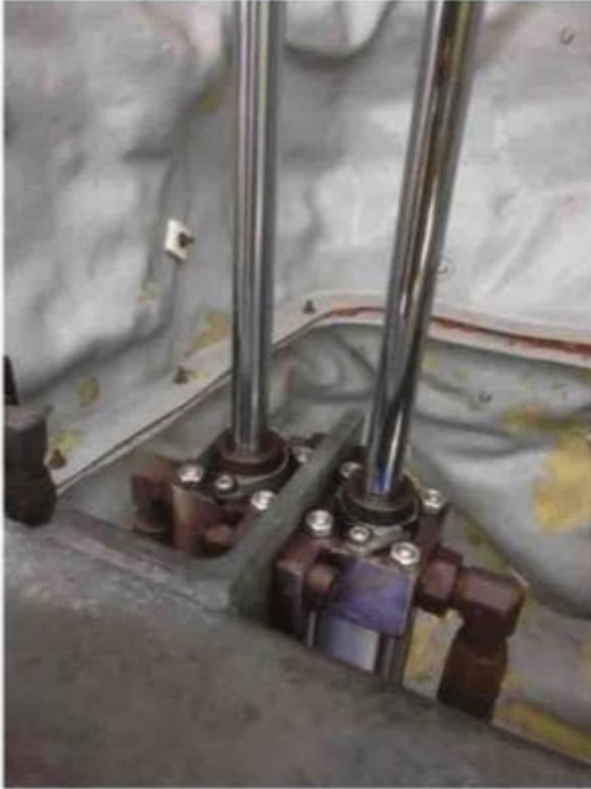
The image above shows the double cylinder set-up on the belay system and the two retaining caps secured by Alan key studs.
