477.

Zamperla Watermania radial arm cracking

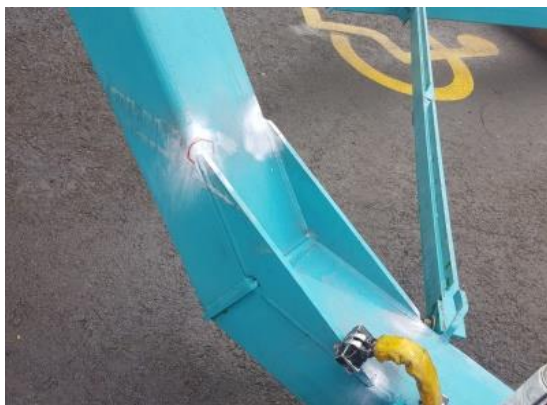
Figure 1

A UK registered inspection body has reported defects that have been found on the strengthening gussets at the change of angle on the radial arms of a Zamperla Watermania ride. The defects were found during the annual inspection of a device that is three years old.

It must be noted that additional cracking was also found once the paint was removed from all of the gusset areas on all other arms.

The manufacturer has been contacted and a weld repair procedure was obtained.
