## FAR Fabbri Crazy Dance fatigue cracks

# Technical Bulletin

**Issued by:** Dr. Eng Alberto FABBRI  
Based in 45032 Bergantino RO - Italy  
(Emesso da / Publi  par / Publicado por)

**Date:** 27 August 2019  
**Contact:** [alberto@fabbrirides.com](mailto:alberto@fabbrirides.com)

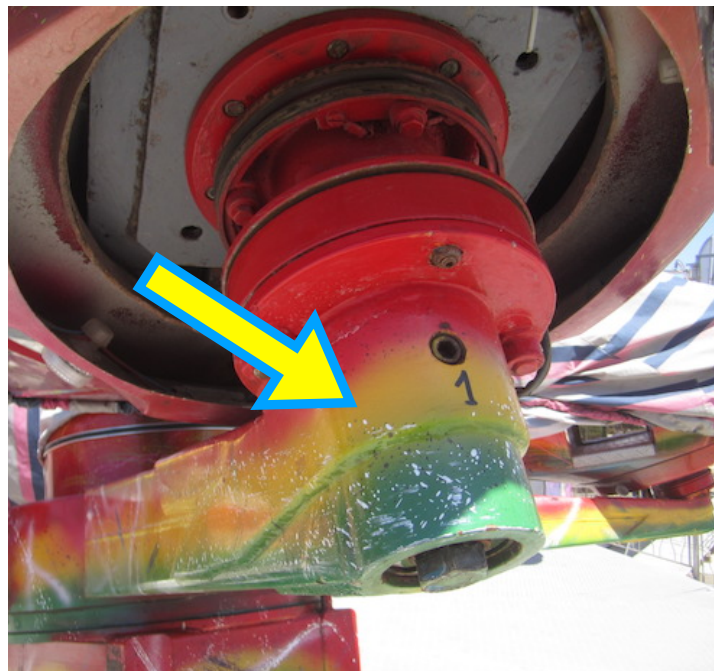
The axle is inside here / El eje esta aqu  dentro / Il perno   qui dentro / L'axe se trouve dedans ici

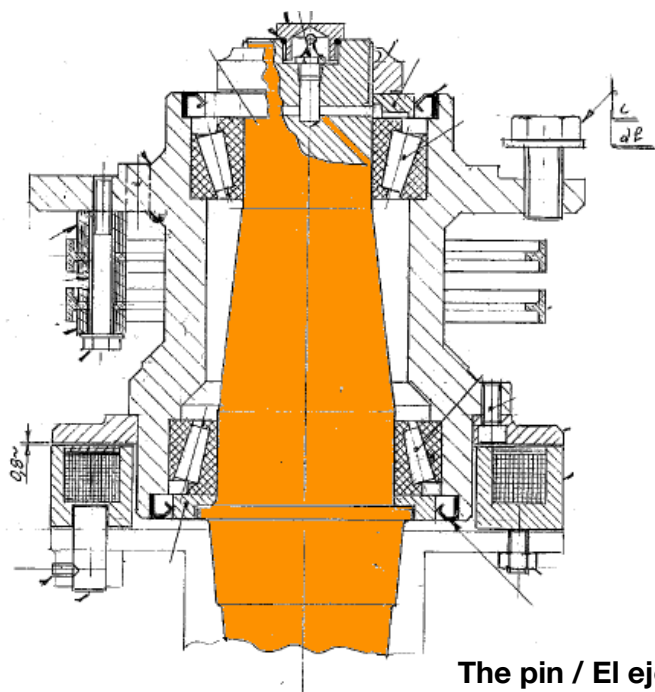
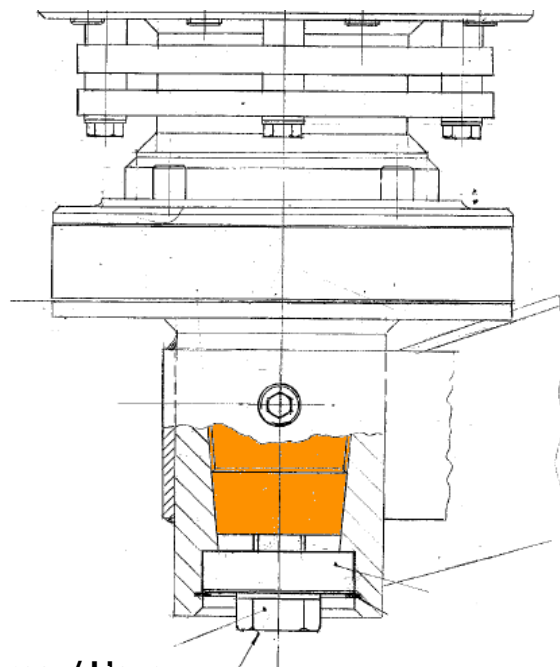
**English:** The pin (in orange colour in the two pictures here below) holds the gondola and is fixed on the arm of the satellite. The bottom part (root) has been found cracked in several gondolas (see two bottom photos). I suggest to have all pins NDT MT checked as soon as possible.

The pin / El eje / Il perno / L'axe

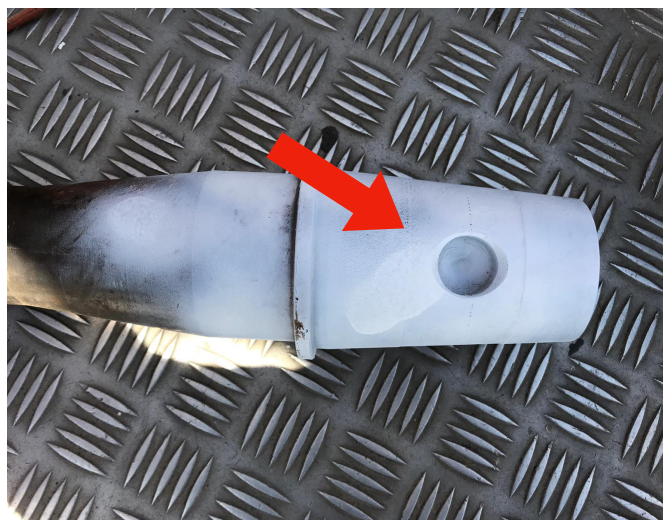
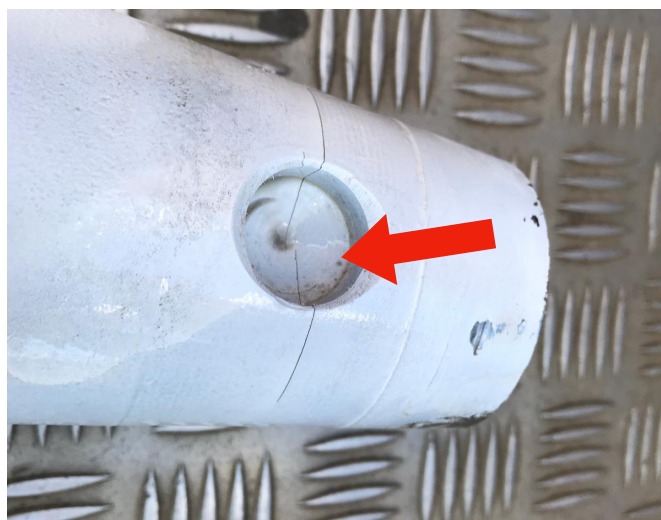
During our activity of NDT inspection of weldings on amusement rides we found in one attraction CRAZY DANCE, originally manufactured by FAR Fabbri (Italy) approx. in year 1997, fatigue cracks on several main axles of the passenger's vehicles.

The cracked pin / El eje agrietado / Il perno criccato / L'axe fissuré
