489.

## Dal Dragon coaster carriage to carriage coupling failure

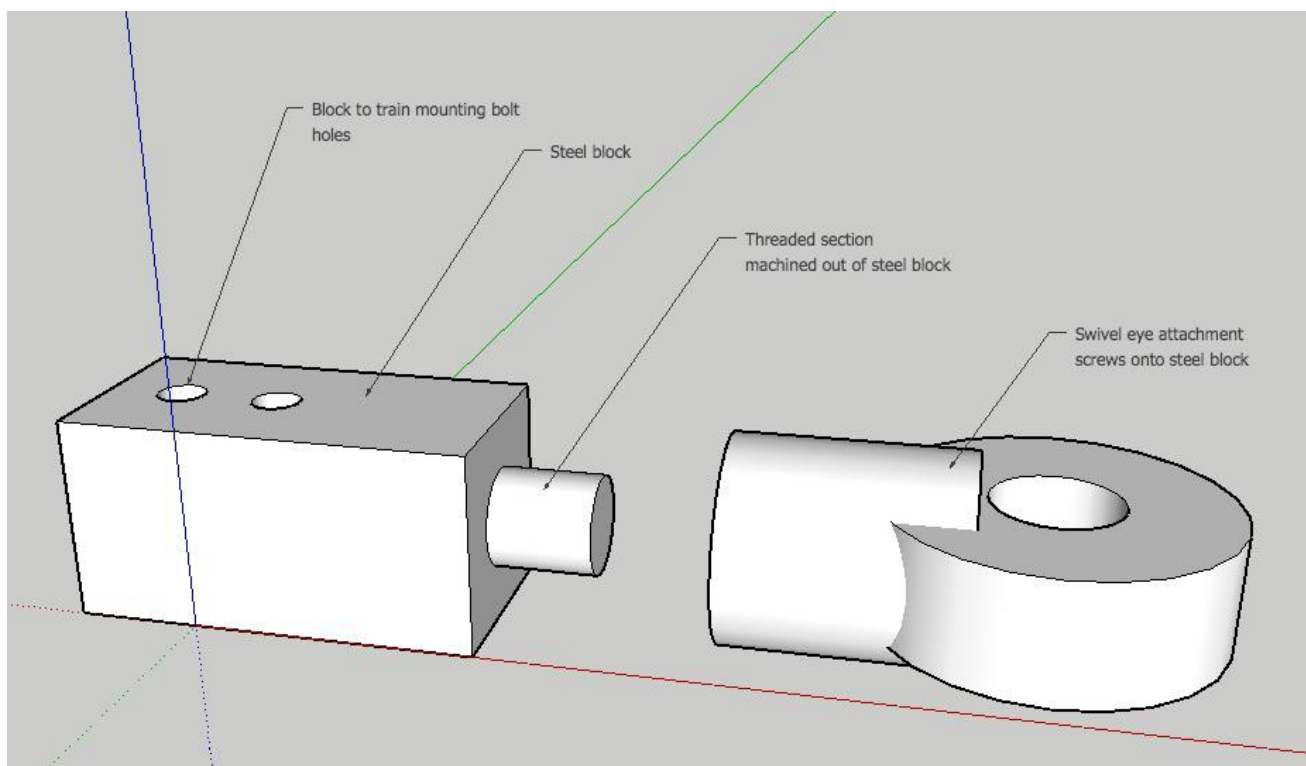
NAFLIC has received a report from a UK inspection body relating to the thread on the carriage to carriage coupling failing on a Dal Dragon type coaster. The device was manufactured in 2005.

This failing allowed the drive carriage to become separated from the rest of the train during a ride cycle, the result being that the drive carriage skewed sideways and jammed on the tracks, while the rest of the train proceeded partially up the next hill only to lose momentum and roll back into the drive carriage. The operator activated the emergency stop and no one was injured by the relatively low speed collision.

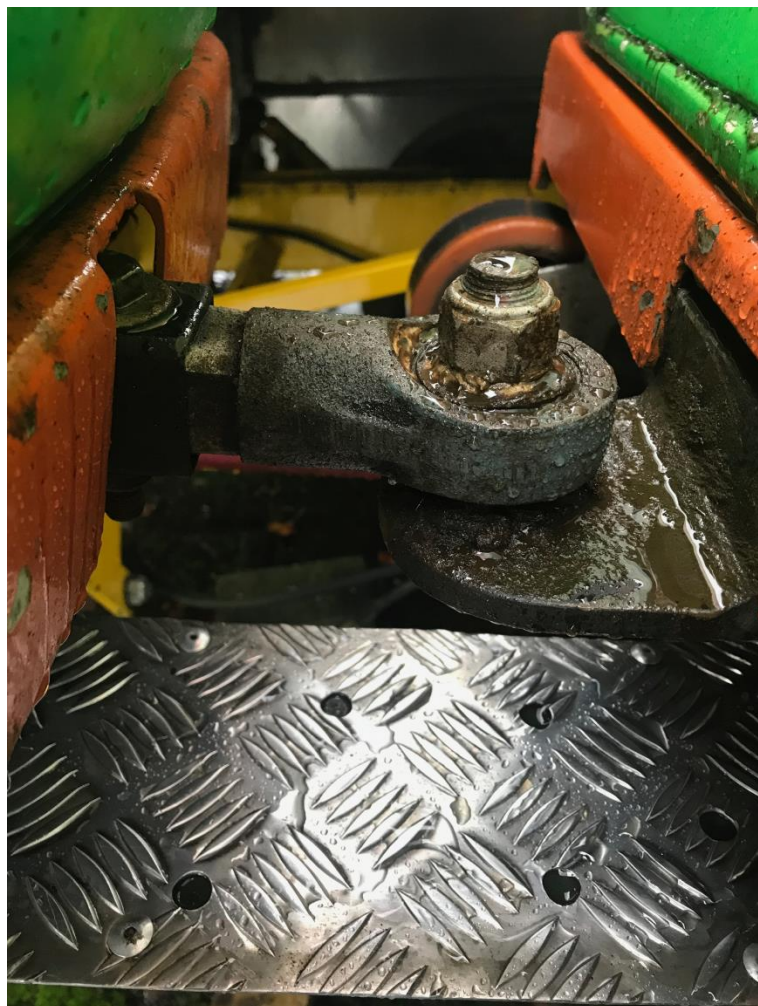
Normal connection

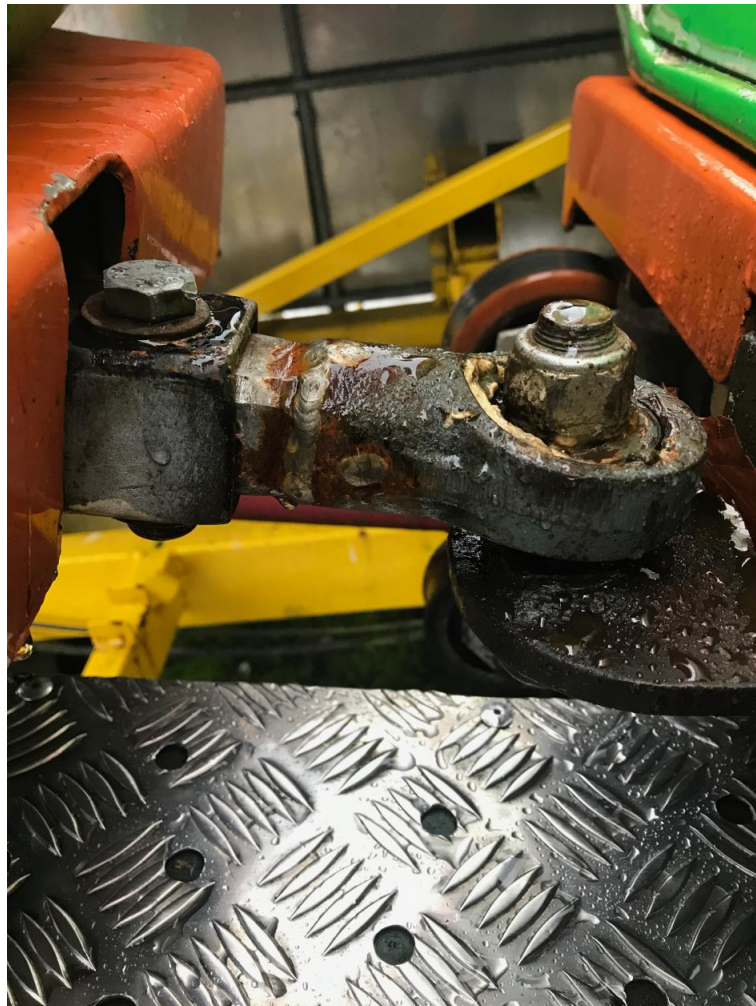
It is noted that this was a previously failed component comprising two parts of dissimilar parent metals. The welding of two different materials is a specialist technique and should only be performed by a competent person. It would generally be the case that this design of coupling would have a secondary linkage.

Weld repair connection (not advised)
