492.

J.Crick manufactured bungee trampolines frame cracking

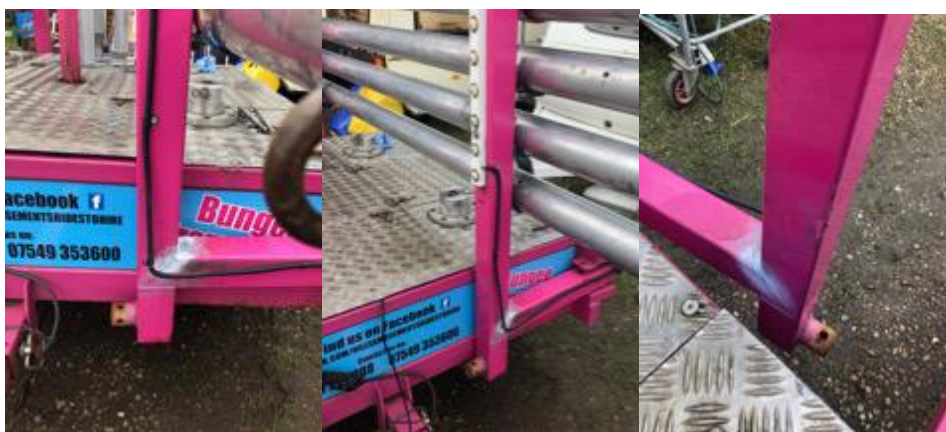
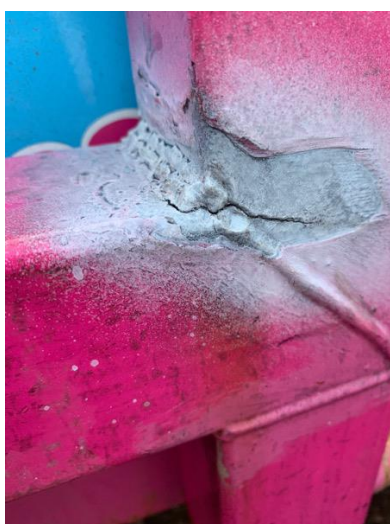
NAFLIC has received a report concerning a J.Crick 4X1 bungee trampolines attraction built in 2009. This relates to cracks found in the outrigger/support frame section of the device (see accompanying photographs).

Cracks were found in the parent material as well as joining the 45 degree welded section. An image of the largest crack is included here. Each side of the upright is cracked on all four frames, with the average length of crack being 25mm.
