502.

IE Park JR Coaster front axle cracking

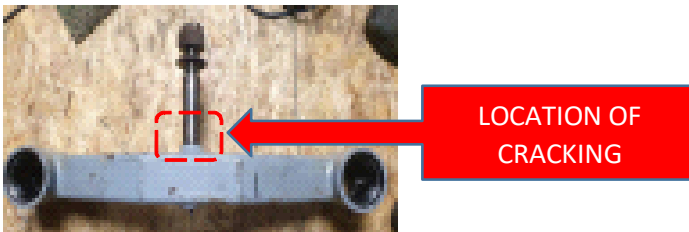
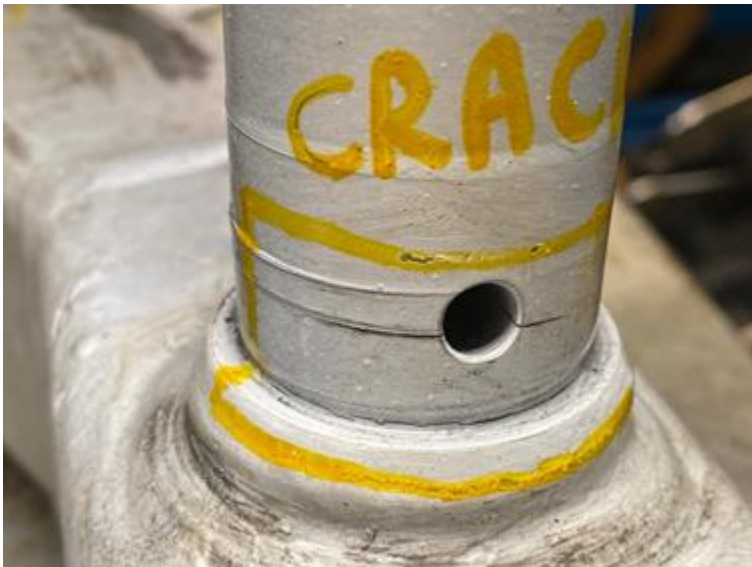
NAFLIC has been informed that two areas of cracking have been identified on a front axle of an IE Park JR Coaster during an annual inspection, via Magnetic Particle Inspection (MPI).

It is recommended that suitable NDT inspection should be performed periodically to identify possible cracking on all safety critical train components, taking note of any stipulations made by the device manufacturer, design reviewer and inspection body.
