505.

Surface corrosion of padded restraints

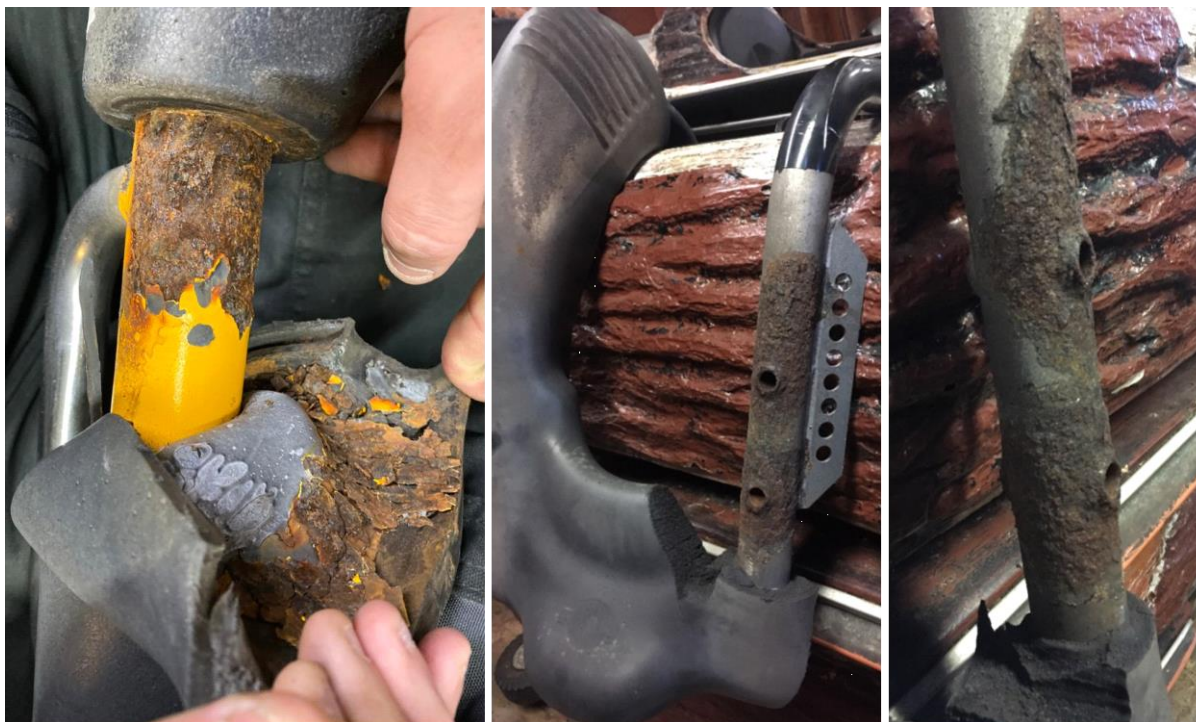
A UK inspection body has identified surface corrosion on a variety of padded restraints on a number of roller coasters and flat rides in recent years. Water ingress has been permitted by deteriorating padding adhesion or disruptions to the padded surface such as fastenings for handles, seat belts or where padded elements have been formed in multiple segments.

The components involved include over-head restraints, padded lap bars and other padded elements of passenger containment system, including handrails.

It is suggested that suitable NDT techniques such as visual or radiographic (x-ray) inspection should be performed periodically on all safety critical padded components operating in potentially corrosive environments, taking note of any stipulations made by the device manufacturer, design reviewer and inspection body. Such results should be interpreted by a competent person and further investigative work such as padding removal performed where evidence of thinning is detected. Consideration should also be given to the water retention properties of padding materials/restraint design and the environment in which it is anticipated to operate by the design reviewer at the time of Pre-Use Inspection.
