KMG 'FRB16' Freak Out – possible cause of a failure to a trailer structure

Bulletin No:	FRB16-N003
Release Date:	Oct 26 th 2021
Effective Date:	Oct 26 th 2021
Supersedes:	None
Completion Date:	See text
Page:	1 of 3

NOTIFICATION

Ride Mfg:	KMG International BV	Affected Production Dates:	All
Ride Name:	FRB16 or Freak Out	Affected Serial Numbers:	01 through 62
Model Number:	FRB16		
Abstract of Issue: Trailer structure

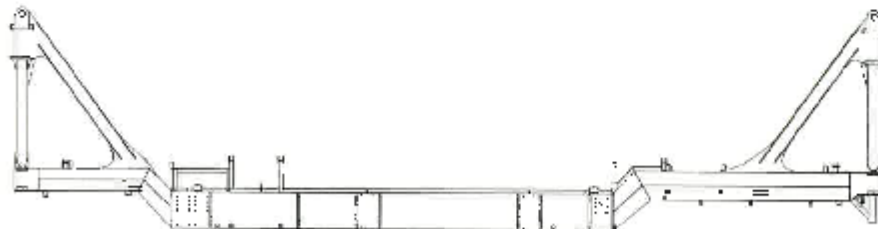
Trailer structure

Recently KMG International investigated the possible cause of a failure to a the trailer structure of a KMG "FRB16" freak out ride. The failure relates to a formed section located midway down the trailer's side. This part of the trailer functions as the side and top wall of the center ballast tank which is filled with water during the operation of the ride.

After investigation it has been determined that that the cause of the failure was improper maintenance of in particular the trailer structure that caused the structure to bend and fall.

- Improper and inferior maintenance of the tank in regards to surface material preparation, priming and painting.
- Several improper and unauthorized welding repairs that were made to the trailer structure.

All owners of "FRB16"/Freak out rides should perform a thorough check of the trailer structure of the ride for any irregularities, not limited to the mid-section of the trailer. Hereby it must be noted that no welding is allowed to the ride without written confirmation of KMG International including the repair or installation of any brackets of any type whatsoever other than those originally present at first delivery. Any irregularities, repairs or brackets not originally installed by KMG International must be documented and reviewed by an inspector for proper execution.

In addition, all owners of "FRB16" rides should perform a check on the trailer structure of the ride for improper and inferior protective paint layers. This check shall include the interior bottom, side and top walls of the center ballast tank, and all outer walls of the trailer structural assembly.

Any locations where the protective paint layer shows signs of degradation should be addressed appropriately. In locations where paint layers have faded or paint layers have flaked in such way that the steel structure is compromised, additional measurements of structural wall thickness must be performed and compared to base thickness to determine if there is loss of wall thickness prior to new surface treatment.
