514.

Fairmatt Miami ride arm cracking

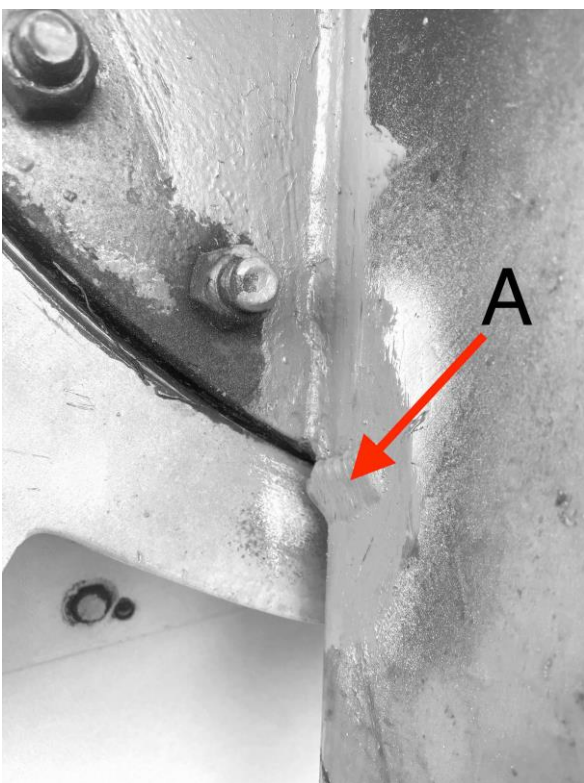
During the NDT inspection of a Fairmatt Miami ride (built in 1993) cracking was found on one of the main drive arms. The cracking was where the box section arm is welded to the drive ring plate (Point A on the attached image). While it is not unheard of for this ride type to crack in this location, this particular ride had cracking in the same area on both sides of the same drive arm and this cracking had returned through a previous weld repair.

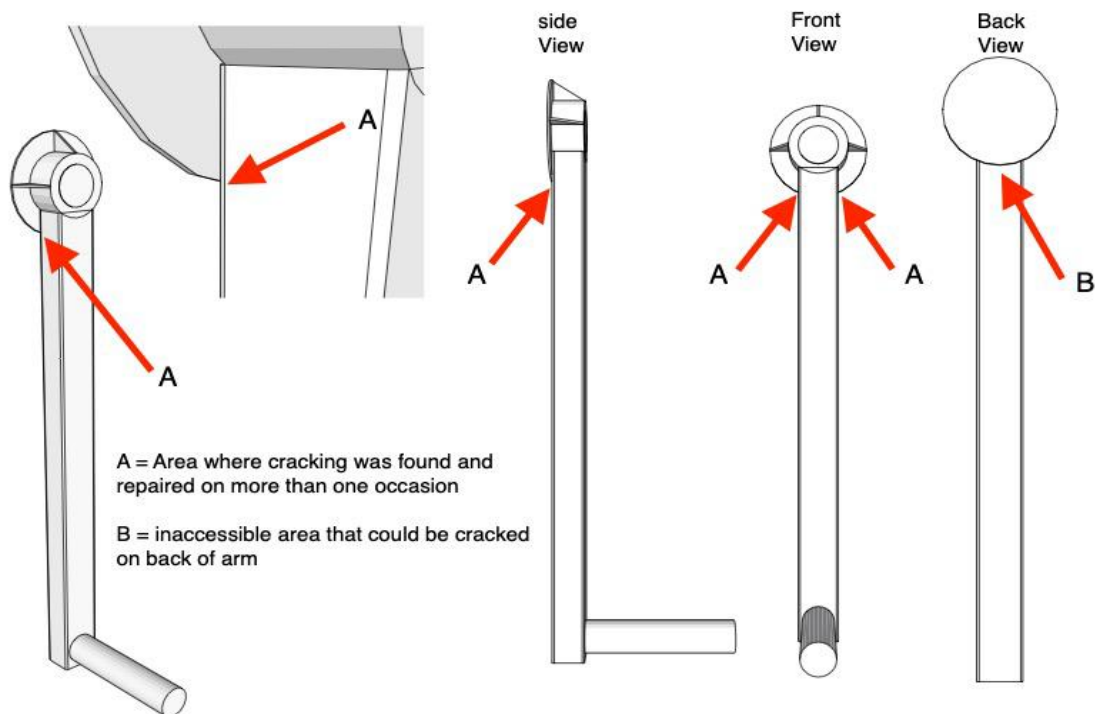
The back of the drive arms are not accessible due to the drive gear ring teeth and access can only be obtained by completely removing the arm from the ride. It is worth noting that generally this procedure cannot be completed “in the field” and may require significant down time.

The return of the crack would suggest that the initial weld repair was unable to cover the full length of the crack. It is possible that this is because the crack has propagated around the back of the arm into the inaccessible area. The fact that this ride has cracking in the same areas on both sides of the one arm could suggest that the crack has penetrated the full length of the back of the drive arm (area B on the second attached image).
