517.

## Frog ride arm cracking

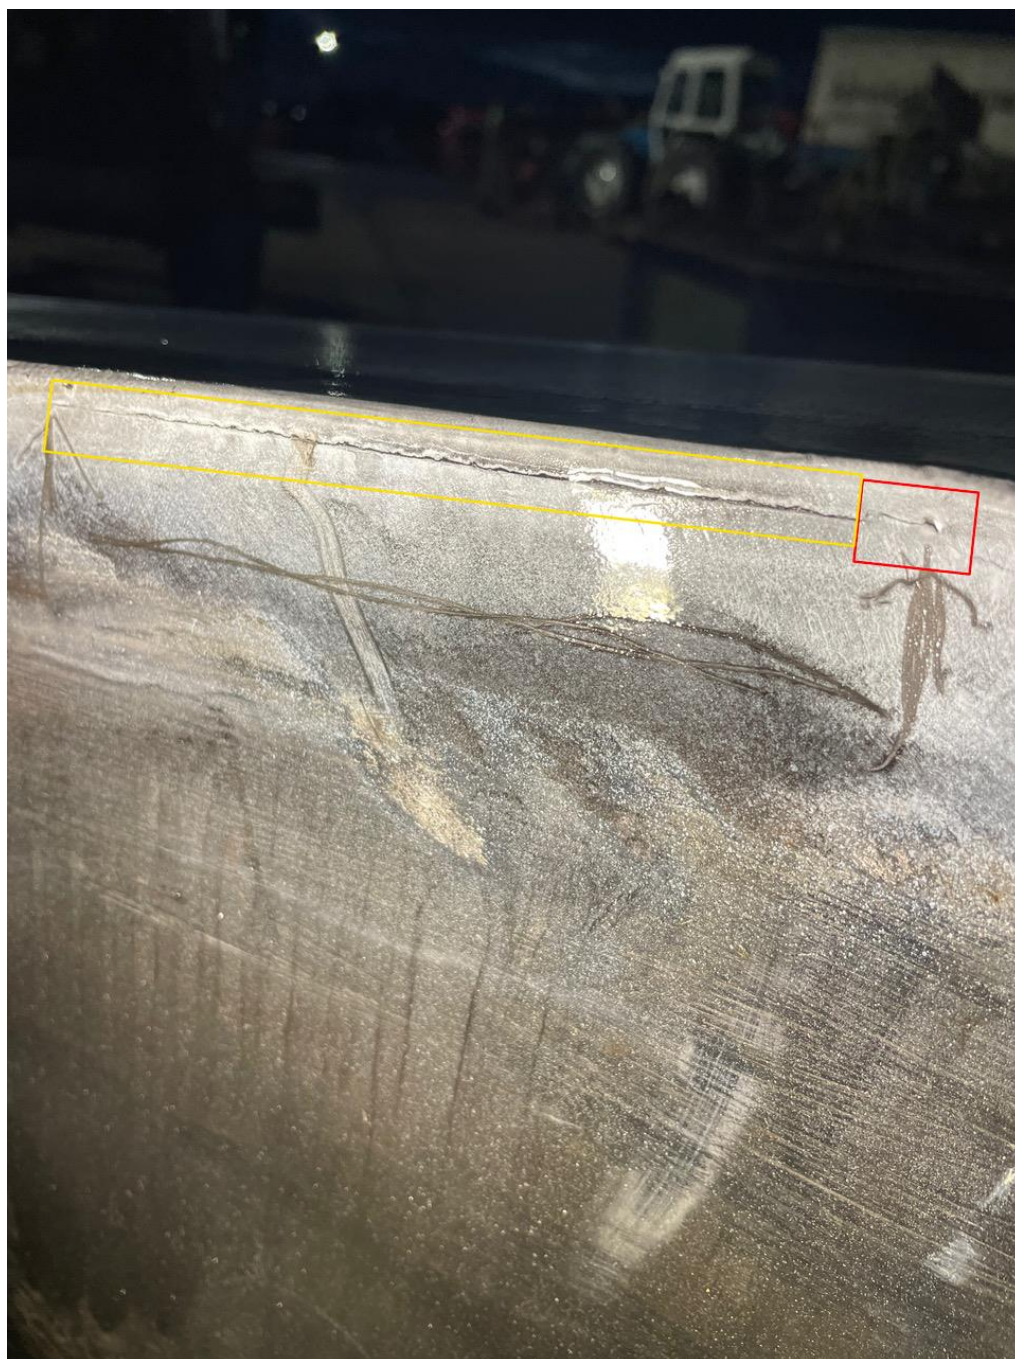
NAFLIC has been informed by a member inspection body that during the in-service inspection of Frog ride 09745 (in June 2022), Capital Inspection found a 3-4mm indication in one of the arms of the device. The arm was taken out of service and removed from the ride for further inspection. It was fully stripped down and re-inspected with both eddy current and MPI, the findings being that the indication was closer to 200mm long and that it followed the joint between the side plate and the top plate of the arm.

The image attached shows the indication found by Capital Inspection in the red box and the rest of the indication found after the arm was stripped in the yellow box.

It is possible that the original indication started at the default in the red box and has then gone on to follow the joint line between side and top plate because this weld had poor fusion.
